BREAKDOWN OF THE IMPELLER WHEEL OF A TG2 KAPLAN TURBINE

The paper deals with the investigation of the breakdown of the impeller wheel of a TG2 Kaplan turbine with the power of 36 MW that was operating for only 6.5 years. To find the cause, both methods of investigation of mechanical properties and analyses of microstructure and micrographics were used. On the basis of the results of individual analyses we found out that the primary cause of the impeller wheel breakdown was inconvenient material of the servomotor rod.

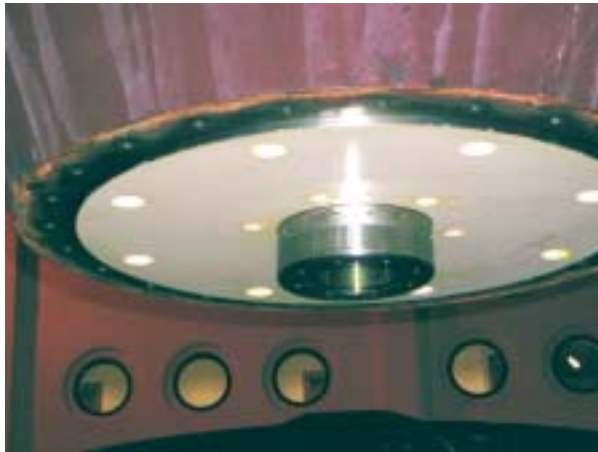
After extracting the turbine impeller wheel from the chamber and dismantling its bottom it was found out that the rod of the servomotor was extruded downwards by about 4.2 cm (Fig. 1). On its upper part it can be seen that there is a fracture of the whole rod cross-section just under its flange (Fig. 2). The fracture has a fatigue character in the constitutive part of its cross-section (Fig. 3), while the initiation of the fracture was from the gasket and slot from

Fig. 1 The rod extrusion from bottom bearing

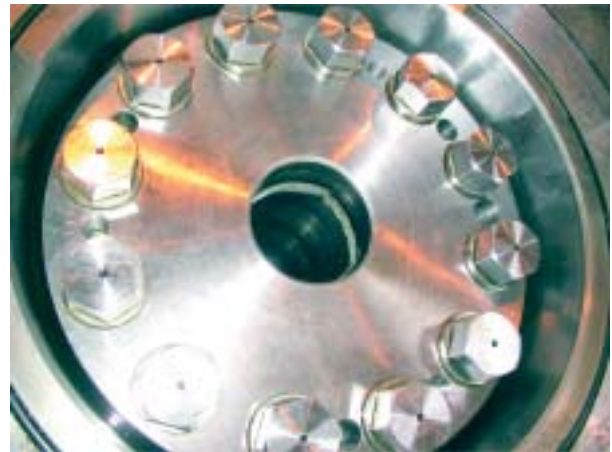
Fig. 2 The fracture of the rod under its flange

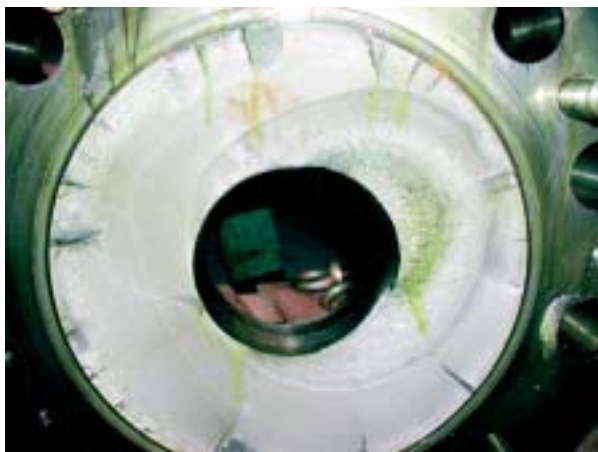
Fig. 3 The fracture of the rod

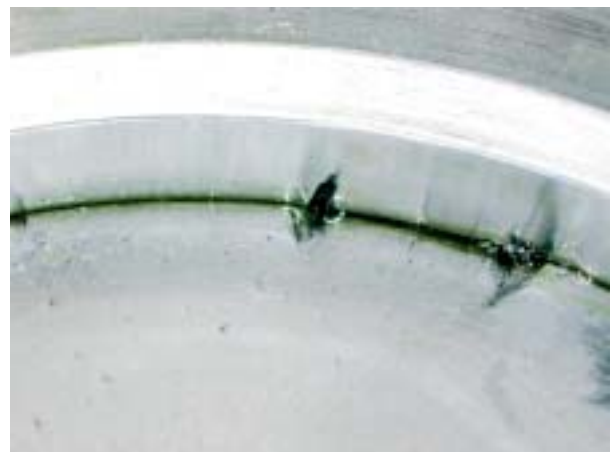
various parts over the whole perimeter of the crossing area. The parts of the damaged gasket (Fig. 4) and forged pieces of metal

Fig. 4 The parts of gasket between the rod and the body of the turbine rotor

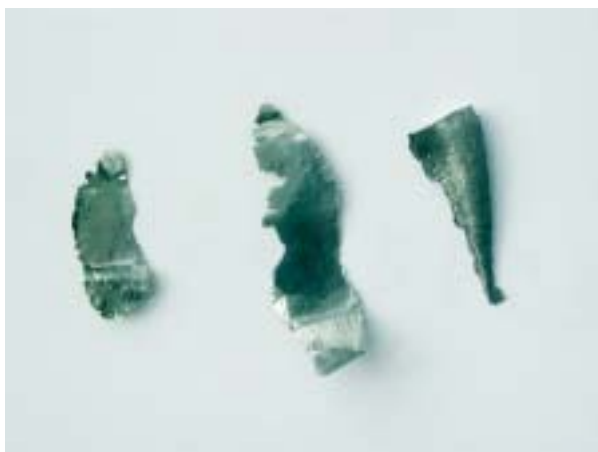
caused by the crack growth were on the surface of the fracture. The thickness of these pieces ranged from 5 to 14 μm (Fig. 5).

Fig. 5 Forged pieces of the rod

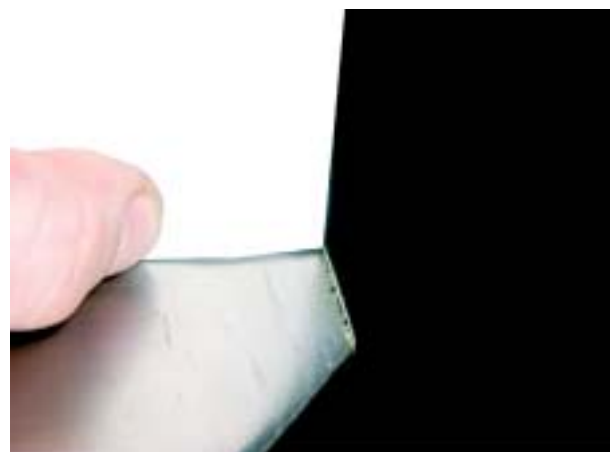
Fig. 6 Extruded material on the edge of the vane

By inspecting the impeller wheel we found out that there are areas without biological corrosion on the external circumference of the vanes. It means that the vanes had a direct contact with the turbine chamber when moving. This presumption is confirmed by the extrusion of material on the whole circumference of the vanes (Fig. 6) and by a continuous glossy track created by a mechanic contact with the vanes (Fig. 7).

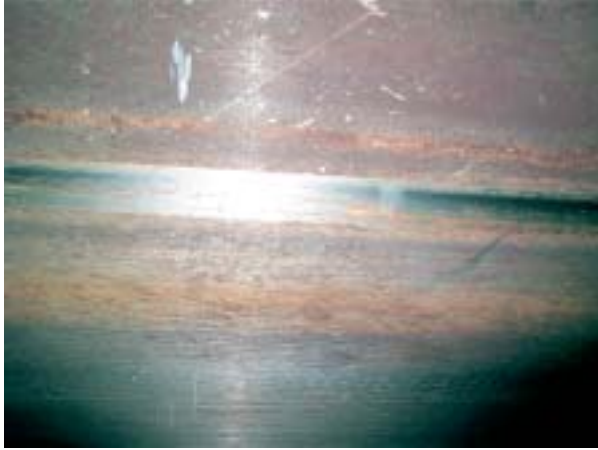
Fig. 7 The failure of the chamber surface of the turbine by wear from vanes

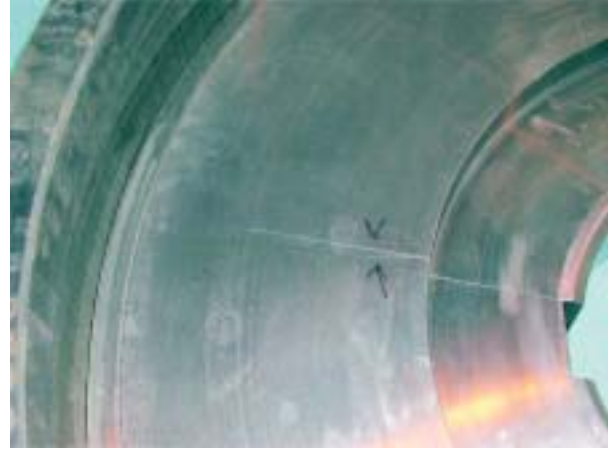
Fig. 8 The crack in the piston of the servomotor

By dismantling the servomotor cylinder it was found out that there is a crack on the piston. The crack is growing in the direction to the external diameter approximately to the two thirds of the diameter (Fig. 8). On the crack tip it is visible that the material of the piston is plastic (Fig. 9). This is typical for crack growing. On the contact area of the matrix that secures the position of the piston on the rod and transmits the forces from the piston to the rod,

The failure of the piston by the crack could be caused by concentration of tensions in the slot for spring, by a directed structure after rolling or by a structural non-homogeneity of the piston material. The contact fatigue on the rod matrix verifies a mutual micro motion between the piston and matrix (pulsating tension) that could contribute to the origin of additional loading of the piston.

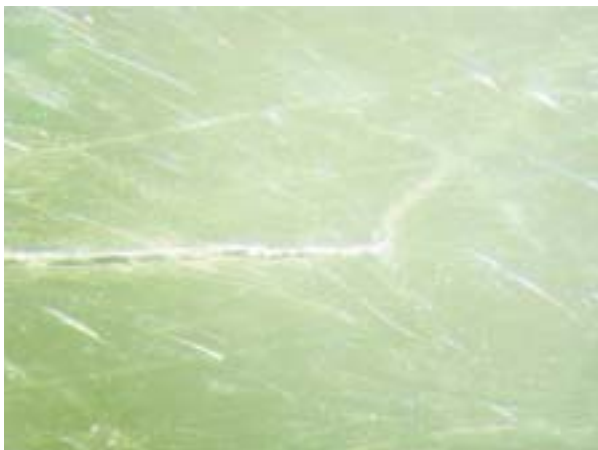
Fig. 9 The detail of the crack end on the piston

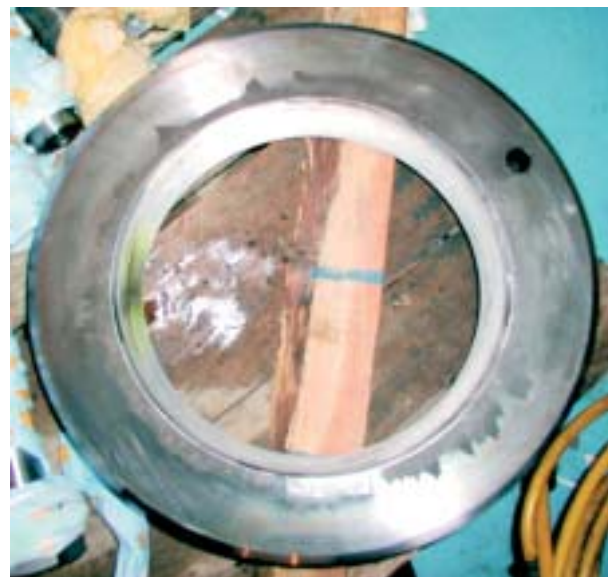
the maps with a changed surface quality were found out (Fig. 10). It is typical for contact fatigue.

Fig. 10 Pressing of the matrix surface

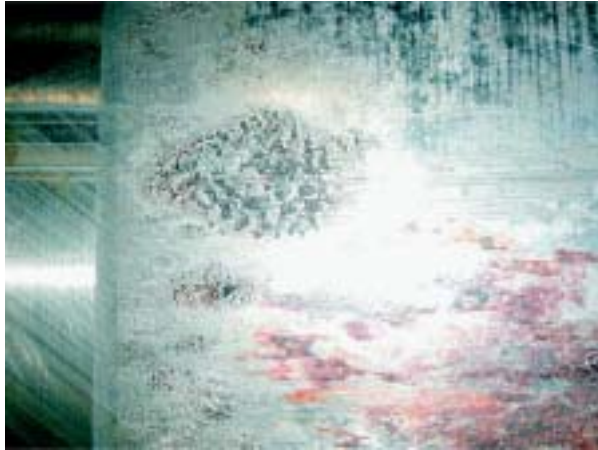
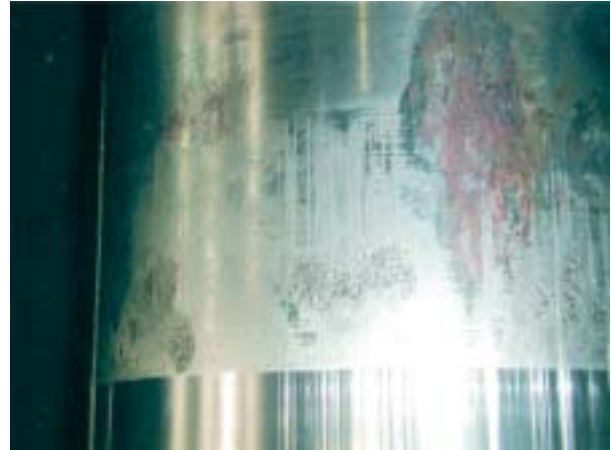
After complete dismantling of the impeller wheel it was found out that the rod is damaged by longitudinal lines and there is a large failure by contact fatigue – pitting (Figs. 11 and 12) on the functional areas of the rod.

Fig. 11 Deep pittings on the functional surface of the rod

Fig. 12 Deep and shallow pittings on the functional surface of the rod

functional areas of the rod and impeller wheel proves that the rod has a relatively big side oscillation that caused contact wearing and contributed to the total fracture of the rod. The side oscillation operated as an additional tension (bending) and it was superimposed on the longitudinal tension from the piston. The oscillation could be caused by asymmetry of the loading from the piston or by the impact of centripetal forces caused by oscillation of the whole impeller wheel.

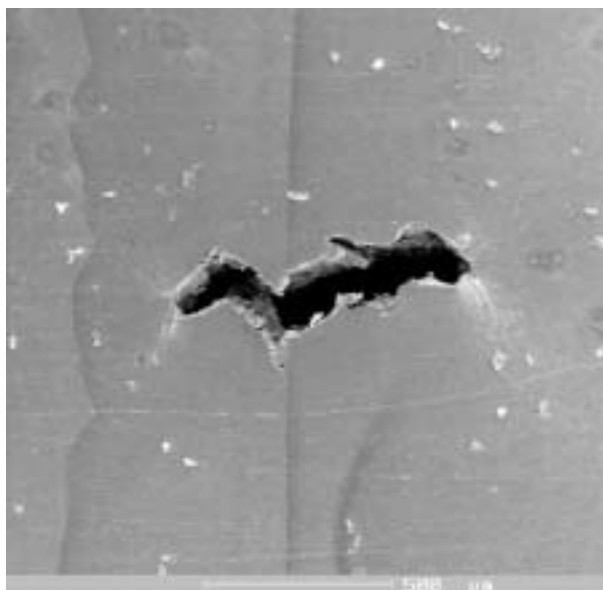
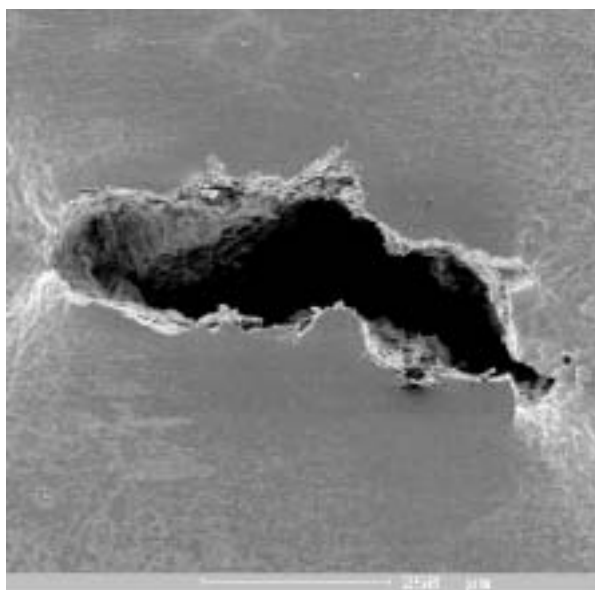
In the area of larger cracks (Figs. 13 and 14) a creation of slip lines – plastic deformation on the crack tip is observed. The creation of cracks is probably conditioned by presence of inclusions in the material structure. These inclusions are non-coherent and hard. They cracked by loading and they got separated from the basic material (Figs. 15 and 16) and it means that they served as micro cracks nuclei.

Fig. 13 A crack on the surface of the testing rod, REM

Fig. 14 A different crack, plastic deformation on the crack tip, REM

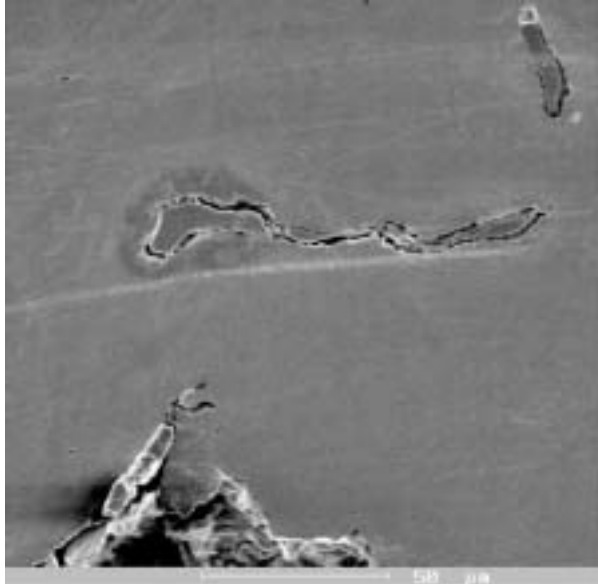
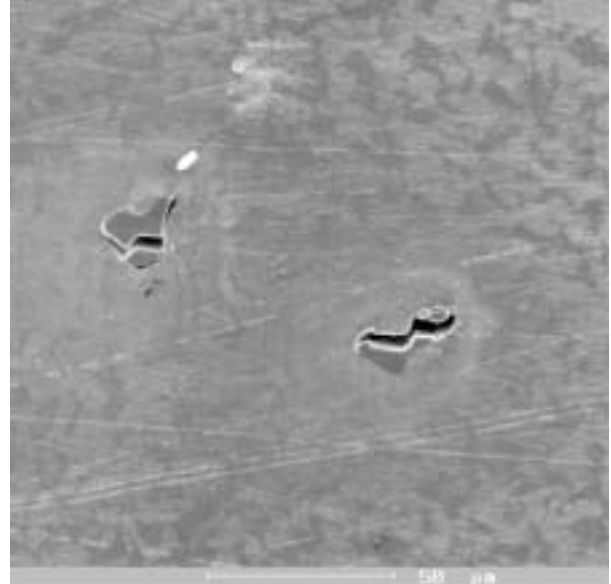
Fig. 15 The separation of an inclusion from basic material, REM

Fig. 16 Cracked inclusions on the surface of the testing rod, REM

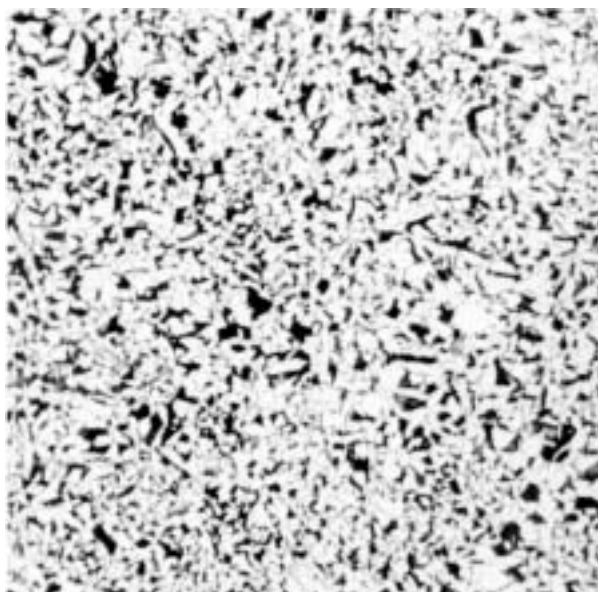
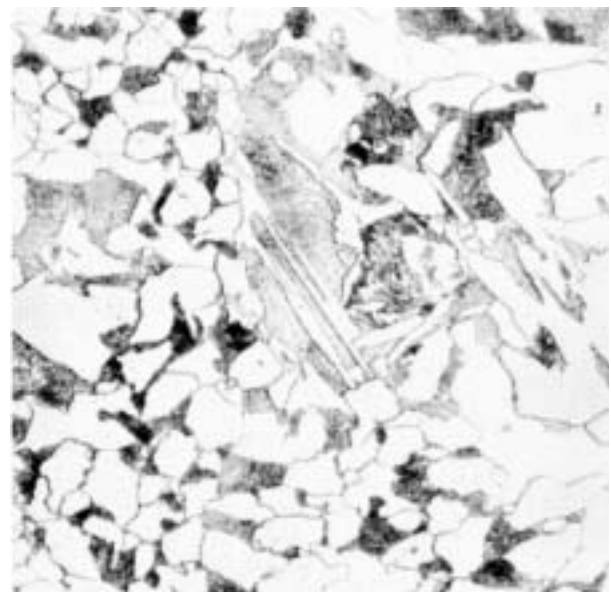
Steel structure is irregular, ferritic-pearlitic, created by grains of different sizes. Pearlite is lamellar in many cases, but it also exists in a spheroidic shape that corresponds to soft annealing. The size of ferritic grains is also very different. Moreover, it exists in the shape of Widmannstätten structure in many cases. Spheroidic pearlite is created by soft annealing that is realized at heating of material just under AC1 and leaving it at this temperature for some hours. In the case of the evaluated rod, a partial spheroidization occurred by slow cooling of the rod after forging. On the other hand, ferrite in the shape of Widmannstätten structure is created by rapid cooling

Fig. 17 Ferritic-pearlitic structure, a longitudinal section, 100x, etch. 3% NITAL

Fig. 18 Ferritic-pearlitic structure, a diagonal section, 400x, etch. 3% NITAL

The metallographic evaluation shows that the microstructure of steel is irregular, ferritic-pearlitic created by grains of various sizes (Figs. 17 to 22) while pearlite is lamellar in many cases but it appears also in a spheroidized shape and in many cases in Widmannstätten structure. It results from these facts that the inadmissible state of the structure was caused by wrong the heat regime at the production. The inclusions occurring in the structure were separated from the basic material and they operated as the crack nuclei (Figs. 15 and 16). At mechanical loading, the cracks were created around the inclusions at the tension just over the yield stress.

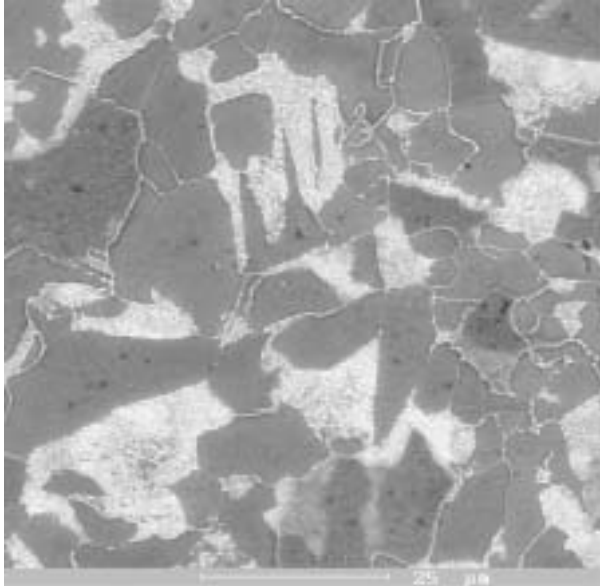
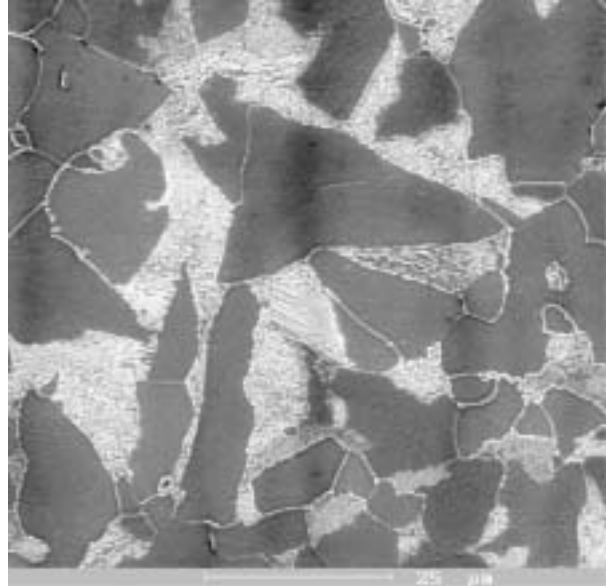
(Figs. 19 and 20) and there are grains of a very small ($6 \mu\text{m}$) size and of very large sizes ($45 \mu\text{m}$).

Fig. 19 Ferritic-pearlitic structure, a longitudinal section , REM

Fig. 20 Ferritic-pearlitic structure, a diagonal section , REM

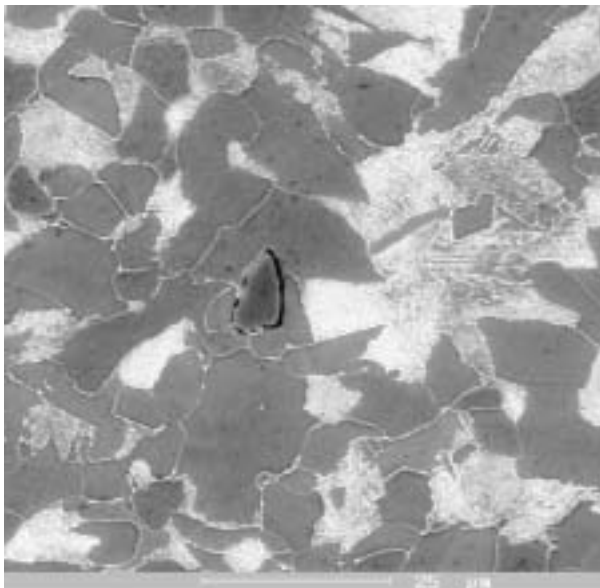
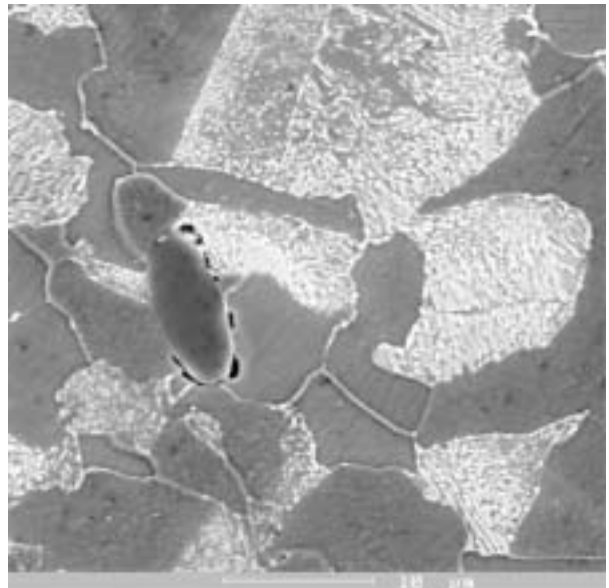
Pearlite is of a lamellar character in some grains and globular in others. Sporadically, Widmannstättenic ferrite was observed in the areas with near by big grains. Except for very irregular grains, inclusions of various shapes and parameters occurred in the structure (Figs. 21 and 22), while they nearly always had a non-coherent interface. The separation of inclusions from the matrix is probably caused by a long-term dynamic loading with a relatively high amplitude (in the relation to fatigue properties of the evaluated steel).

Fig. 21 The presence of an inclusion in the material structure, irregular size of grain, REM

Fig. 22 The detail of ferritic-pearlitic structure with occurrence of an inclusion, REM

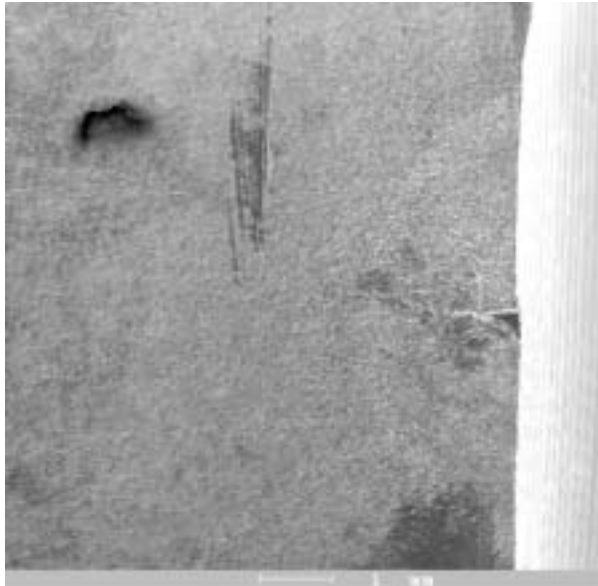
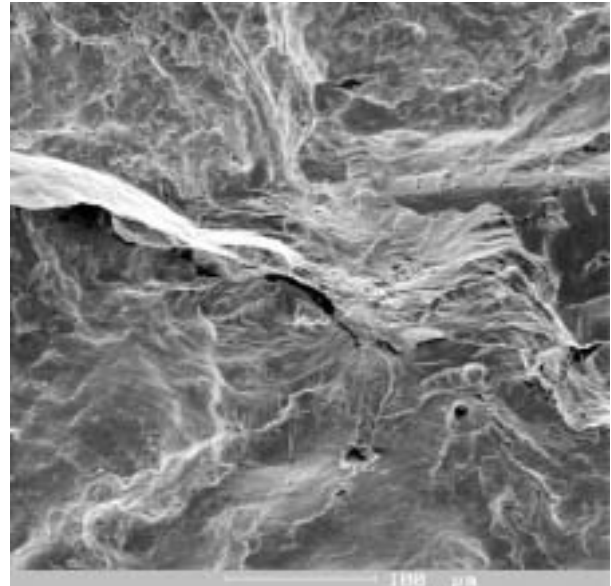
The specimen for the fractographic evaluation was extracted in the way to record the place of a supposed beginning of the crack growth, its gradual progress to the final fracture (Figs. 23 to 28). There were two sources on the evaluated fracture area (Fig. 23) from where the crack began to grow. In Fig. 23 the source is on the surface, the second source is superficial (Fig. 24). Most probably there was a bigger inclusion that served as a crack nucleus. But we cannot confirm this as the fracture area is damaged by

Fig. 23 The beginning of the crack growth – one of the sources, REM

Fig. 24 The detail of a sub-surface source, REM

The fatigue fracture started from several sources on the rod circumference which is related to the inconvenient structure and state

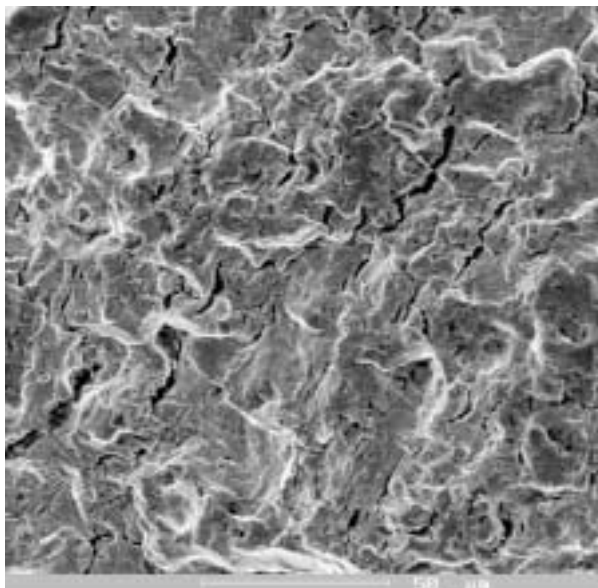
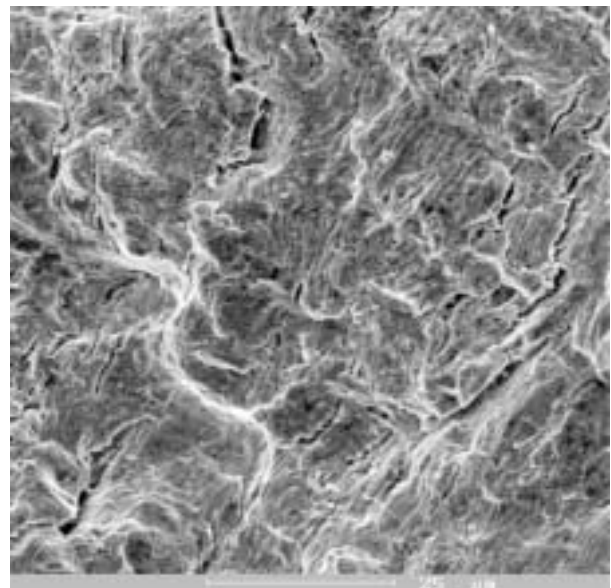
The character of the fatigue fracture area in the direction from the source to the force fracture is shown in Figs. 25 and 26. The whole fatigue fracture is characteristic by a transcrystalline fatigue failure with the occurrence of relatively deep secondary cracks (Fig. 25). At bigger magnifications typical fatigue signs - striations were observed (Fig. 26).

Fig. 25 The character of fatigue fracture area further from the source, REM

Fig. 26 A transcrystalline fatigue failure with the occurrence of striations and cracks, REM

of the material (Figs. 23 to 26). The fatigue fracture is characterized by a transcrystalline fatigue failure with ductile and fragile striations (Figs. 25 and 26) while there are many secondary cracks on the fatigue fracture area. The area of force fracture is characterized by a transcrystalline ductile failure with dimple morphology while the dimples have a very distinct diameter (Figs. 27 and 28).

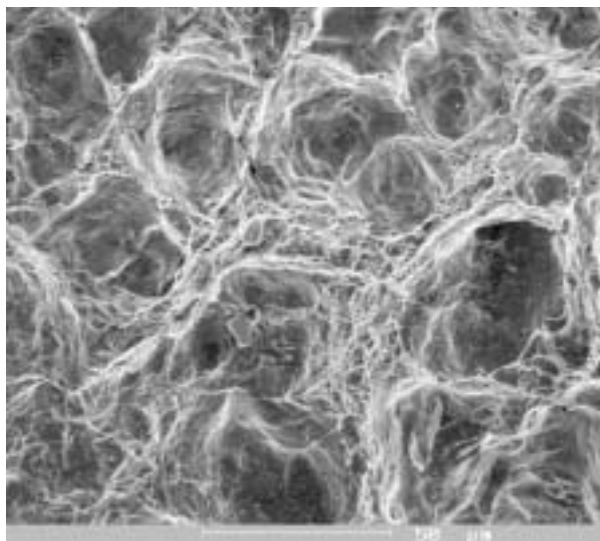
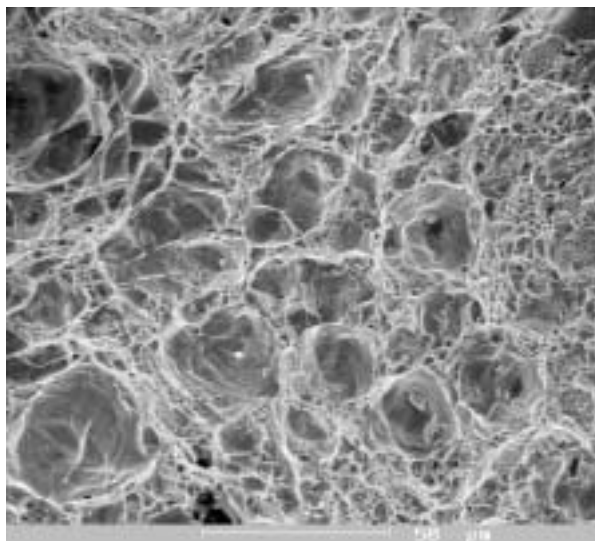
The area of fracture is characteristic with a transcrystalline ductile failure with dimple morphology (Figs. 27 and 28), while the dimples were very heterogeneous which is related to the material heterogeneity. Big dimples correspond to ferrite, small dimples are pearlitic.

Fig. 27 The area of fracture, a transcrystalline ductile failure with dimple morphology, REM

Fig. 28 The area of fracture - big dimples are ferritic, small are pearlitic, REM
