Jan Kec - Ivo Cerny - Jan Lustinec - Romana Pavelkova\*

## INFLUENCE OF REPAIRING USING WELDED STEEL PATCHES ON STRUCTURAL INTEGRITY OF A HIGH PRESSURE GAS PIPELINE

**Keywords:** pipeline, hydrostatic burst test, repair patches, full scale test.

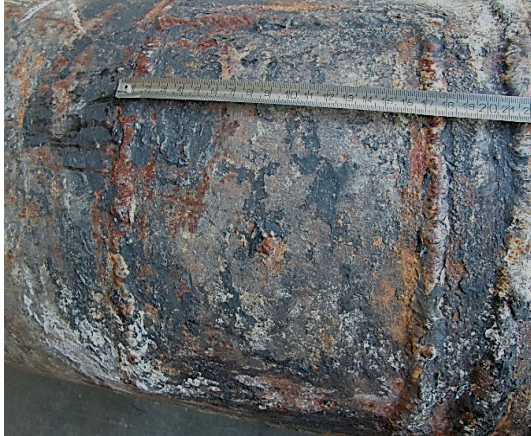
Figure 1 Steel repair-patch A

Preliminary NDT (non-destructive testing) inspection showed the lack of root fusion in the whole length of repair patch A - Figure 1. On the contrary, no imperfection of the weld integrity was found in the fillet weld in patch B (Figure 2) during the NDT inspection.

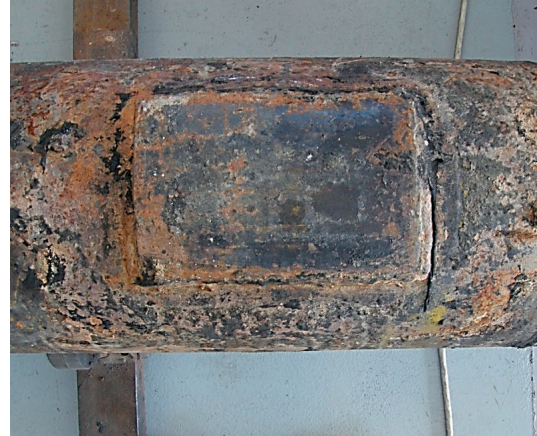
Figure 2 Steel repair-patch B

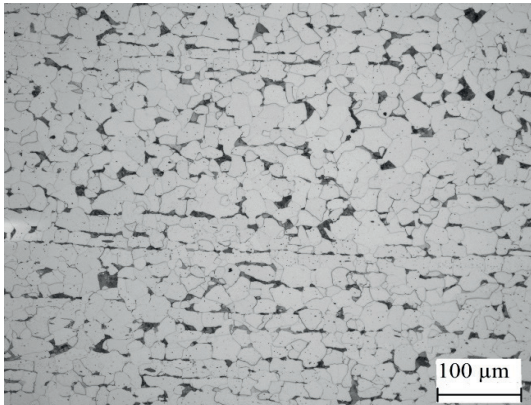
Investigations of microstructure and properties were carried out in longitudinal and circumferential direction. The base microstructure was ferrite-pearlite in both directions with uniform ferritic grains of the size 7.5 according to [10]. The pearlite colonies had typical lamellar morphology - Figure 3. A row-like structure was sometimes observed in the specimen centre.

Figure 3 Ferrite-pearlite microstructure of the pipe

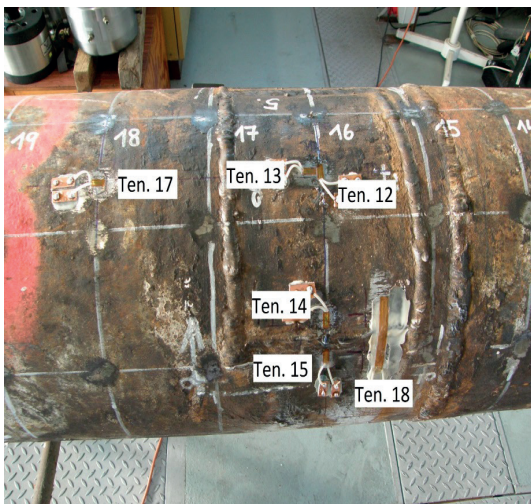
In the case of the repair patch A, six strain gauges were used - Figure 5, two of them oriented longitudinally (strain gauge 13 situated in the centre of the repair patch A and strain gauge 17 distant 200 mm from the centre of the repair patch A in the longitudinal direction). Three strain gauges were oriented in the circumferential direction (strain gauge 12 situated in the centre of

Figure 5 Gage location on repair patch A

the repair patch A, strain gauge 14 placed near the weld in which – according to NDT inspection – a lack of root fusion occurred along its whole length). Strain gauge 15 was situated also near the weld, but it was placed at the tube side. Special, very long strain gauge of the base length 50 mm was bonded across the whole weld.

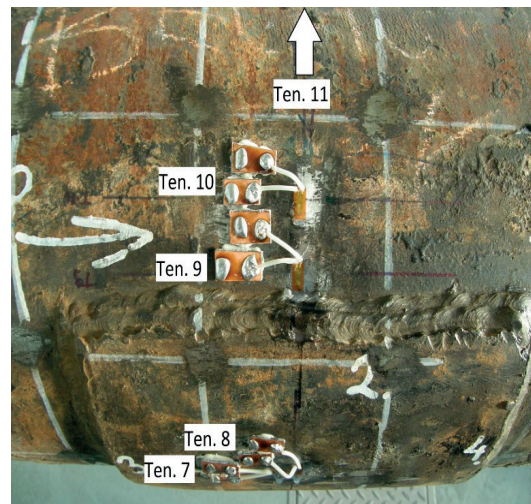
Figure 6 Gage location on repair patch B

For measurement of the deformation of the repair patch B, five strain gauges were applied - Figure 6. Four strain gauges were oriented circumferentially, one of them was used for measurement of the circumferential strain in the centre of the patch B (strain gauge 8), the remaining three were situated on the tube wall (strain gauges 9, 10, 11). One strain gauge was oriented longitudinally and was placed in the centre of the patch B.

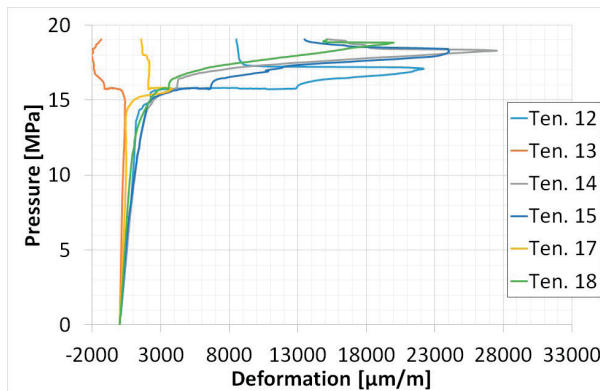
The full scale hydrostatic burst test was carried out with continuous measurement of deformations and one planned dwell at the yield point with regard to the biaxial state of stress  $p_{oy} = 16.8$  MPa. The increase of deformation in both repair patches was linear up to 15.5 MPa. After that, a rapid increase of deformation occurred (see Figures 7 and 8). Destruction occurred at 19 MPa in the repair patch B, which was overlapped. The reached stress value 19 MPa was at least three times higher than the operational one. It was shown that in this specific case this type of repair ensured quite a good safety level.

Figure 7 Dependency of pressure on deformation of the patch A

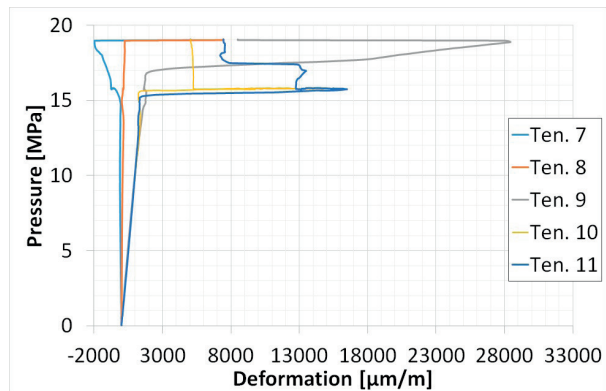
Figure 8 Dependency of pressure on deformation of the patch B

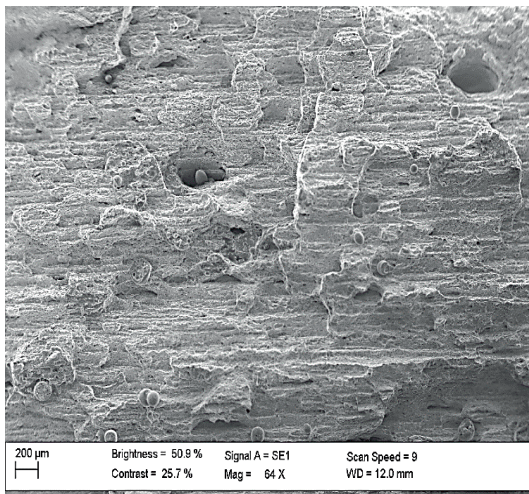
Figure 9 Woody fracture

Area of the fracture initiation was cut out and investigated by means of the Zeiss EVO MA 10 scanning electron microscope. Failure initiation occurred at the fusion zone which represented the boundary between the weld and the heat affected zone and formed a notch effect in the structure. No structural defects (pores, cracks, inclusions) were found inside the area of failure initiation. The fracture type can be classified as woody fracture that occurs in wrought steels in connection with a bad metallurgical quality (Figure 9). It is known in general that woody fracture can be related to row-like structure, inhomogeneities in phosphorus and sulphur contents, presence of gas bubbles or hydrogen [11]. A more detailed analysis of the woody fracture revealed its dimple morphology (see Figure 10). In areas more distant from the fracture initiation, the shear fracture prevailed.

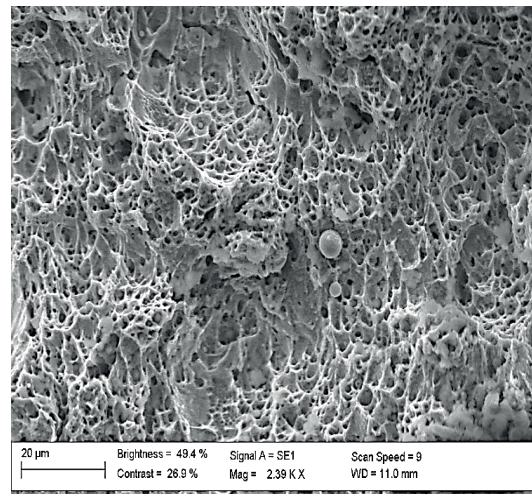
Figure 10 Dimple morphology of woody fracture
