ANALYSIS OF RESULTS OF MONITORING AND PREDICTION OF QUALITY DEVELOPMENT OF BALLASTED AND BALLASTLESS TRACK SUPERSTRUCTURE AND ITS TRANSITION AREAS

Keywords: Railway track, railway superstructure, diagnostics, track geometry, measuring trolley KRABTM-Light.

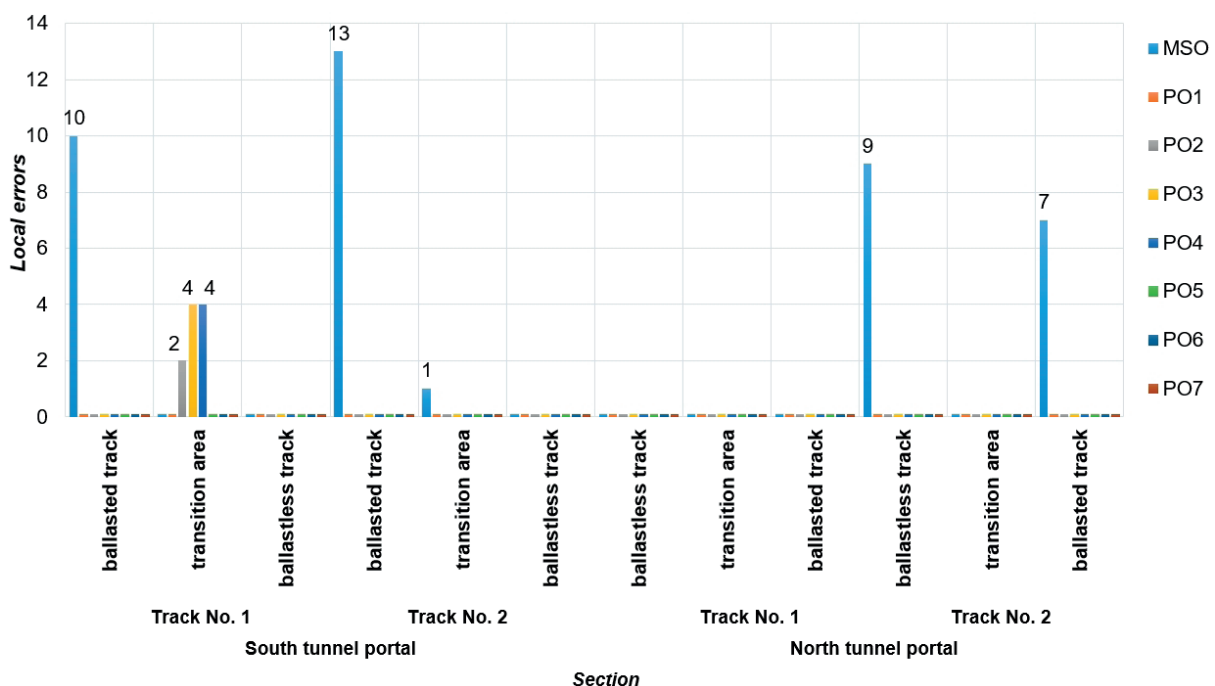
Fig. 2 Incidence of local errors in the monitored section- measurements carried out using measuring trolley KRAB™-Light

The overview of quality development of the track geometry of the monitored section is shown in Figs. 2 - 7. The incidence of local errors of measured parameters is stated separately for ballasted track sections, transition areas and for ballastless track sections (Fig. 2).

The experimental section monitoring has been carried out since July 2012, with six-month periodicity. The input measurement (MSO) was carried out 2 days before putting the track in operation. Within the input measurement, 40 local errors were recorded, out of them 30 in sections with ballasted track, 9 in sections with ballastless track and 1 local error was diagnosed in the transition area of the section 2.1. After this measurement, the supplier carried out the repair of track geometry and microgeometry of rail heads by grinding in the transition areas and in the sections with gravel superstructure (unfortunately, the supplier did not provide the details of repair works). The operational diagnostics has been applied seven times (PO1 to PO7).

In the second operational measurement (PO2), the local errors of the rail top level of the right rail (VP) and the top level of left rail (VL) were for the first time recorded in the transition area of the section 1.1, confirmed by the track geometry car of ZSR (Zeleznice Slovenskej republiky - the Railways of the

Slovak Republic). In the following measurements - PO3 and PO4 - further quality degradation of the section 1.1 was diagnosed, confirmed by the increased number of local errors (Fig. 2) as well as worsening value (increase) of the overall number of quality (Fig. 7). In November 2014, the railway infrastructure manager carried out repair interventions in the transition areas of the sections 1.1 and 2.1. In this way the diagnosed local errors were removed. The complex continuous diagnostics, carried out by the measuring trolley *KRABTM Light*, and monitoring by the railway infrastructure manager applying the levelling method from December 2014 to August 2015 in the sections 1.1 and 1.2 confirm further lowering of the track. Their values cannot at present be considered local errors as the operational tolerances were not exceeded. However, due to further degradation of particular parameters of the sections in question, incidence of local errors is expected in the near future. The sections 1.2 and 2.2 in the transition areas do not show any errors in values. The quality development in the measurements carried out so far do not indicate any probability of their incidence in further measurements [5, 6 and 10].

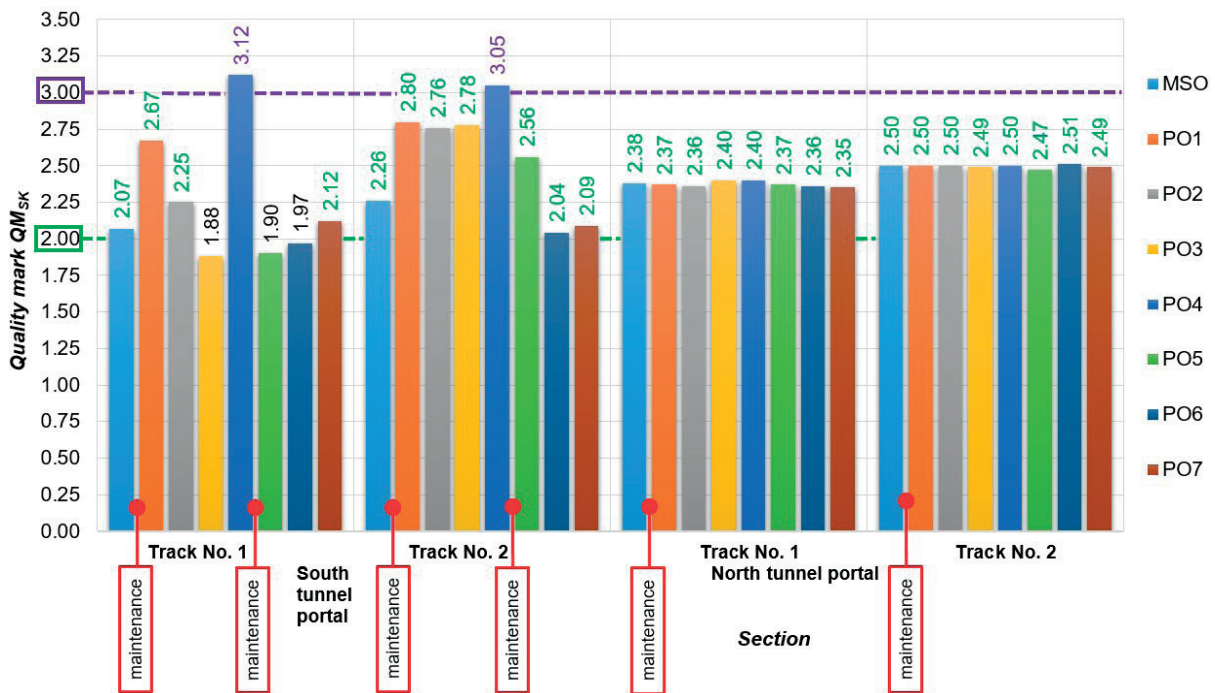
The quality marks of the alignment of the right rail (after calculation also of the left one) QM_{SK} (Fig. 3) were within MSO, PO1, PO2 and PO3 measurements placed in the interval $2 < QM \leq$

Fig. 3 Quality marks of the geometric quantity alignment of the right rail in respective monitored sections - measurement carried out by measuring trolley *KRABTM Light*

3 (recommendation: to design the repair of track geometry in the maintenance work plan) in all the monitored sections. The quality marks in the interval $3 < QM \leq 4$ (recommendation: to carry out the repair of the track geometry until the nearest inspection) were

reached in the sections 1.1 and 2.1 within PO4 measurement. After repair interventions before PO5 measurement, the values of quality marks improved (decreased) to the interval $0 < QM \leq 2$ (the state of the track geometry in the evaluated section is

satisfactory) in the section 1.1 or to $2 < QM \leq 3$ in the section 2.1. In PO7 measurement, slight deterioration of QM_{SK} in the section 1.1 was found out placing it to the interval $2 < QM \leq 3$.

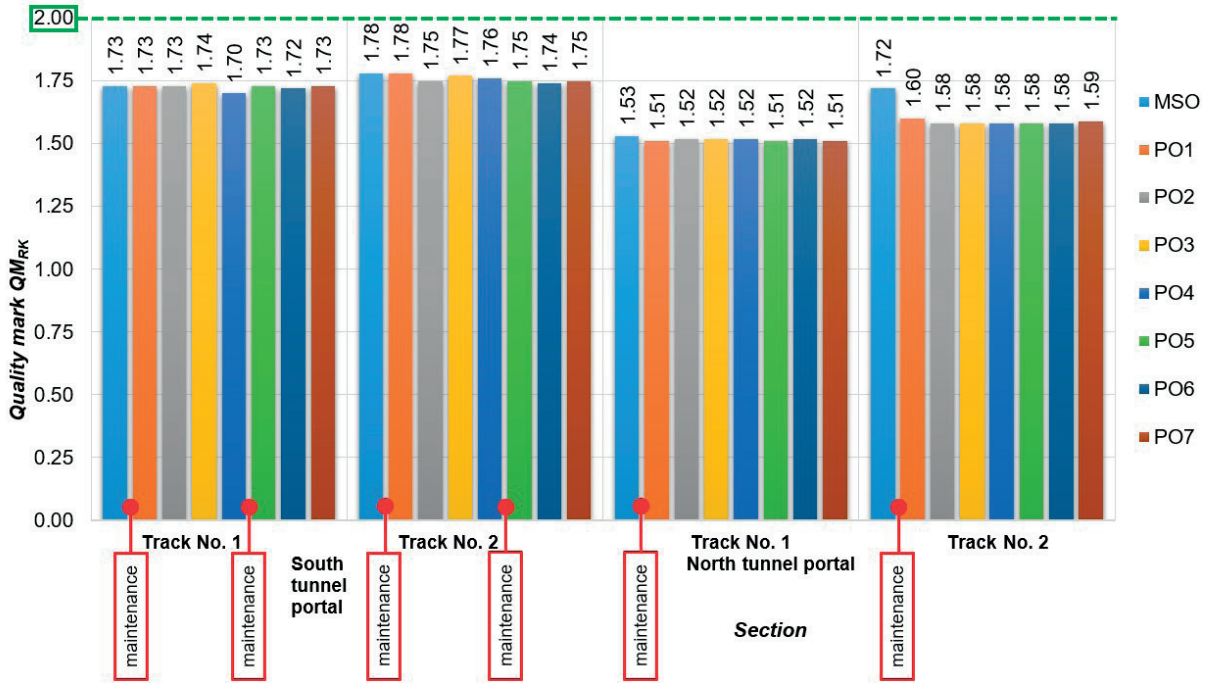
Fig. 4 Quality marks of the geometric quantity rail gauge tolerance in respective monitored sections - measurements carried out by measuring trolley KRAB™-Light

The quality marks of rail gauge tolerance QM_{RK} in all the sections and measurements are in the interval of values $0 < QM \leq 2$, which indicates that the state of track geometry is satisfactory (Fig. 4). Higher values of quality marks QM_{RK} in the sections 1.1 and 2.1 result from higher share of ballasted track sections compared to the sections 1.2 and 2.2 with prevailing better quality ballastless track (also securing higher durability of rail position). The values of QM_{RK} obtained by monitoring carried out during operation (measurements PO1 to PO7) present the rail gauge as a parameter with permanently satisfying quality development.

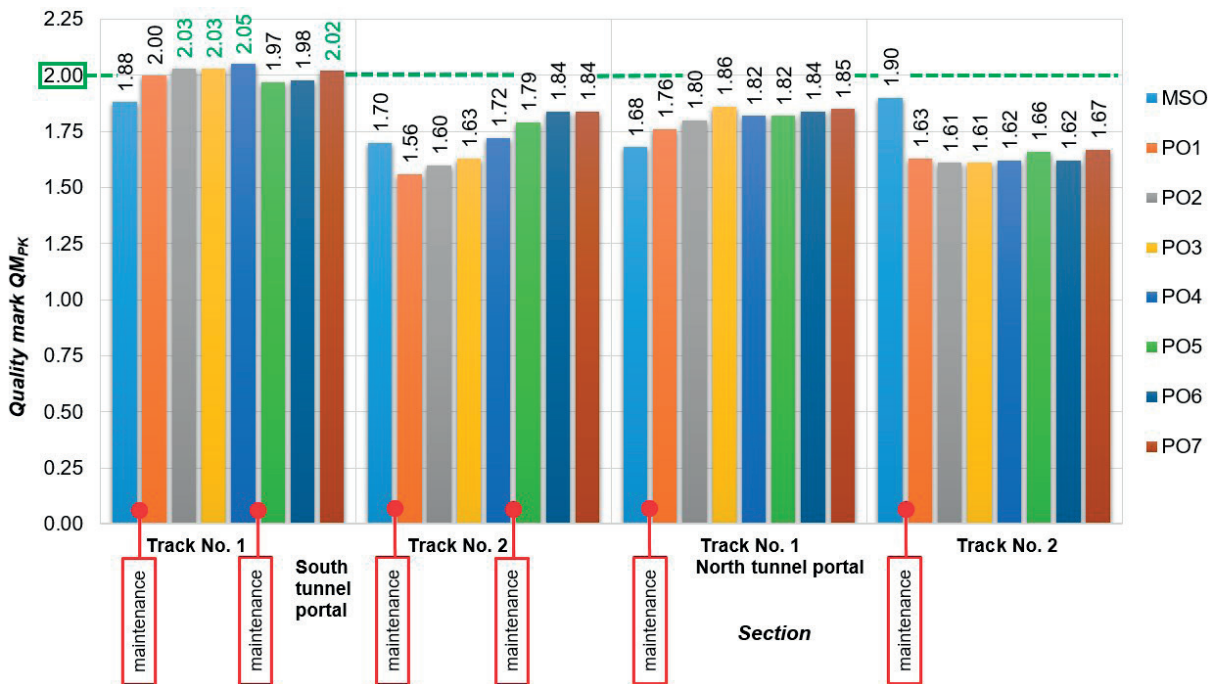
Fig. 5 Quality marks of the geometric quantity rail superelevation in respective monitored sections - measurements carried out by measuring trolley KRAB™-Light

The quality marks of superelevation QM_{PK} are in the interval of values $0 < QM \leq 2$ in all the sections and $2 < QM \leq 3$ in measurements PO2, PO3, PO4 and PO7 in the section 1.1. After repair interventions (after PO4 measurement) the values moved into the interval $0 < QM \leq 2$. The trend of quality increase in this section proven by measurements PO5 and PO6, is indicated as stopped by measurement PO7: the quality mark QM_{PK} is in the interval $2 < QM \leq 3$ (Fig. 5).

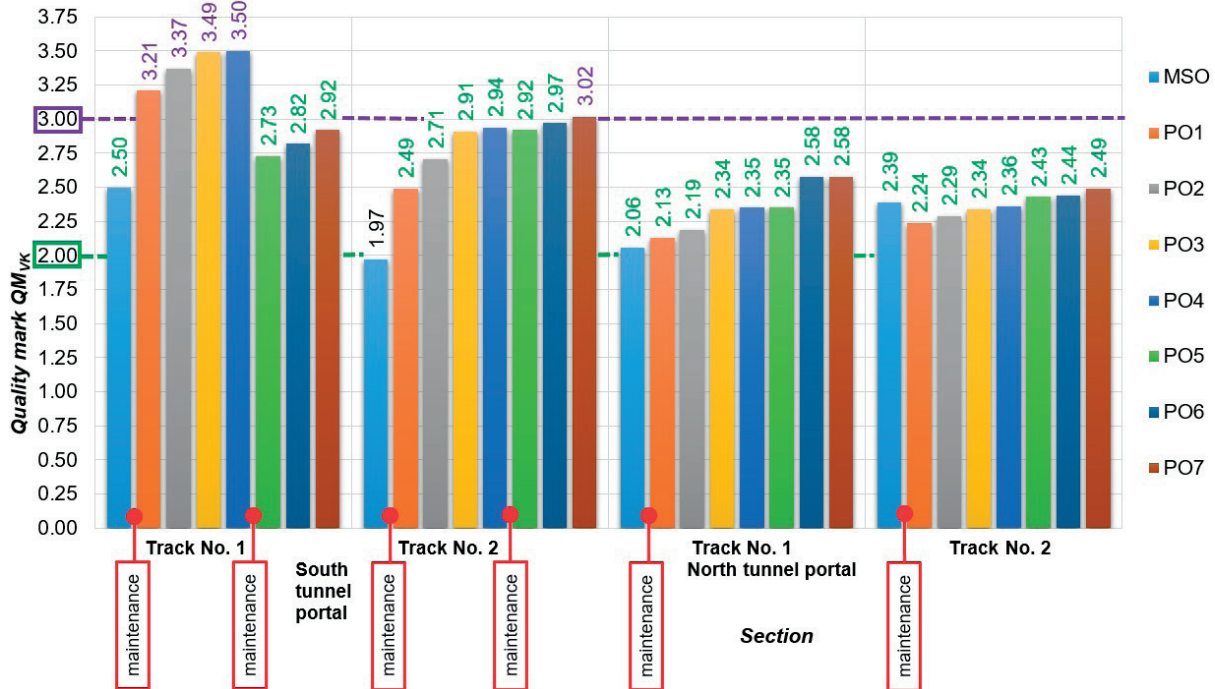
Fig. 6 Quality marks of geometric quantity rail top level of the right rail in respective monitored sections - measurement carried out by the measuring trolley KRABTM-Light

The quality mark with the worst development according to the measurements carried out so far seems to be the quality mark of the top level of the right (after calculation also of the left) rail QM_{VK} (Fig. 6).

The errors of the parameter of the top level of rails are the most frequently occurring defects, which is also confirmed by

evaluation of measurements by the track recording car of ZSR. With the exception of measurement MSO in the section 2.1, in all the measurements of monitored sections the determined values were $2 < QM \leq 3$ and in the measurements PO1, PO2, PO3 and PO4 in the section 1.1 the values were $3 < QM < 4$ which indicates the necessity to carry out the repair of track geometry until the nearest inspection. By the repair intervention carried out in sections 1.1 and 2.1, before measurement PO5, the values of QM_{VK} decreased. The measurements PO5 and PO6 placed these values into the interval $2 < QM \leq 3$. In the measurement PO7 QM_{VK} reached values in the interval $3 < QM < 4$, in the section 2.1. The tendency of quality mark deterioration in the section 1.1 predicts the determination of QM_{VK} value within the interval $2 < QM \leq 3$ in the near future.

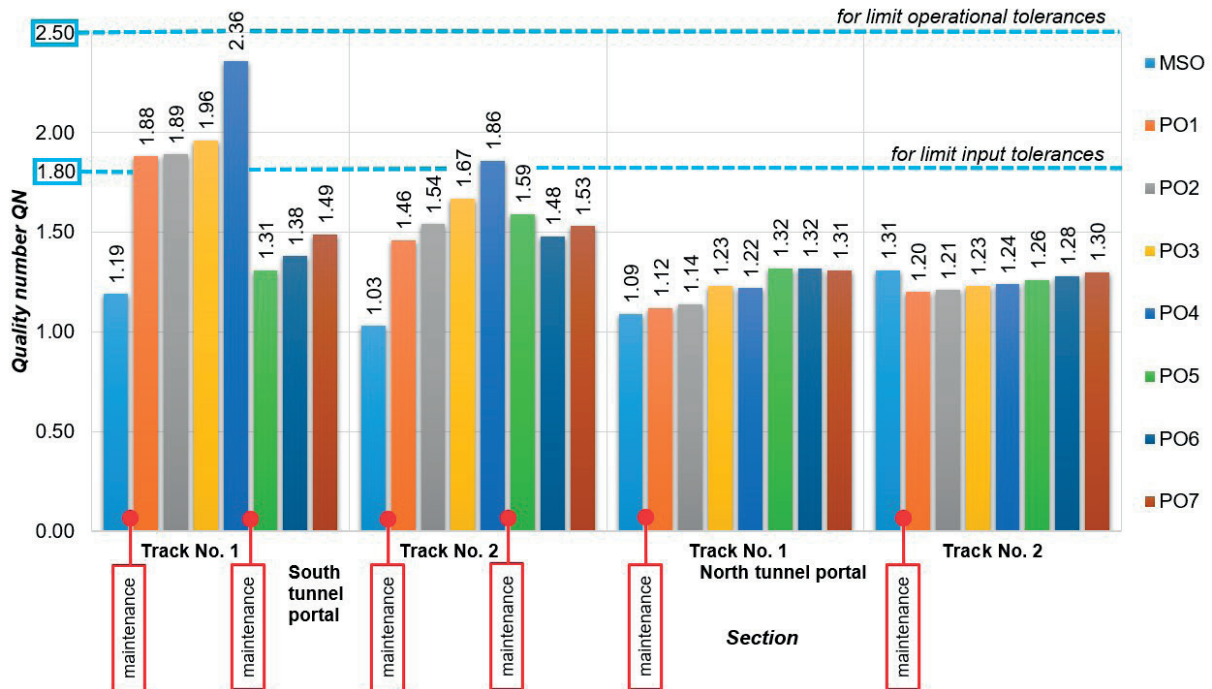
Within PO1, PO2, PO3 and PO4 measurements, further continuous quality deterioration of sections 1.1. and 2.1 was determined, as indicated by the overall quality number. The repair interventions, carried out in November 2014 by the railway infrastructure manager with the aim to remove the local errors of the parameter VK (top level of rail) as a priority, decreased significantly the values of quality numbers of respective sections, from the value 2.36 (PO4 measurement) to the value 1.31 (PO5) in the section 1.1 and from the value 1.86 (PO4) to the value 1.59 (PO5) in the section 2.1. The tendency of results of measurements PO5, PO6 and PO7 indicates certain increase and thus quality deterioration of sections 1.1 and 2.1. In the sections 1.2 and 2.2, the quality deterioration (QN increase) is slight only.

Fig. 7 Overall quality number in respective monitored sections - measurement carried out by measuring trolley *KRABTM-Light*

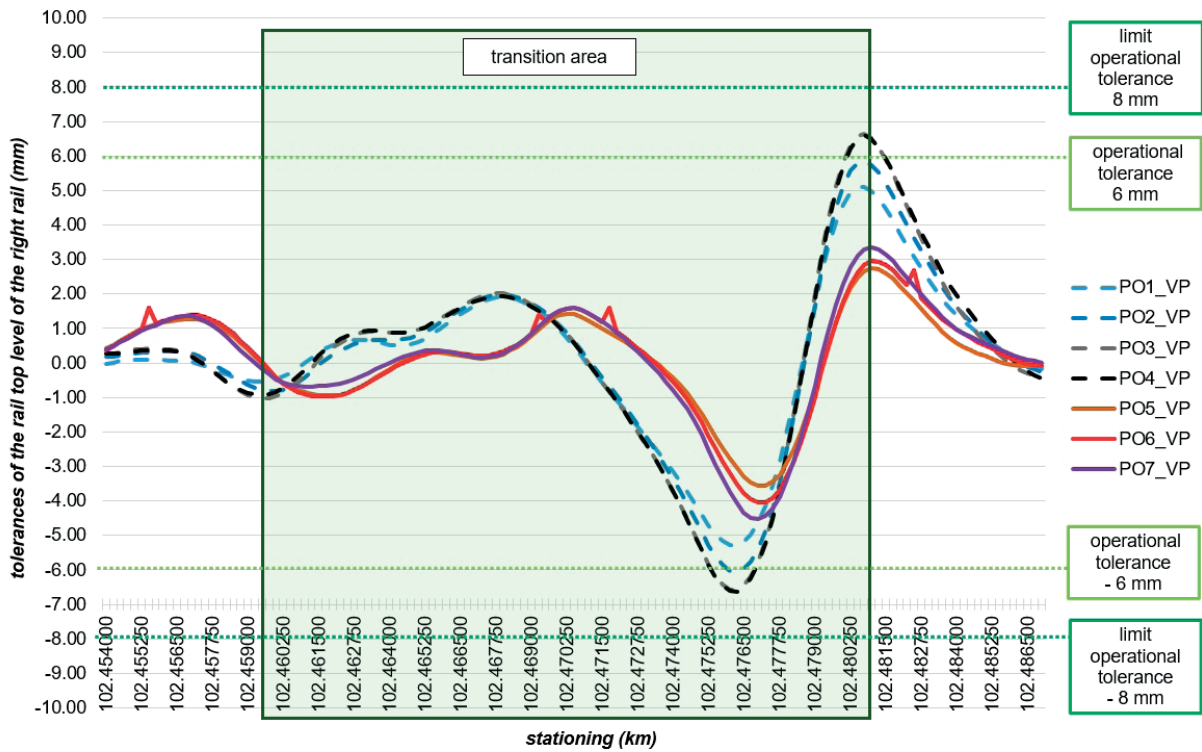
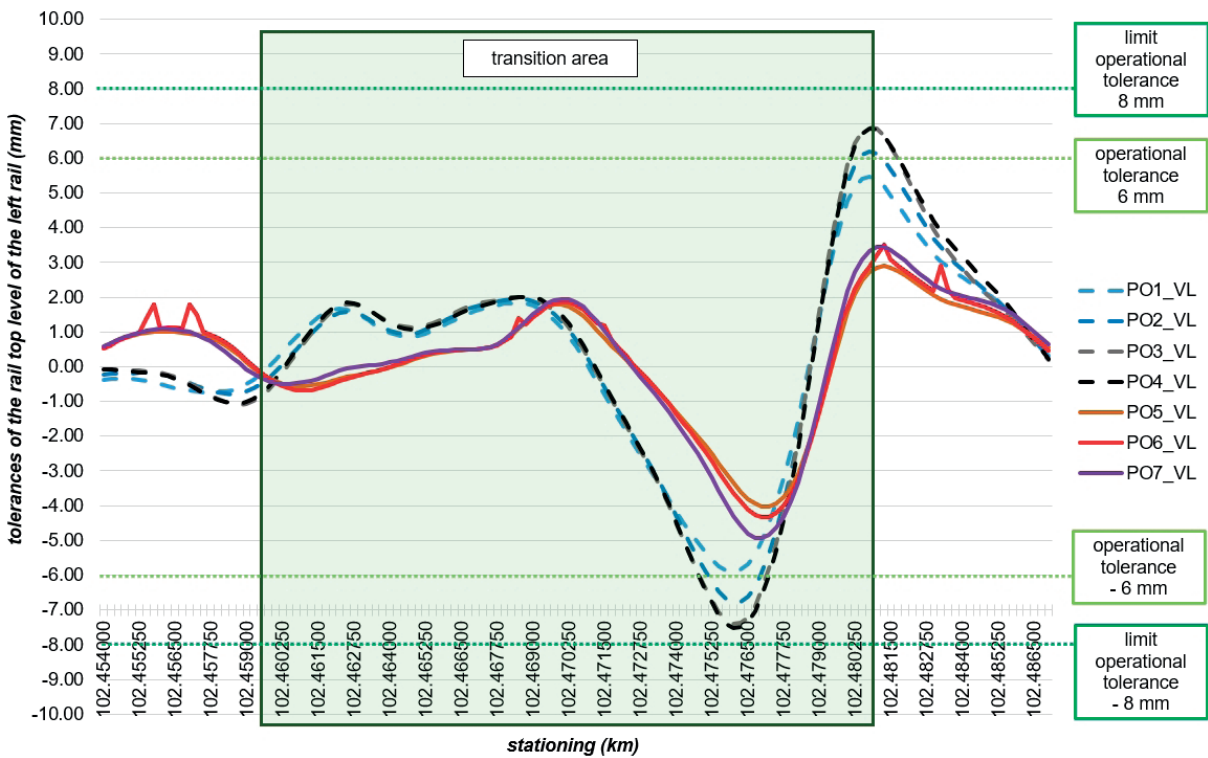
The tolerances of the top level of the right (after calculation also of the left) rail in the transition area of the section 1.1 (Figs. 8 and 9) detect the parameter errors on the level of exceeded operational tolerance defined by values ± 6 mm in the fourth operational measurement for the right rail, or in the third and

fourth operational measurement (upper limit + 6 mm) and in the second and fourth operational measurement (lower limit - 6 mm) for the left rail. The parameter error on the level of exceeded operational tolerance can be confirmed by errors detected by the measuring car of ZSR in individual measurements carried out within regular measurements in compliance with regulations for rail diagnostics. The completed repair of the track geometry in the transition area decreased the tolerance values but the places with limit tolerance values remained the same (contact of transition area with ballastless track and the start of the ballastless track structure).

Fig. 8 Tolerance of the top level of the right rail in the transition area of the section 1.1 (km 102.460 500 - km 102.480 500)

Fig. 9 Tolerance of the top level of the left rail in the transition area of the section 1.1 (km 102.460 500 - km 102.480 500)

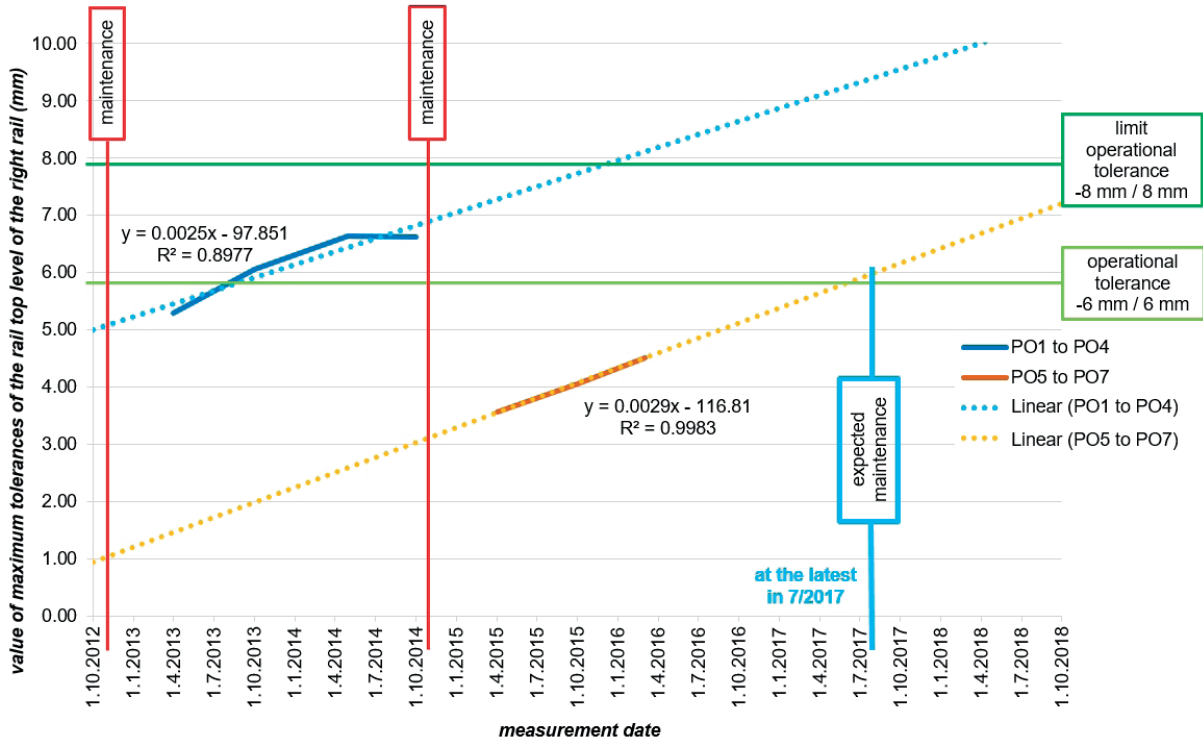
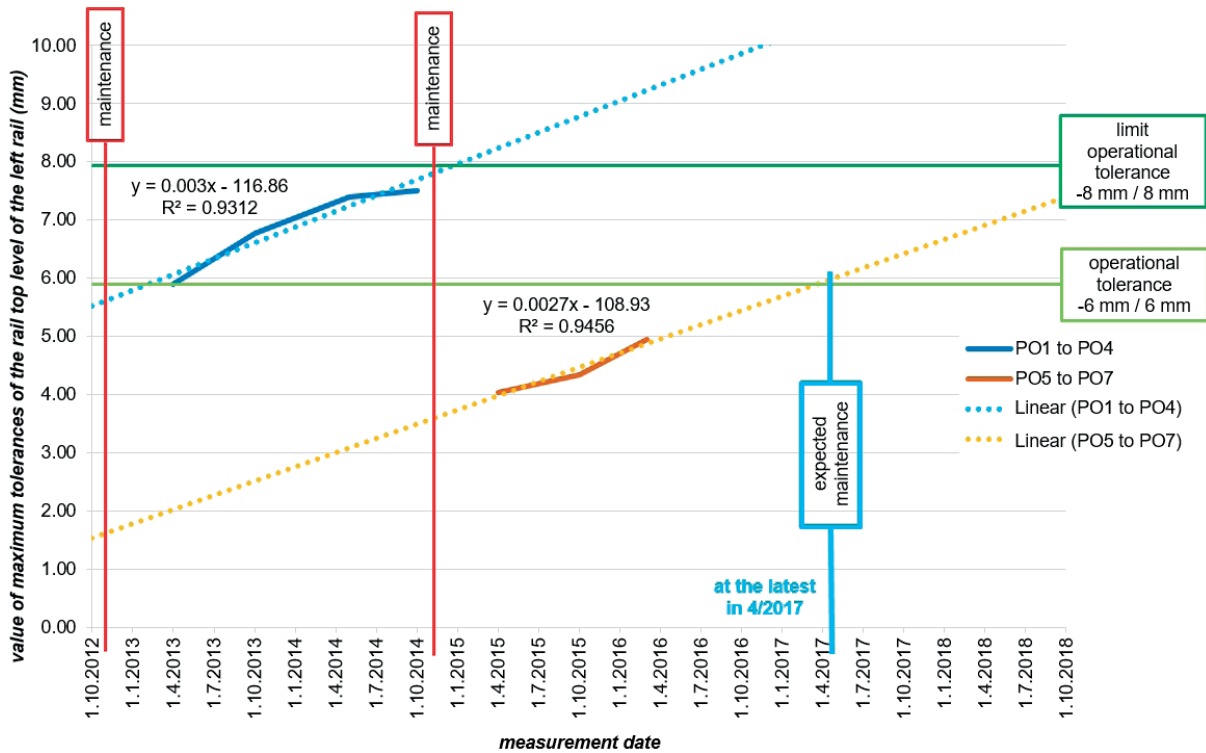
From the point of view of further quality development and subsequent maintenance planning, there was observed a tendency of development of maximum tolerances of both rails (Figs. 10 and 11) with the prediction of reaching the tolerance of the top level of

Fig. 10 Measurements PO1 to PO7 and the developmental tendency of maximum tolerances of the right rail in the transition area of the section 1.1 and its vicinity (km 102.454 000 - km 102.487 000)

Fig. 11 Measurements PO1 to PO7 and the developmental tendency of maximum tolerances of the left rail in the transition area of the section 1.1 and its vicinity (km 102.454 000 - km 102.487 000)

the right (left) rail on the level of exceeded operational tolerance. The developmental tendency shows that the absolute value of maximum tolerance of the top level of right rail will reach the level of operational tolerance at the latest in July 2017, the absolute value of the maximum tolerance of top level of left rail will reach the level of operational tolerance probably earlier – at the latest in April 2017, and these levels of exceeded operational tolerances should be detected within the second measuring campaign of the measuring car ZSR (in summer 2017). After detection of these tolerances, the infrastructure manager is supposed to plan and, as soon as possible, also to carry out the repair of track geometry in the respective section.
