Petr Jonsta - Irena Vlckova - Zdenek Jonsta - Roman Heide*

MATERIAL ANALYSIS OF DEGRADED STEAM TURBINE ROTOR

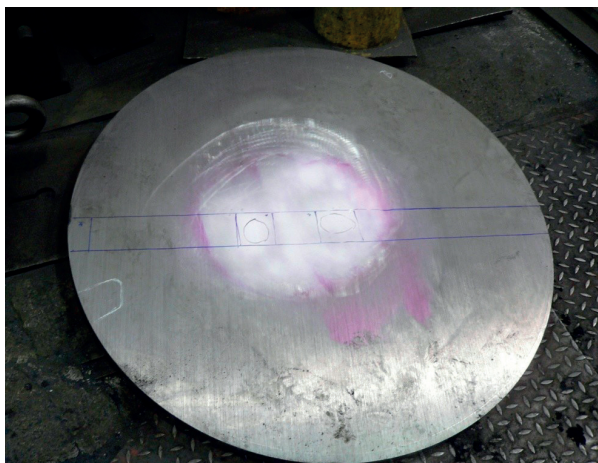
Fig. 1 Experimental plate

During the ultrasonic test, inadmissibly large indications, bigger than 2 mm, were detected in the rotor examined around the forging axis on the head side of the ingot. The defective areas are encircled on the experimental plate (Fig. 1). In sum, 35 inadmissibly large indications of Dn 2.1 to 2.6 mm were found. Most of them were of Dn 2.1-2.2 mm, three of the indications had the dimension of Dn = 2.4 mm, one of them had the dimension of Dn = 2,6 mm. All indications were located at the depth of 427 - 558 mm below the surface of the rotor body. Almost the entire half of the rotor on the ground side of the ingot was without any inadmissible defects.

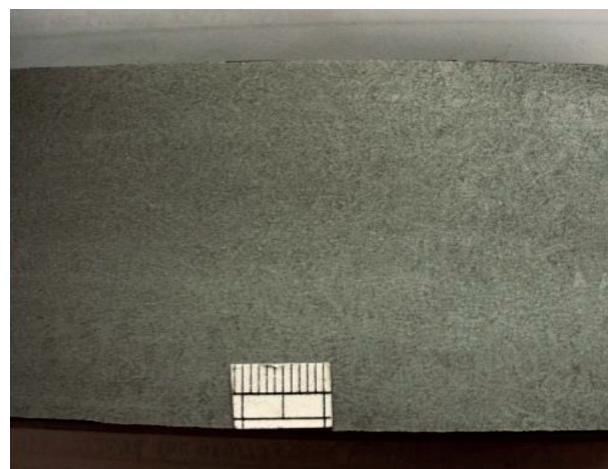
Fig. 2 Macrostructure below the surface

individual dendrites were relatively fine; their size ranged about 1 mm and their arrangement was chaotic. To the depth of approx. 200 mm below the surface, the dendritic segregation was manifested less intensively than in the other parts of the forging cross section (Fig. 2). It was the areas of more evident segregations in which the above mentioned defects were detected. Moreover, a distinctive phenomenon in these areas was the spots of existence of stem segregates. The chaotically arranged dendrites and cross sections of stem segregations, not exceeding the size of 2 mm, are then presented in Fig. 3.

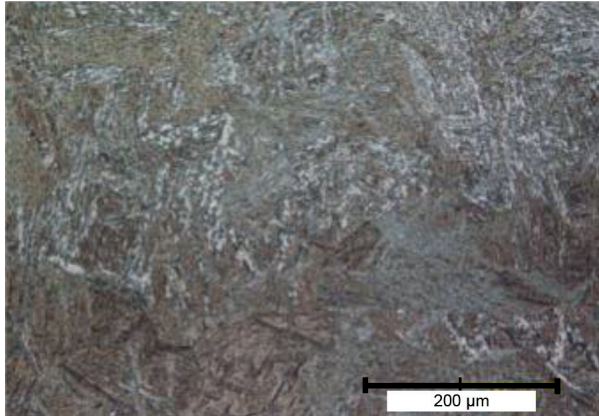
Fig. 4 Microstructure of the basic metal matrix

Throughout the entire volume, the analyzed steel had a fine-grained microstructure made of tempered heterogeneous bainite, which shows evidence of both high hardenability of the steel used for the rotor manufacture and the optimum hardening mode. The microstructure of the basic metal matrix was mostly of the acicular character (Fig. 4). More distinctive

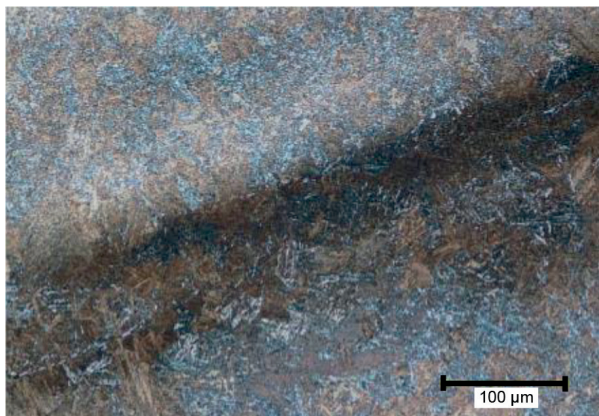
Fig. 5 Macrostructure with segregates

dendritic segregations in higher depths below the rotor surface are presented in Fig. 5.

In addition to bainite, these areas, characterized by lower carbon content, probably contain probainitic acicular ferrite. The occurrence of carbides of globulitic morphology bears evidence of high tempering temperature after hardening [7].

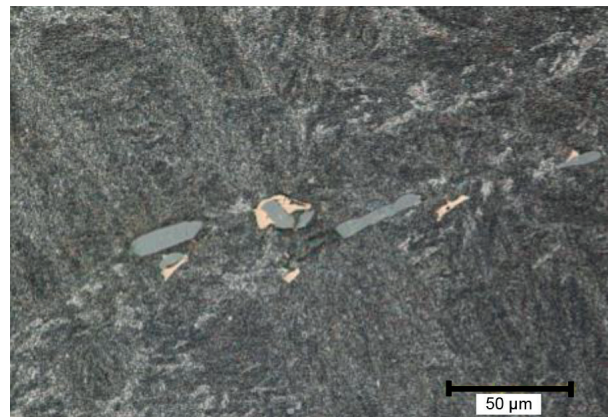
Fig. 6 Microstructure with inclusions

At the points of inadmissible ultrasonic findings around the forging axis, discontinuities were detected in the form of coarse inclusions, rounded elongated cavities and coarse inclusions situated inside the cavities. The length of the largest of these discontinuities at the metallographic samples exceeded 2mm, as indicated above. The coarse inclusions formed conglomerates of non-metallic particles

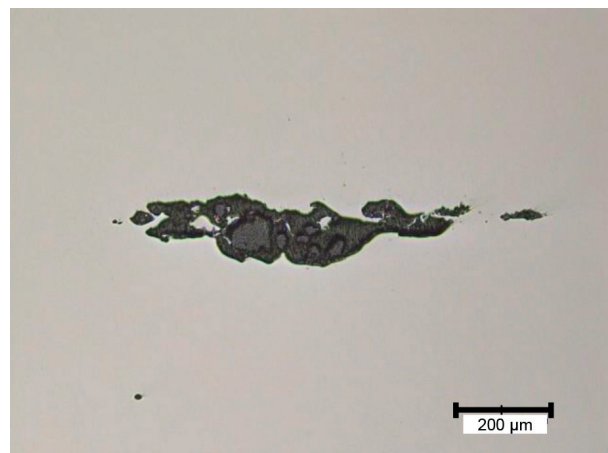
Fig. 7 Complex inclusion

the dominant constituent of which was brittle sharp-edged complex oxides on the basis of $MgO \cdot Al_2O_3 \cdot CaO$. An example of a complex inclusion at the place of ultrasonic indication is presented in Fig. 7. Besides these inadmissible discontinuities, tiny oxidic and oxysulphidic inclusions of micrometric dimensions as well as titan nitrides or carbonitrides were analyzed (Fig. 8).

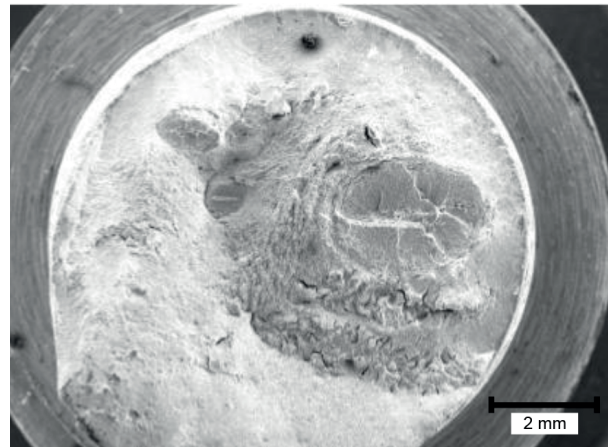
Fig. 11 Defective area with intercrystalline failure

significant fact is the presence of intercrystalline failure on the fracture area in the vicinity of the fish eyes, as apparent in Fig. 11.

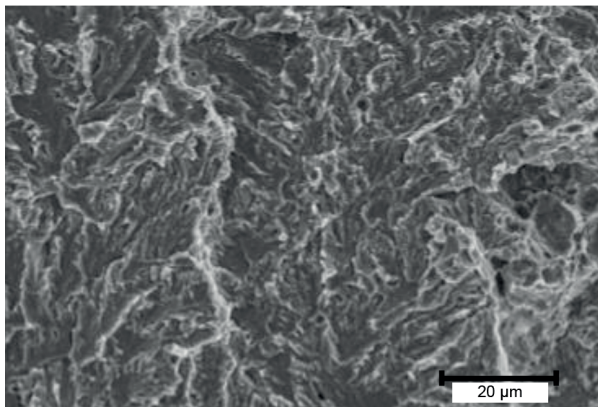
Fig. 9 Brittle transcrystalline cleavage

The following Fig. 9 presents the morphology of brittle transcrystalline cleavage. This was typical of substantial part of the fracture area. The fine cleavage facets are characteristic of the bainitic structure detected earlier by the metallographic analysis.

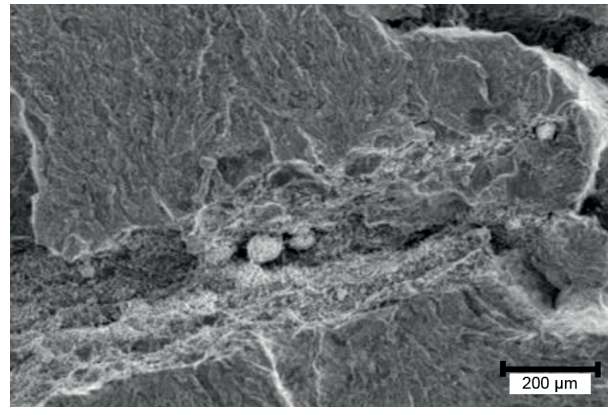
Fig. 12 Inclusions in rows

Figures 12 and 13 present inclusions in these defective zones of fracture areas. Figure 12 documents oxidic and oxysulphidic inclusions arranged in lines in the centre of the defective zone of the fracture area, Fig. 13 then shows these inclusions in detail.

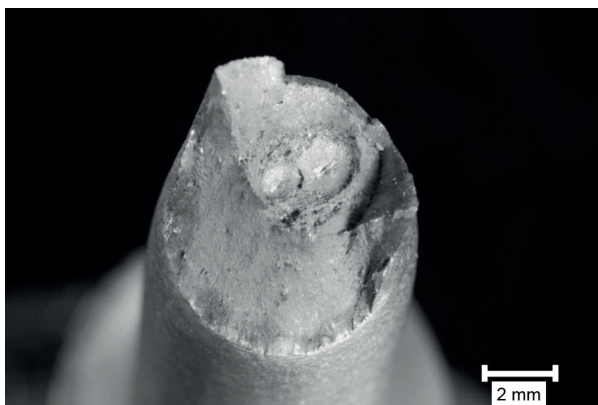
Fig. 10 Fish eyes in the fracture area

The fracture area of tensile tests featured defective zones which are typical as the so-called “fish eyes” (Fig. 10). The fish eye morphology is characteristic of defects resulting from hydrogen action [9]. This proposition is supported by the analysis of chemical composition. Apparently, the hydrogen content reached the value of 1.2 ppm, as opposed to the maximum admissible 0.8 ppm (see Table 1). Another

Therefore, one can state that the defect in the technological process, which was the broken porous block, hindered proper flushing and movement of the melt, which was degassed insufficiently at the same time. This resulted in both a substantial increase in the hydrogen content as well as increased content of oxygen. The increase in the hydrogen content by approx. 50% above the maximum admissible level led to hydrogen embrittlement taking effect in typical fish eyes and intercrystalline steel failure. The increased oxygen content resulted in substantial increase of the steel inclusion rate, which led to significant deterioration of its micropurity.
