Martin Moravcik - Peter Kotes - Miroslav Brodnan - Patrik Kotula *

SOME EXPERIENCE FROM THE ANALYSIS OF EXISTING 40 YEARS OLD PRESTRESSED BRIDGES IN THE NORTH OF SLOVAKIA

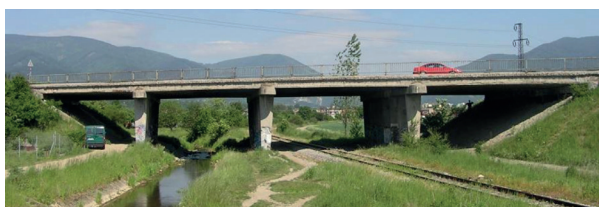
Fig. 1 The view of bridge No. 018-293 near the town of Martin on I/18 road

Failures, which have been observed on bridge 018-293, result both from the state of knowledge about bridge building accessible at the time when the bridge was built and also from insufficient maintenance at present. Outer girders, connection joints between the girders and over-supporting parts of the beams are the mostly damaged parts of the superstructure. On outer girders we can see uncovered, exposed, corroded tendons with some ruptured wires. Similar situation can be seen also in Figs. 4 and 5. Loss of cement mortar can be seen mainly in the peripheral connection joints and in over-supporting areas as a result of water leakage through these joints. Precast girders carry all typical features of the first prestressed concrete bridges built in Slovakia. The areas and the edges are rough and broken, the visible surfaces are marked with water leaking through the carriageway and insulation on the superstructure.

It was found out that the strength of concrete on bridge No. 018-293 corresponds to concrete class C25/30 according to [10], or to concrete class B 330 according to the previous Slovak standard. Strength of concrete was tested in a non-destructive way with the Schmidt hammer type L. Content of chloride ions, especially in the concrete cover, was determined by the tests of RCT instrument. The carbonation depth was determined by a simple indication method by spreading the concrete with phenolphthalein. On the exposed areas of reinforcement incurred by the fall of the concrete cover, the corrosion of prestressed reinforcement was found leading to the rupture of some wires.

On the basis of inspections, the bridge classification according to [11] was replaced by [12] as follows: - The bridge top cover condition: V. = bad, the substructure condition: IV. = satisfactory, the superstructure condition: VI. = very bad, complex bridge condition: V. = bad.

In the case of bridge No. 018-293 it is expected that the reconstruction work will be done with traffic moved over one lane of the bridge. Due to corrosion and subsequent rupture of prestressing tendons of outer girders it was proposed to remove them and replace them with new ones. Increasing the load carrying capacity should be achieved also by new composite slab concreting. The corroded caps have to be strengthened also in several possible ways, for example, by additional prestressing, or by other new reinforcement on the metallic or non-metallic base (FRP materials).

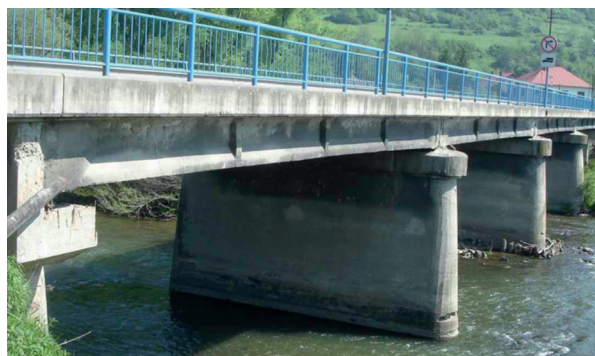
Fig. 2 The view of bridge No. 059-091 in Nizna over the river Orava

The precast superstructure of bridge No. 059-091 carries all the signs of such bridges from the 1st generation of prestressed structures in Slovakia. Consequences of water leakage through the carriageway and insulation can be seen on the superstructure. Anchored areas of the superstructure cross prestressing, particularly in over-supporting sections carry the signs of failures

due to leakage as, for example, removed concrete cover, and corroded anchors. However, the structural system realized in this way is still relatively solid. The girders in the longitudinal direction have still sufficient pressure reserve, which is noticeable in the overhanging. There are some major defects due to technical difficulties connected with cross prestressing and separate spans without linking the neighboring spans by a composite slab.

Despite the high age of the bridge and history of the Orava river bridged in this place, it was recommended to repair this bridge in order to increase its lifetime, and, at the same time, to maintain such capacity which corresponds to the current trends in designing new bridges. We suggest to repair the bridge superstructure by new external prestressing and new composite concrete slab.

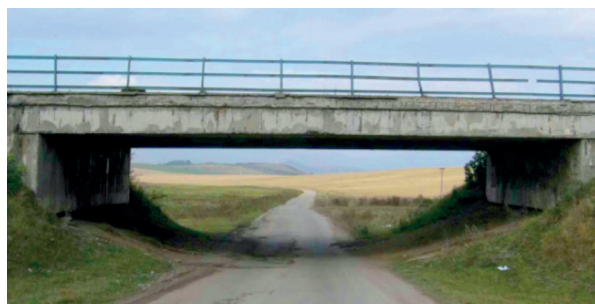
Fig. 3 The view of bridge No. 065-086 near the village Mosovce

One of the main deficiencies of the precast superstructure of bridge No. 065-086 from the KA-61 girders is a box shape of the designed girder. The closed shape of the girder cross-section causes the wet environment inside the girder, which affects the rapid reinforcement corrosion. That effect can be seen on many bridges constructed from the KA-61 girders.

In the case of bridge No. 065-086, the numerical model of the “curtain” slab was taken into account. The combination of the strengthening method was used due to the insufficient load carrying capacity. At first, all existing deteriorated elements will be removed from the top of the bridge. The new external prestressing (2 Monostrand tendons on 1 girder) was designed. Then new 150mm depth of the composite slab concreting on the top of the girders is assumed to be applied. That kind of the structural invasion completely changes behavior of the superstructure from a “curtain” slab to the solid orthotropic slab (Fig. 9). The superstructure being strengthened, similar repair work will be conducted as in the above mentioned cases.

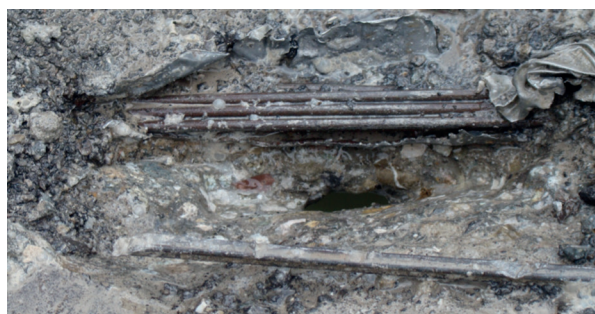
Fig. 4 The partial rupture of wires of the prestressing tendon - bridge No. 059-091

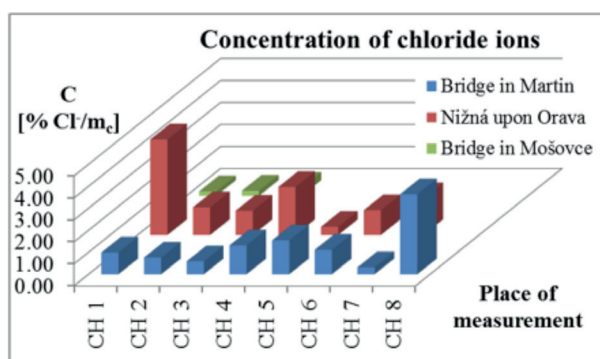
It was found out that the strength of concrete of the precast beams on bridge No. 059-091 was C30/37 (B 400), which corresponds to the designed value. Content of chloride ions Cl-/mc was above the critical value (Fig. 6). The carbonation depth was lower than the concrete cover (Fig. 7). Technical condition

Fig. 6 The concentration of chloride ions- overview

It was found out that the strength of concrete of the precast beams on bridge No. 065-086 was C35/45 (B 500), which corresponds to the designed value similarly as with the above mentioned bridges. Content of chloride ions Cl-/mc exceeds the critical value of content of chloride ions Cl- (Fig. 6). The carbonation depth did not reach the value of the concrete cover

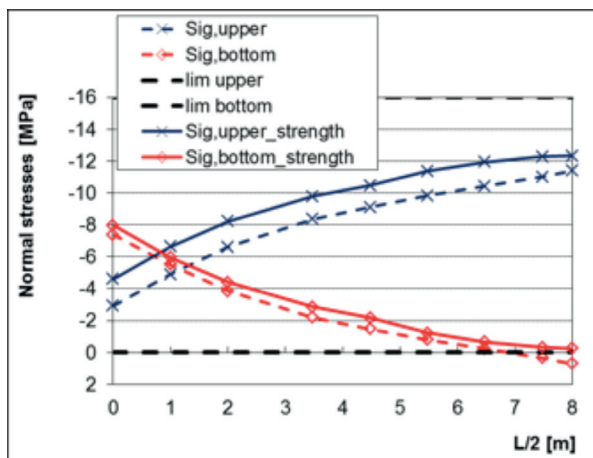
Fig. 8 The normal stresses course along the half span of bridge No. 065-086

- The bridge top cover condition: V. = bad, the substructure condition: IV. = satisfactory, the superstructure condition: V. = bad, complex bridge condition: V. = bad. The load carrying capacity calculation showed the following results: $V_n = 25$ tons, $V_r = 59$ tons, $V_e = 183$ tons, which again indicates the insufficient structural capacity, see Fig. 8.

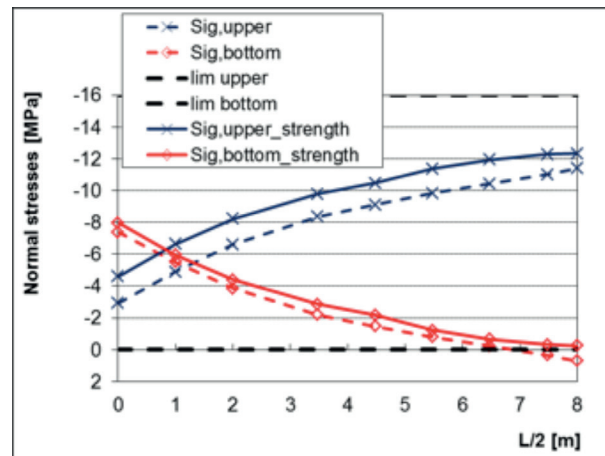
Fig. 9 The course of normal stresses along the half span on strengthened structure of bridge No. 065-086

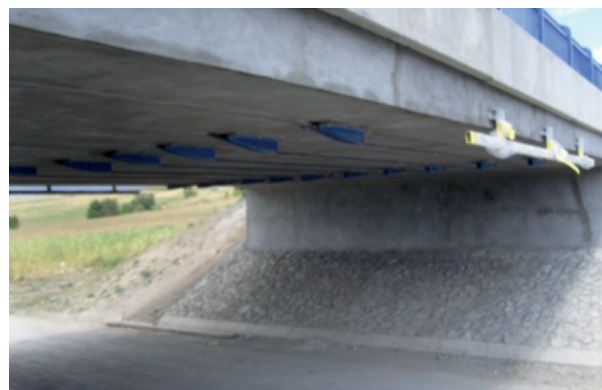
Fig. 10 Bridge No. 065-086 after strengthening by external prestressing

This is demonstrated by the example of bridge No. 065-086 where repair work has been successfully done recently. Composite slab concreting and the external prestressing combination method were used for the structural strengthening, as shown in Fig. 10.
