EFFECTS OF ATMOSPHERIC CORROSION ON THE CAR PARK ROOF STRUCTURE

The paper presented shows the actual state assessment and the verification of structural reliability of the existing load-bearing structure of an exterior car park roof, emphasizing the estimation of corrosion losses in the steel structure that have considerably lowered its lifespan and obstructed its safe operation.

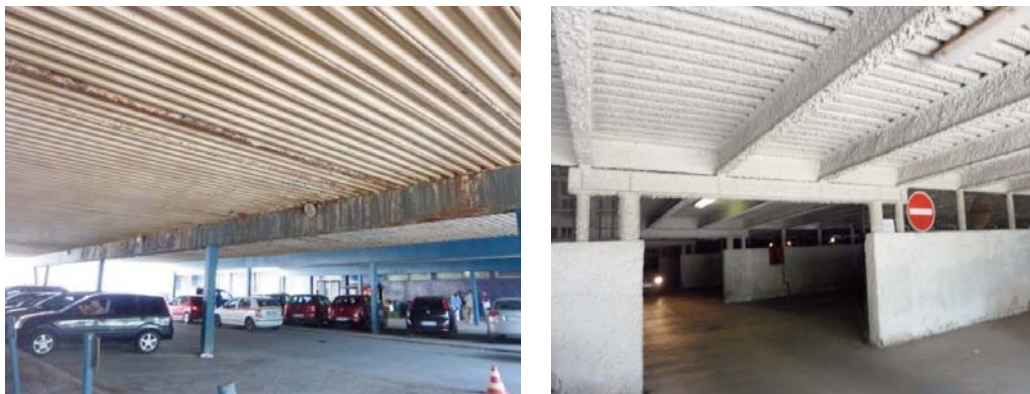
Fig. 1 The external (left) and the internal (right) roof structures of the University Hospital car park, Kosice, Trieda SNP 1

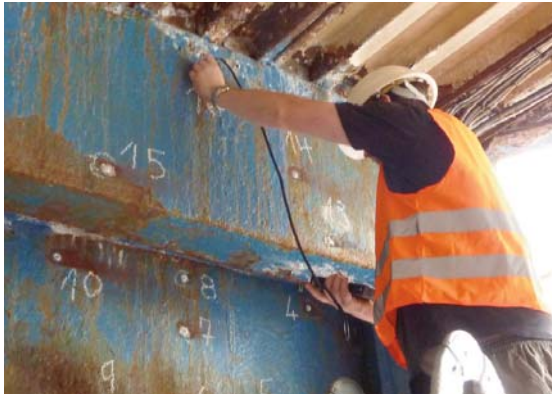
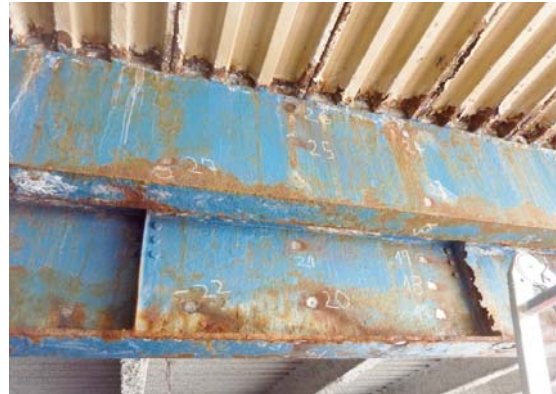
Fig. 2 Experimental measurements of the section thickness of Beam 6 in the most exposed locations

As expected, the most substantial deviations were detected in Beam 6. Degradation of its braces was evident, the flange and web thicknesses in the indicated locations remarkably reduced. The corrosion losses in the thickness of the lower flange were most dramatic – up to 6 mm. Similarly, serious losses occurred in the web, namely in the first field, from the original 8 mm to barely 5 mm. Due to the degradation effects of the environment most of the braces (the shear reinforcement) in the beam were damaged leading to a significant decrease in its shear resistance.

All diagnosed degradation effects had substantially reduced the load-bearing capacity of all steel members and thus jeopardized the safety of the structure.

dized the safety of the building as a whole. By their nature and geometry, the examined beams did not meet the requirements for safe and reliable occupancy of the building any longer; therefore, measures for its renovation were inevitably proposed and implemented.

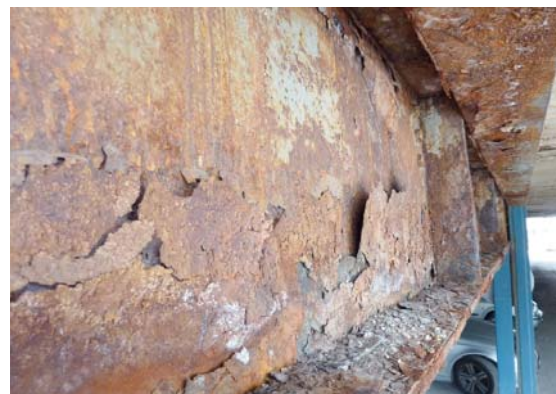
On visual on-site inspection of the existing structures it was concluded that Beams 1, 2 and 4 did not exhibit any signs of damage. It was further concluded that they were reliable and safe. The reason for their well-preserved condition might be their original good quality. On the contrary, Beams 3, 5 and 6 were greatly affected by corrosion, so it was essential to assess their real state, determine the actual corrosion losses in the individual fields of the examined beams as well as to examine the effects of external factors. The condition of the above-mentioned beams is shown in Figs. 2 and 3.

Fig. 3 Views of the steel frame details of the external car park roof structure (the condition before the renovation)

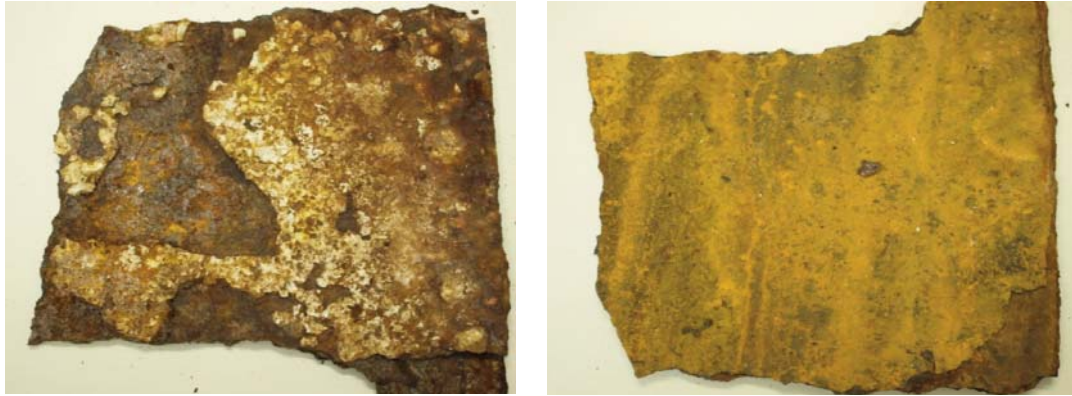
The rate of degradation of steel members was determined on mechanically removed rust samples from Beam 6 whose material was badly corroded, flaky, non-compact. The details of the sample surface are documented in Fig. 4. An optical microscope BRESSER was used to assess corrosive changes in the samples in great detail. At only the magnification of 20 (Fig. 5 left), both pitting and surface corrosion was indicated resulting in the separation of layers of rust. In Fig. 5 on the right, there is a detail of the same surface magnified 80x where a deep microcrack can be seen with evident surface corrosion.

Fig. 4 Appearance of the external part of the sample (on the left) and of the reverse side of the sample (on the right) with the residues of coating

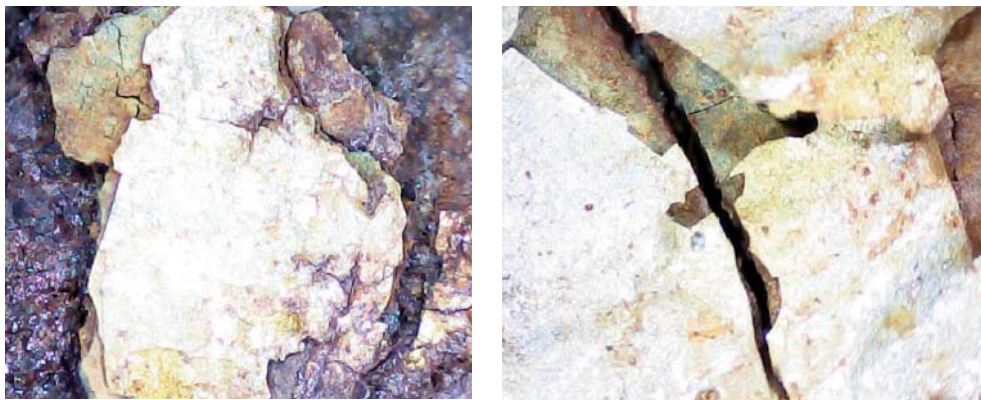
Fig. 5 Micrograph of the sample surface - magnified 20x (on the left), serious surface corrosion evident under a microcrack -at the magnification of 80 (on the right)
