## DESTRUCTIVE TESTING OF THE WELD JOINTS ON SPLIT SLEEVE FOR BRANCH CONNECTIONS REPAIRS

*New type of repairing technology for branch connection defects on gas pipelines has been designed recently. Repairing technique is based on manufacturing of split sleeve and welding of its parts together and to the repaired pipes by manual metal arc welding technology. Appropriate testing has to be performed to ensure practical and permanent use of such kind of sleeve in commercial area. Destructive testing was performed to confirm quality of the welds on the prototype sleeve repair. Macrostructural and hardness evaluation showed inhomogeneity present in some welds. According to that, microstructure observations, spectral analysis and mechanical tests were performed on the base metal of the sleeve. It has been showed that even when some problems may be present, repairing technique by split sleeve can be still suitable for permanent repairs of the defects of the branch connections.*

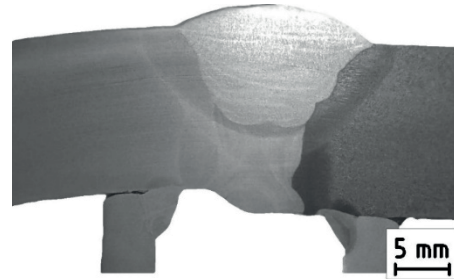
Macrostructural analysis of the split sleeve weld joints was performed in terms of the EN ISO 17639 standard. Four characteristic welds were selected to analysis. Macrographs of the butt weld joints are shown in Fig. 2 and 3. Unacceptable defects were not detected neither on the macrographs of the butt joint between cylindrical and sphere-like part (Fig. 2) nor in the macrograph of weld joint between sphere-like segments of the sleeve (Fig. 3). Some imperfections might be observed such as linear misalignment or excessive penetration. Dimensions of these imperfections are within the allowed range according to standards (ISO 5817-B). In the lower part of the Fig. 2 and 3 the sealant carriers can be seen, which serve to carry a sealants that isolates the places of welding from places where leaking gas is present. Large size of the root opening can be seen between the sealant carrier and wall of the sleeve in macrograph shown in Fig. 3. Weld joint between the sealant carrier and split sleeve wall are only supplementary and after the sleeve is welded onto the pipeline, it has no function. Such kind of defect might be consider as acceptable for the functionality of the split sleeve. Macrostructural evaluation of the weld between the cylindrical and sphere-like part (Fig. 2) shows significant heterogeneity of the joint, which might be a sign of inappropriate microstructure and also mechanical properties of the base metal.

Fig. 2 Macrograph of butt weld joint between cylindrical (left) and sphere-like (right) part of the sleeve

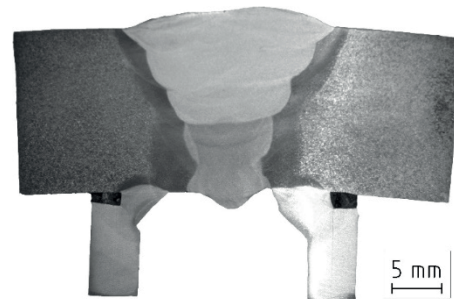
Fig. 3 Macrograph of butt weld joint between sphere-like parts of the sleeve

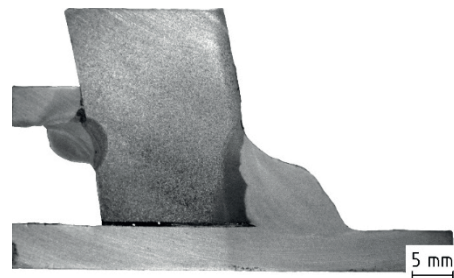
Typical macrographs of the girth fillet welds are shown in Fig. 4 and 5. Fillet welds do not show the presence of unacceptable defects similarly to the butt welds. Base metal and heat affected zone on the side of the sphere-like part also pointed out different character of macrostructure (Fig. 4) that confirms weld joint heterogeneity.

Fig. 4 Macrograph of fillet weld joint between sphere-like part of the sleeve and pipe

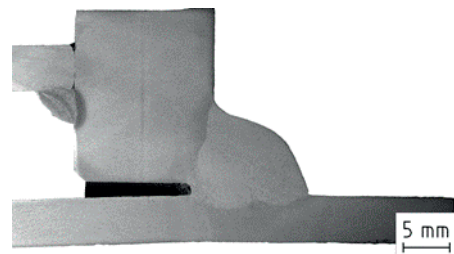
Fig. 5 Macrograph of fillet weld joint between cylindrical part of the sleeve and pipe

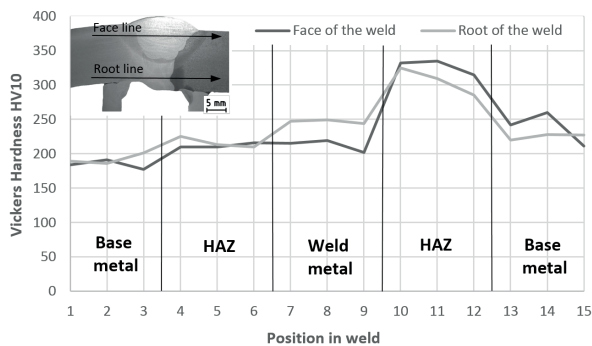
ISO 9015-1 standard. Significant increase of Vickers hardness can be seen in heat affected zone (HAZ) of the weld on the sphere-like side of weld joint (Fig. 6 - 8). In these areas hardness reaches values higher than 300 HV and in some cases it almost reached maximal allowed value for this type of material (380 HV without heat treatment according to EN ISO 15614-1 standard). Hardness of weld joint on the side of cylindrical part of the sleeve did not significantly increase in HAZ (Fig. 6, 8 and 9).

Fig. 6 Hardness of butt weld joint between cylindrical and sphere-like part of the sleeve

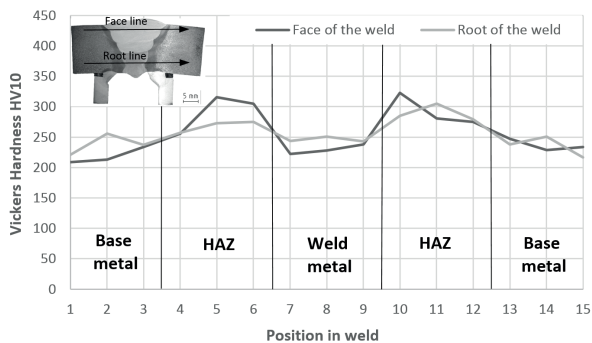
Fig. 7 Hardness of butt weld joint between sphere-like parts of the sleeve

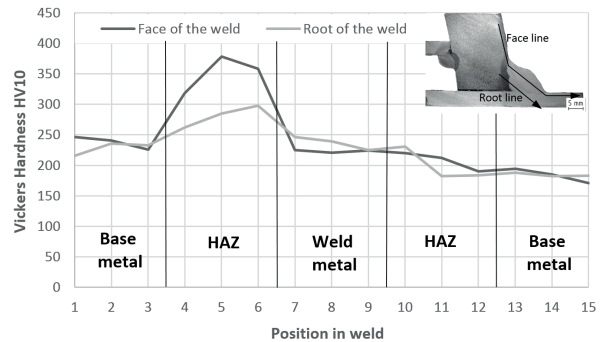
Fig. 8 Hardness of fillet weld joint between sphere-like part of the sleeve and pipe

Higher carbon level leads to significant increase of the hardness (up to 378 HV), especially in fillet welds with increased heat transfer to the wall of the sphere-like part of the sleeve. Welding and cooling conditions then lead to increased cooling rate in HAZ of the fillet weld on the sleeve side and increasing of the Vickers hardness. This effect together with material structure sensitive to hard and brittle phase formation may cause exceeding of the hardness tolerance.

To prevent similar behavior of the weld joints, there should be performed measurement of chemical composition before machining of the semi-product and/or full annealing of steel block or manufactured part should be applied. Even when some insufficient material properties can be present, repairing

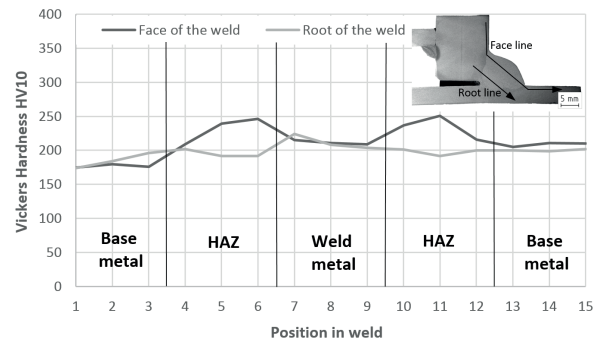
Fig. 9 Hardness of fillet weld joint between cylindrical part of the sleeve and pipe

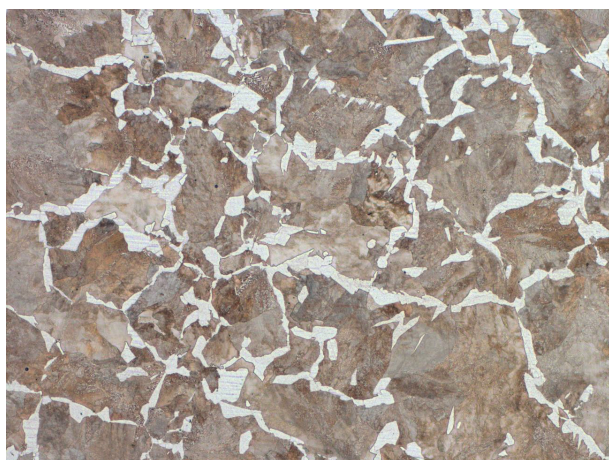
Microstructure analysis was performed in order to verify microstructure of the sphere-like part of the split sleeve. Characteristic microstructure of sphere-like part of the sleeve is shown in Fig. 10. Microstructure is formed by large perlite grains surrounded by ferritic envelopes. Base metal microstructure of the cylindrical part of the split sleeve (Fig. 11) is fine-grained ferritic-pearlitic and corresponds with S355 grade steel quality.

Fig. 10 Microstructure of the sphere-like part of the sleeve, etch. 5 % Nital

Macrostructural analysis and hardness evaluation of the weld joints of split sleeve for branch connection repairs was performed on four characteristic welds. Significant inhomogeneity of the base metal and HAZ on cylindrical and sphere-like side of the weld was observed during macrostructural analysis. This fact was approved by followed microstructural evaluation (coarse-grained pearlitic structure of sphere-like part base metal).

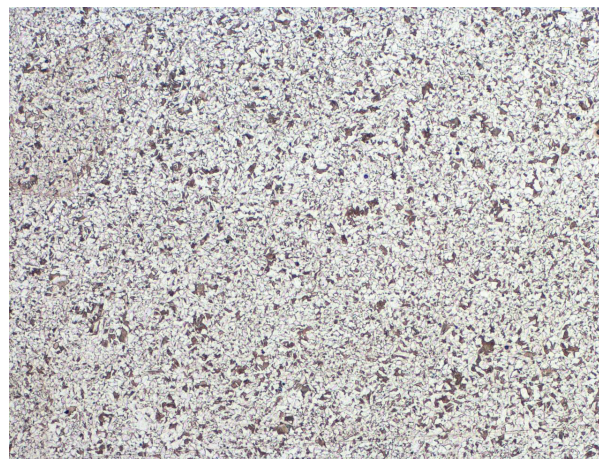
Fig. 11 Microstructure of the cylindrical part of the sleeve, etch. 5 % Nital
