ENSURING OPERATIONAL RELIABILITY OF OVERPASS ON "ALMATY-KAPSHAGAI" HIGHWAY SECTION IN KAZAKHSTAN

The article presents results of the overpass condition survey, technical survey, static tests and assessment of the structure operational reliability, a double-decker overpass on Almaty-Kapshagai highway section in Kazakhstan.

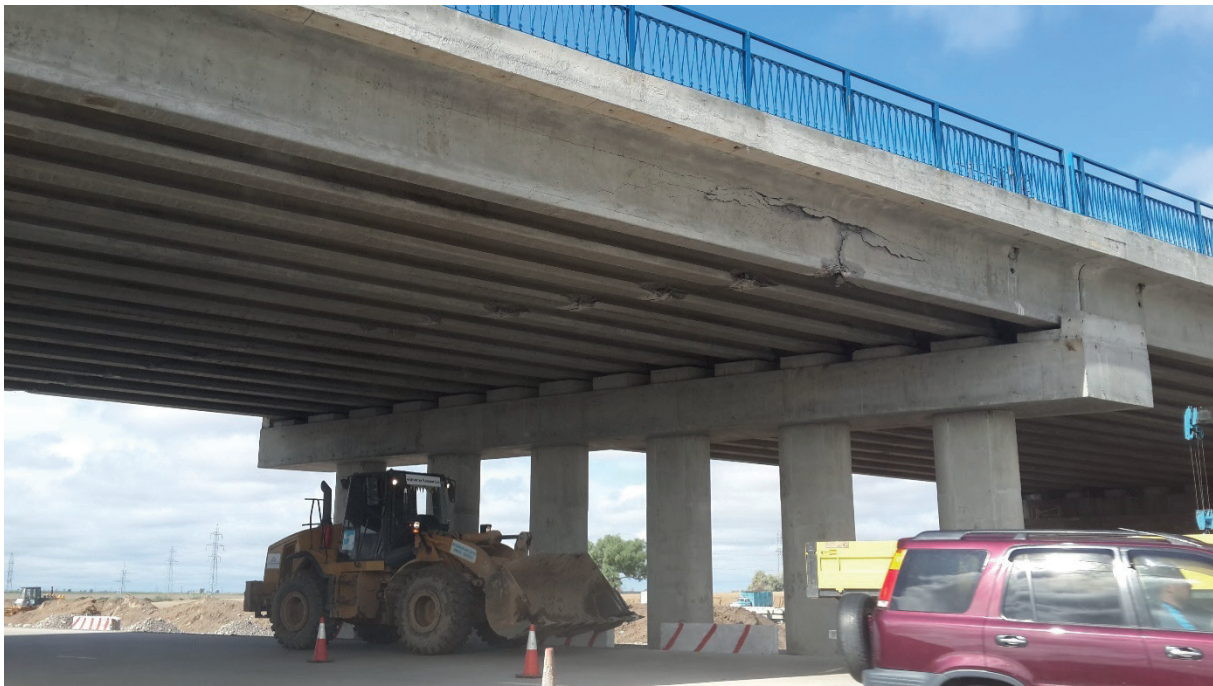
Figure 1 General view of the overpass from Kapshagai before repair

Figure 1 shows a general view of the road overpass before repair and Figure 2 shows the repaired superstructure No. 1 [1].

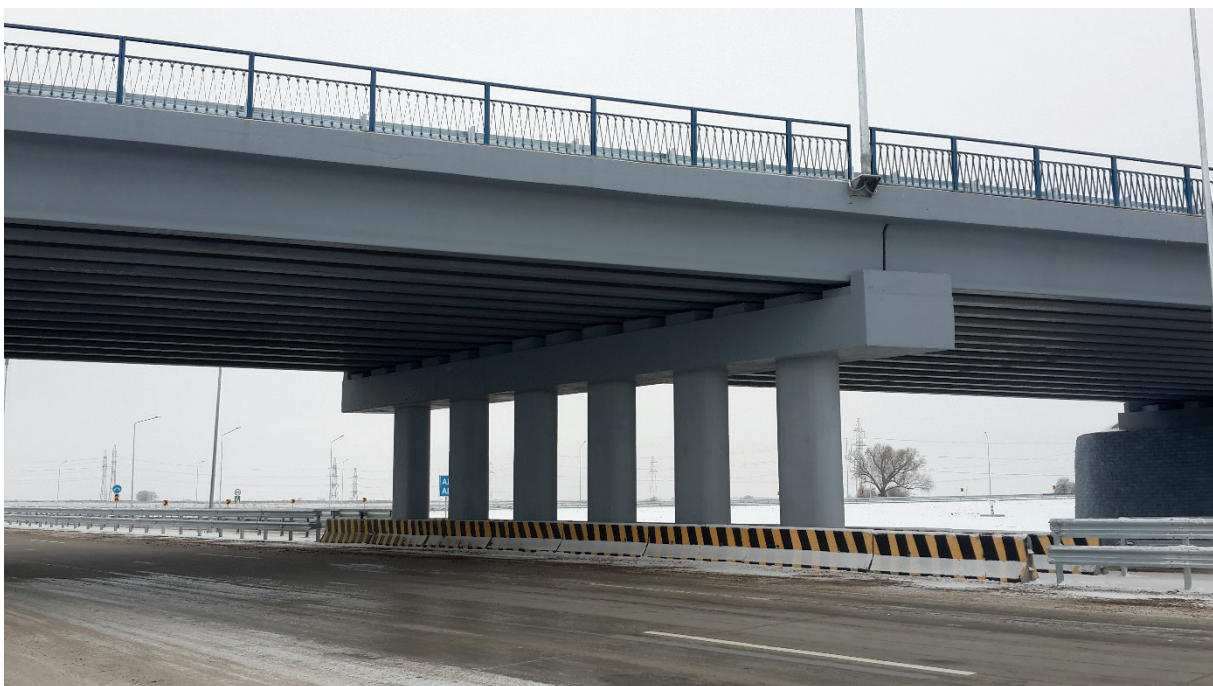
Figure 2 General view of the repaired superstructure No. 1 from Almaty

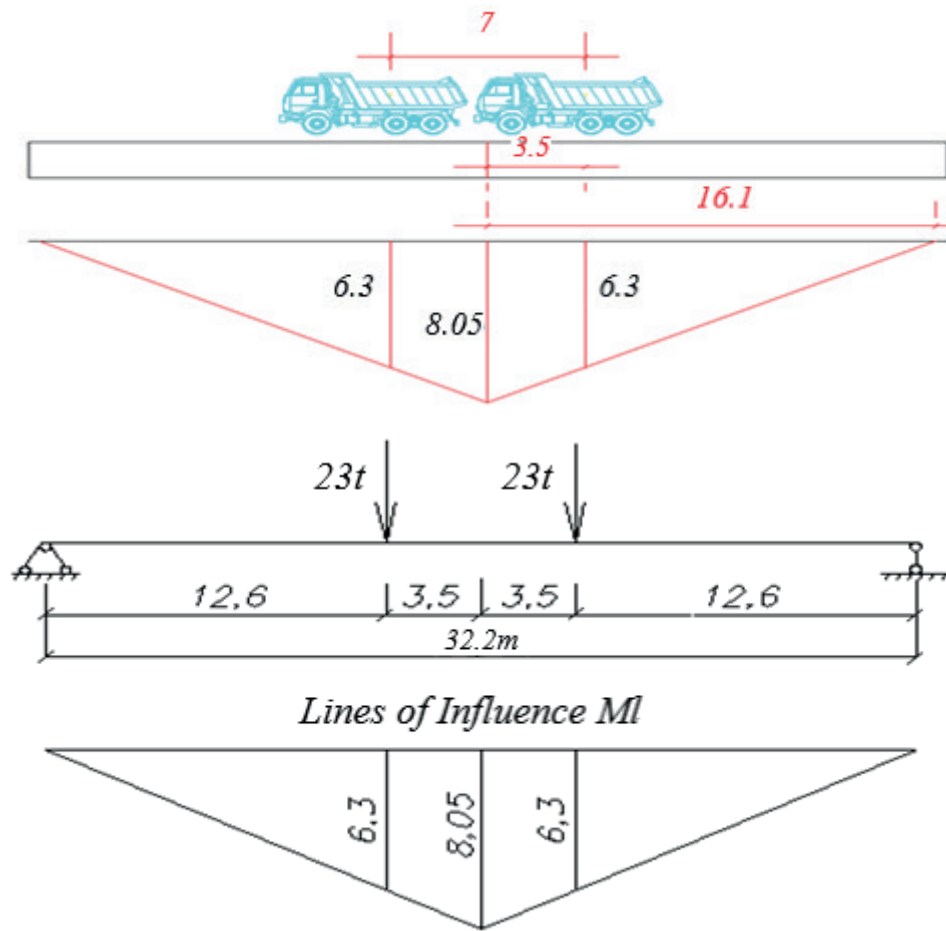
Figure 3 The influence line of the bending moment in the middle of the beam span and the position of the test load on the superstructure

Here is the test load calculation. The influence line of the bending moment in the middle of the beam span

and the position of the test load on the superstructure are shown in Figure 3.

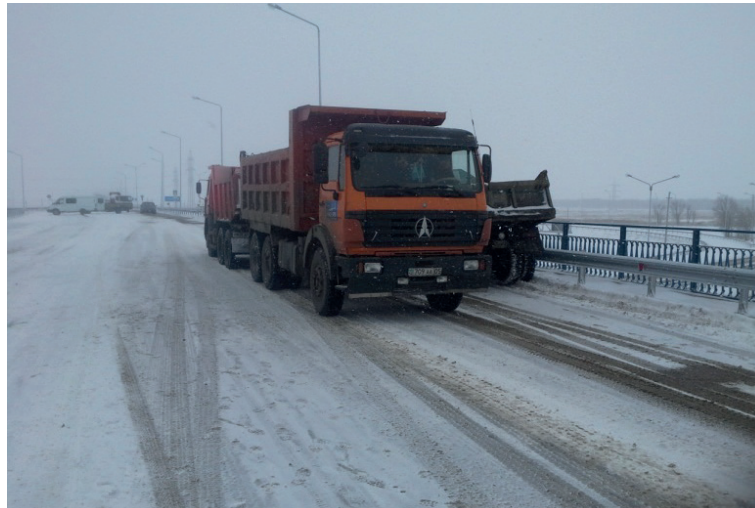
Figure 4 Vehicles are located at the roadway safety fence of superstructure No. 1 from Kapshagai at the first stage of testing

Table 4 shows the transverse location factor (TLF) values from the action of the test load when the last row of trucks is located at a distance of 1.5m from the roadway safety fence and in the middle of the superstructure (Figures 4, 5 and 6).

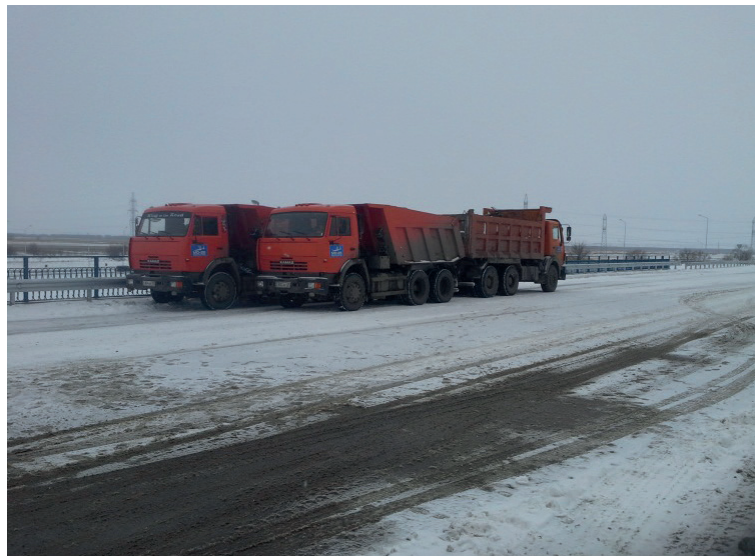
Figure 5 Vehicles are located at the roadway safety fence technical of superstructure No. 1 from Almaty at the second stage of testing

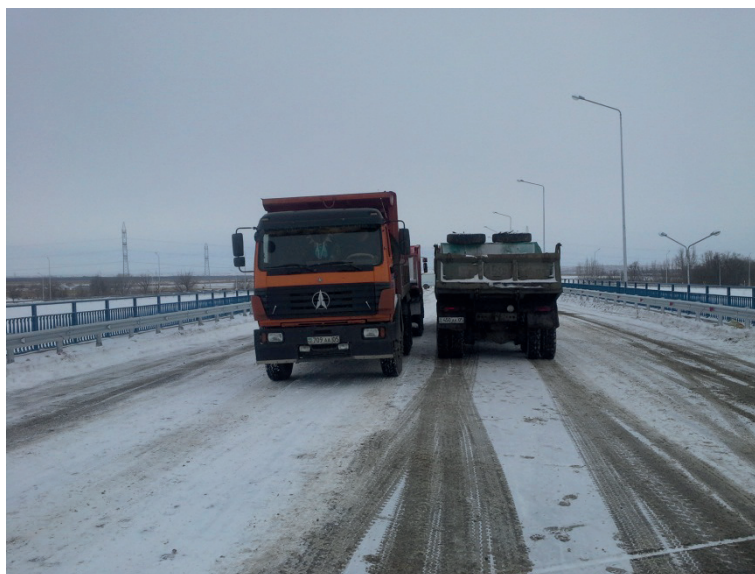
Figure 6 Vehicles are located at the longitudinal axis of superstructure No. 1 at the third stage of testing

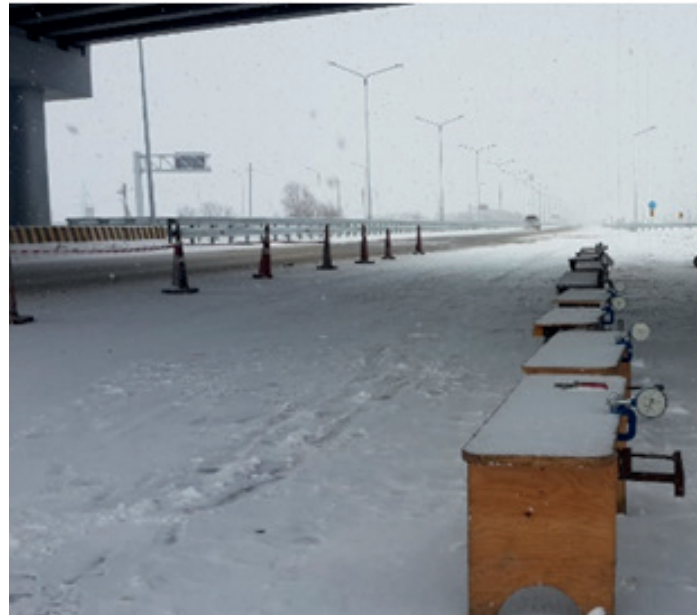
Figure 7 Location of deflection gauges under each of the fourteen beams in the middle of the superstructure No. 1

The repaired superstructure No. 1 was subjected to the control tests. Aistov and V. A. Kucherenko CRIBS deflection gauges with the price of division on the scale of the device of 0.01 and 0.1mm, respectively, were used to determine the deflections in fourteen beams of superstructure No. 1. The superstructure No. 1 was loaded in stages and beams deflections [17-18] were recorded at each stage of loading.

Figure 7 shows the deflection gauges' location under fourteen beams in the middle of the superstructure No. 1.

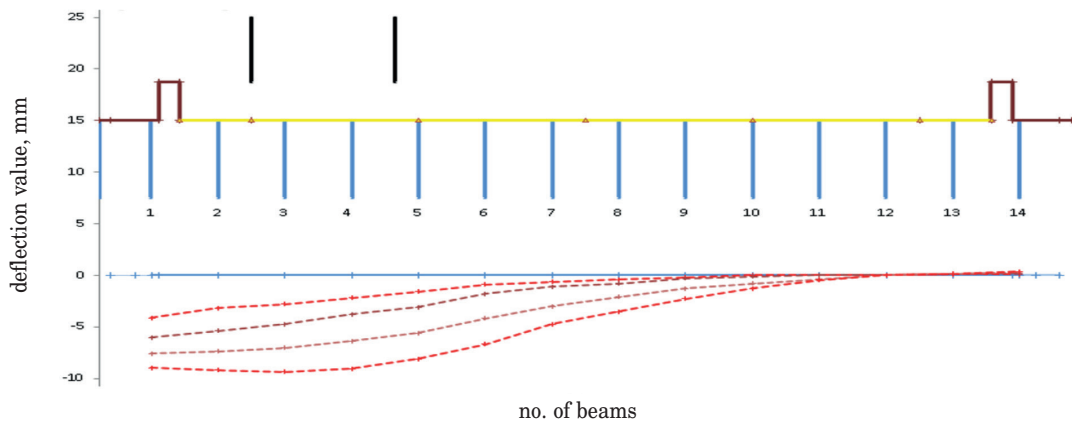
Measurement type	Beam No.	zero count	1 stage	f, mm	2 stage	f, mm	3 stage	f, mm	4 stage	f, mm
			count	count	count	count	count	count		
Aistov	1	25	340	3.15	628	6.03	783	7.58	925	9
Aistov	2	0	320	3.2	538	5.38	736	7.36	920	9.2
Aistov	3	47	325	2.78	521	4.74	752	7.05	983	9.36
Aistov	4	770	991	2.21	1150	3.8	1409	6.39	1676	9.06
CRIBS	5	3	19	1.6	34	3.1	59	5.6	84	8.1
CRIBS	6	0	9	0.9	18	1.8	42	4.2	67	6.7
Aistov	7	26	88	0.62	136	1.1	328	3.02	502	4.76
Aistov	8	12	53	0.41	92	0.8	223	2.11	364	3.52
CRIBS	9	2	4	0.2	5	0.3	15	1.3	25	2.3
CRIBS	10	4	4	0	5	0.1	12	0.8	17	1.3
Aistov	11	44	43	-0.01	44	0	82	0.38	89	0.45
Aistov	12	46	45	-0.01	44	-0.02	47	0.01	47	0.01
Aistov	13	23	12	-0.11	11	-0.12	11	-0.12	10	-0.13
Aistov	14	36	25	-0.11	18	-0.18	5	-0.31	0	-0.36

Figure 11 Loading and unloading stages, the superstructure transverse profile and outline of the beam deflections during the loading and unloading at the first stage

At the first stage of testing, the maximum deflection value has been recorded in beam No. 3, which was $f = 9.36\text{ mm}$.

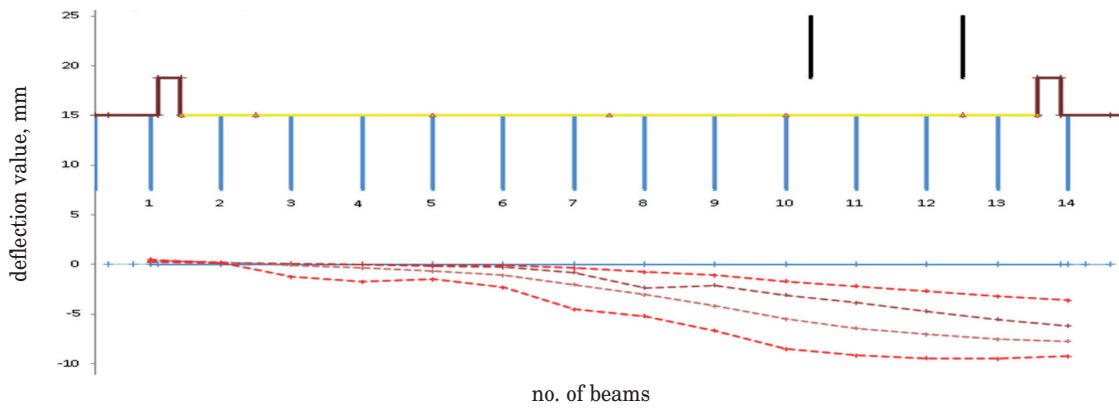
Measurement type	Beam No.	zero count	1 stage	f, mm	2 stage	f, mm	3 stage	f, mm	4 stage	f, mm
			count	count	count	count				
Aistov	1	57	36	-0.21	27	-0.3	20	-0.37	9	-0.48
Aistov	2	21	10	-0.11	4	-0.17	2	-0.19	5	-0.16
Aistov	3	71	64	-0.07	62	-0.09	78	0.07	197	1.26
Aistov	4	785	786	0.01	787	0.02	821	0.36	961	1.76
CRIBS	5	3	4	0.1	5	0.2	10	0.7	18	1.5
CRIBS	6	0	1	0.1	3	0.3	11	1.1	23	2.3
Aistov	7	25	61	0.36	107	0.82	228	2.03	479	4.54
Aistov	8	6	82	0.76	243	2.37	313	3.07	528	5.22
CRIBS	9	1	12	1.1	22	2.1	43	4.2	68	6.7
CRIBS	10	2	19	1.7	33	3.1	57	5.5	87	8.5
Aistov	11	21	239	2.18	406	3.85	663	6.42	940	9.19
Aistov	12	25	292	2.67	496	4.71	729	7.04	971	9.46
Aistov	13	10	331	3.21	564	5.54	763	7.53	958	9.48
Aistov	14	31	393	3.62	651	6.2	806	7.75	958	9.27

Figure 12 Loading and unloading stages, the superstructure transverse profile and outline of the beam deflections during the loading and unloading at the second stage

At the second stage of testing, the maximum deflection value has been recorded in beam No. 13, which had a value equal to $f = 9.48\text{ mm}$.
