# STRUCTURAL BEHAVIOR OF PRESTRESSED CONCRETE BRIDGE GIRDER WITH EPOXY JOINT

Assylkhan Jalairov<sup>1</sup>, Dauren Kumar<sup>2,\*</sup>, Khaini-Kamal Kassymkanova<sup>3</sup>, Zeynep Sarsembekova<sup>2</sup>, Gulzhan Nuruldaeva<sup>4</sup>, Gulnar Jangulova<sup>2</sup>

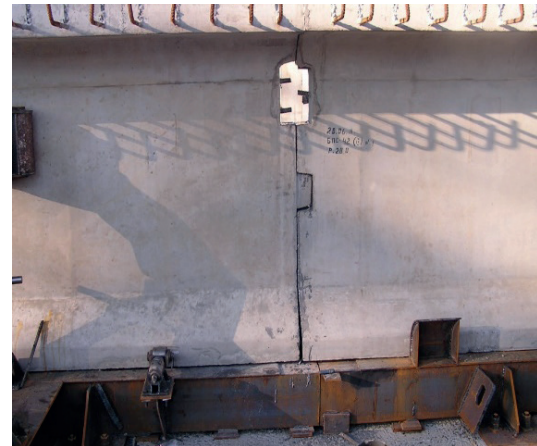
**Figure 9** Missing contact of the segment heads of 42.0-m-long composite beam in No. 1 adhesive joint zone after the tension of the prestressing tendons

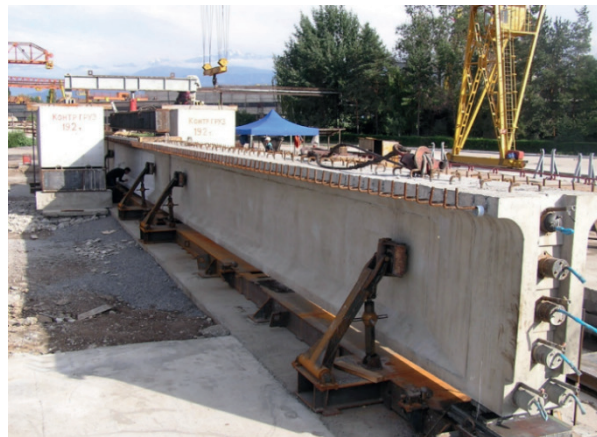
**Figure 10** The fittings designed for injecting grout are shown at the end of the composite beam

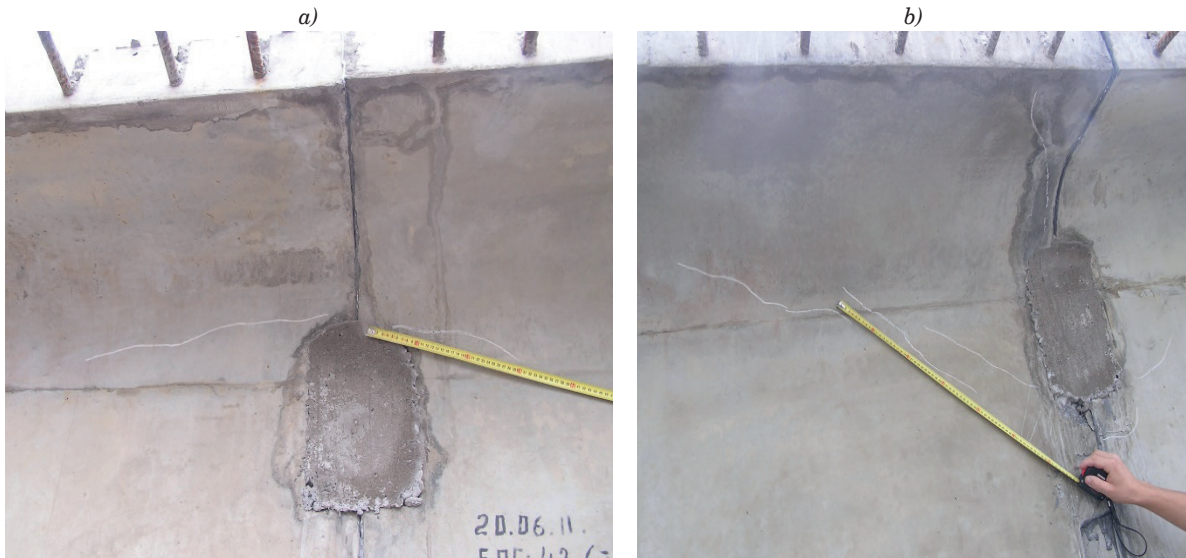
**Figure 11** Cracks formation in blocks concrete in the monolithic insert zone after stressing of 42.0-m-long composite beam by tendons: a) the southern side of No. 1 adhesive joint; b) the northern side of No. 1 adhesive joint

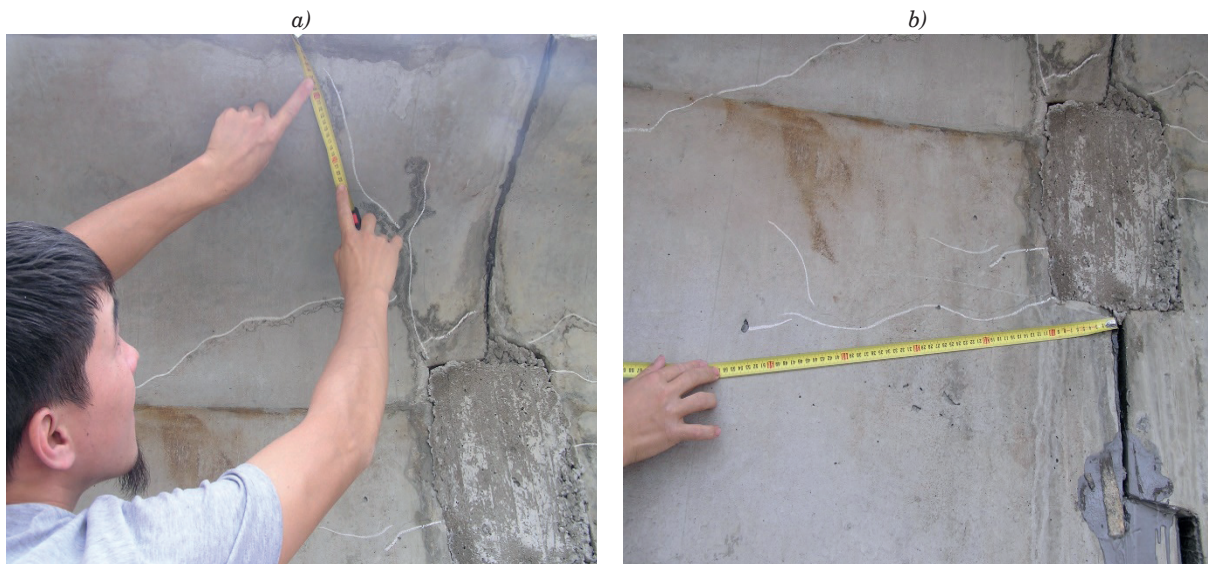
**Figure 12** Cracks formation in blocks concrete in the monolithic insert zone after stressing of 42.0 m-long composite beam by tendons: a) the southern side of No. 1 adhesive joint; b) the northern side of No. 1 adhesive joint

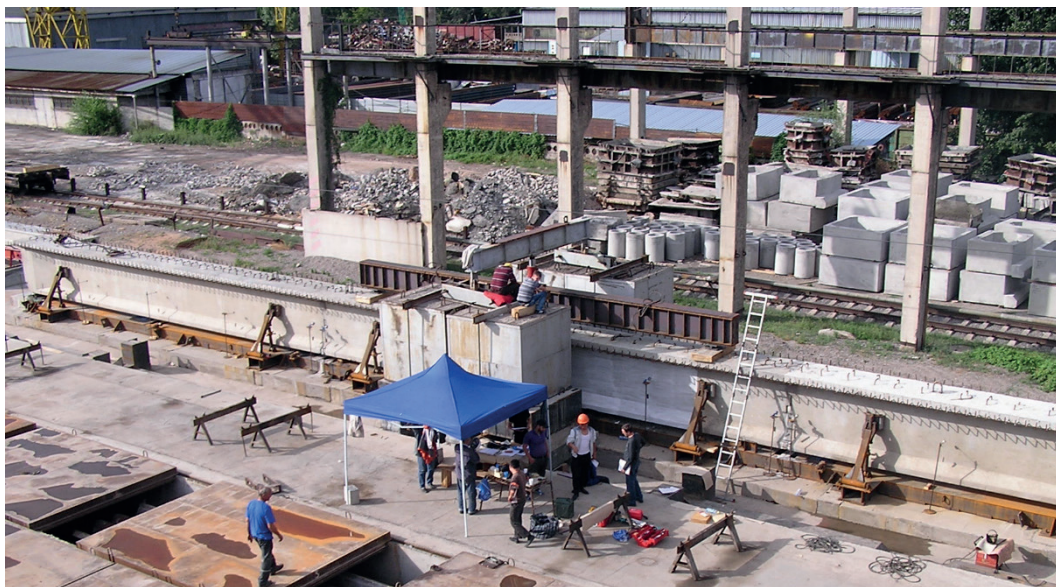
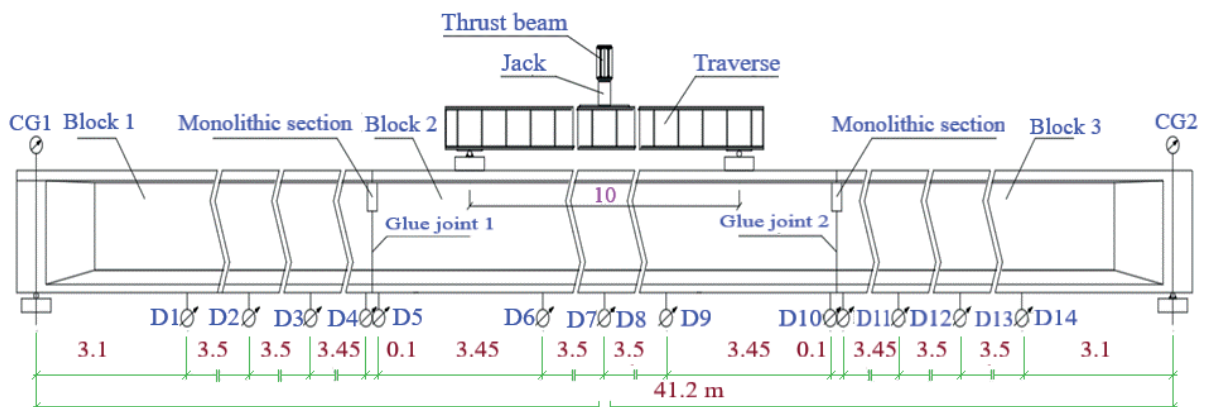
**Figure 15** The composite beam scheme with a length of  $L=42.0$  m with loading and mechanical devices (CG3, CG3\*, CG4 and CG4\* indicators in N1 and N2 adhesive joints zones are conditionally not shown):  
 ∅ - (D1-D4) deflectometers; ⊗ - (CG1-CG2) mercer clock gauges

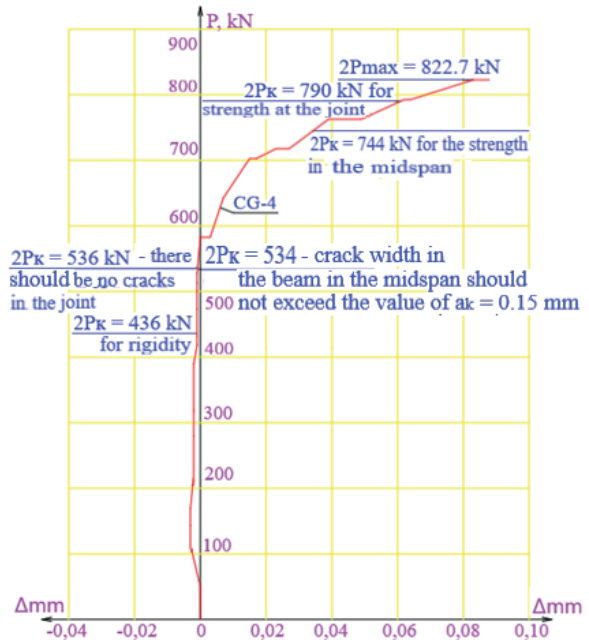
Figure 24 Opening in No. 2 joint zone
