Jan Zamecnik - Juraj Jagelcak \*

## EVALUATION OF WAGON IMPACT TESTS BY VARIOUS MEASURING EQUIPMENT AND INFLUENCE OF IMPACTS ON CARGO STABILITY

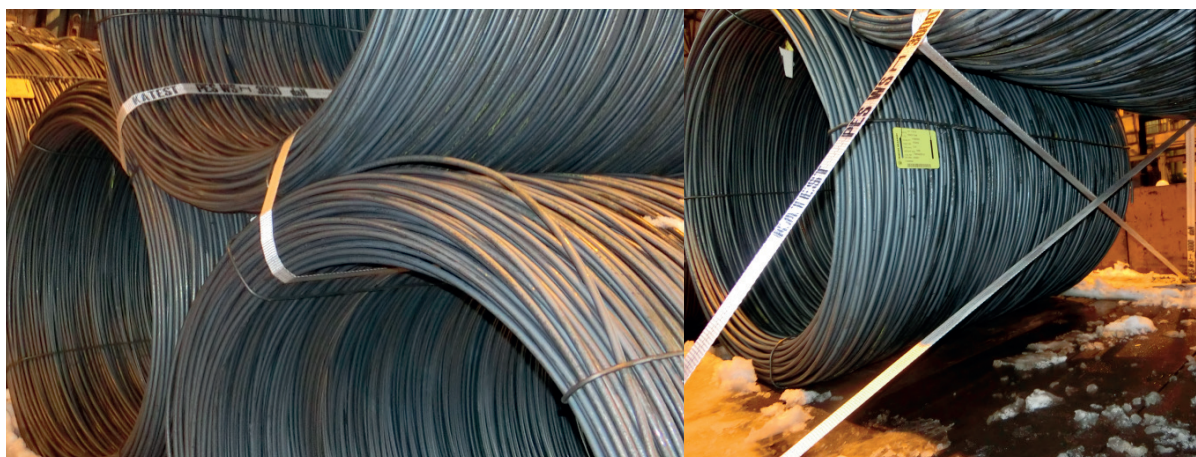
Fig. 1 Securing of the coil in the upper layer in the first series of impact tests (on the left) and in the second series of impact tests (on the right)

The second series of impact tests was done with the same wagon and cargo loading distribution, but the way of securing the upper coil was different. The upper coil was secured by a loop lashing by two straps to lashing points of the wagon. After the first impact (F04) the cargo did not move. After the second impact a 5

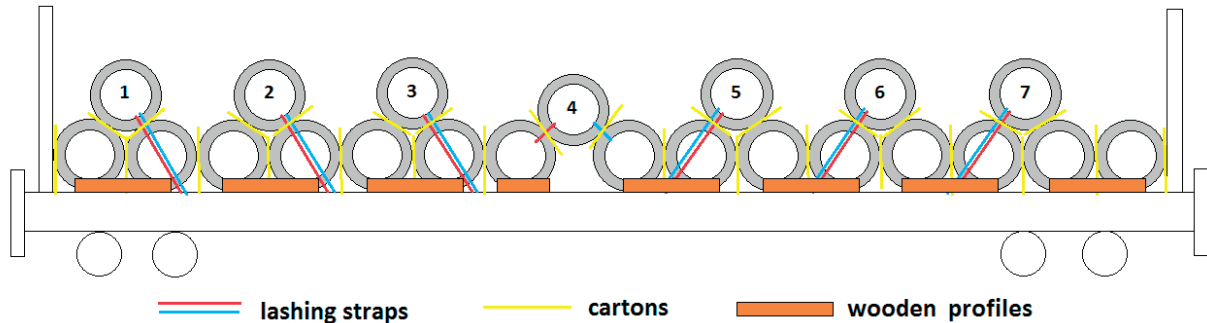
Fig. 2 Cargo loading on the wagon Rils in the third series of impact tests

In the third series of impact tests the wagon Rils was used. The wagon was loaded by 22 coils, 15 of which on the floor and 7 in the upper layer. The coils 1 to 3 and 5 to 7 were fixed always

by a loop lashing with two lashing straps to the lashing points of the wagon (see Figs. 2 and 3), whilst the middle-placed coil no. 4 was lashed by lashing straps only with the neighbouring coils placed on the floor and there was 60 cm long space under it. The neighbouring coils were separated by 5 mm thick cartons. The cargo was blocked against transverse movement by wooden profiles. After the first impact (F07) the coils in the upper layer skipped up but no movement of cargo was detected. The forces in lashings in the front part of the impacting wagon increased, but lashing straps in the rear part of the wagon became looser. After the second impact (F08) the 5 cm long space was created in the rear part of the wagon. This space was created because the coils pushed one into another and the space under coil no. 4 was not shortened. The measuring devices MT6 and Saver 9X placed in the middle of the wagon, measured high acceleration in the vertical axis in this impact (1.08 g by MT6). The speed of impacting wagon before the third impact in reverse direction (R09) was very low, so the reverse impact test was repeated. In the repeated reverse impact test R10 the cargo moved frontwards and 5 cm long space was created in the rear part of the wagon. Loose lashing straps in the front part of wagon (which had been its rear part in F07 and F08) became tightened and the straps in the rear part of the wagon became looser.

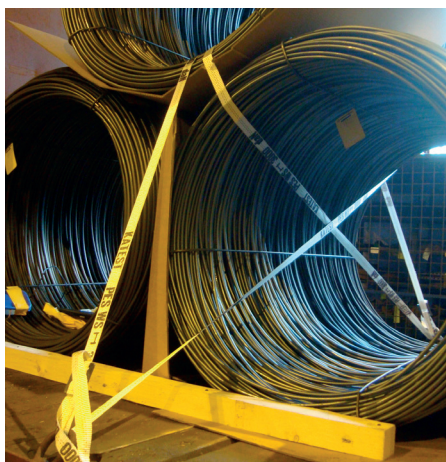
Fig. 3 Lashing on the wagon Rils in the third series of impact tests

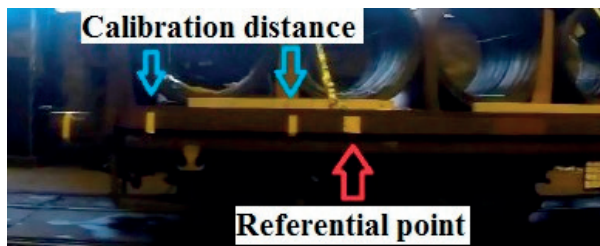
Fig. 4 Illustration of calibration distance and referential point on the wagon. Source: [3]

If the video analysis is used for evaluation of impact or braking parameters, there is important to take into account that correctness of acquired data depends on correct setting of calibration distance (referential distance according to which the software can count the video recording distances to real distances). It is also necessary to remove fish-eye effect. We used calibration distance of 1 meter, which was marked on the

impacting wagon (Fig. 4). We also used referential point which was marked on the wagon and had contrastive colour. Tracker software using the function of Autotrack traced this referential point and recorded values of calculated speed and distance. The calibration distance is located in different place at the beginning and at the end of video recording and is recorded under different angle due to movement of observed wagon. So there are some differences in the measured values between using calibration distance in place at the beginning of video recording (cal. dist. 1, about 20 m before the place of impact) and calibration distance in the place at the end of recording (cal. dist. 2, at place of impact) due to distortion of video. Therefore, there are two data results. For purposes of comparison with other measuring equipment we used the average value of both results. Runs of speed and accelerations are similar when using both results (see Figs. 5 and 6), only calculated numerical values are different. Result values from video analysis are stated in Table 4.

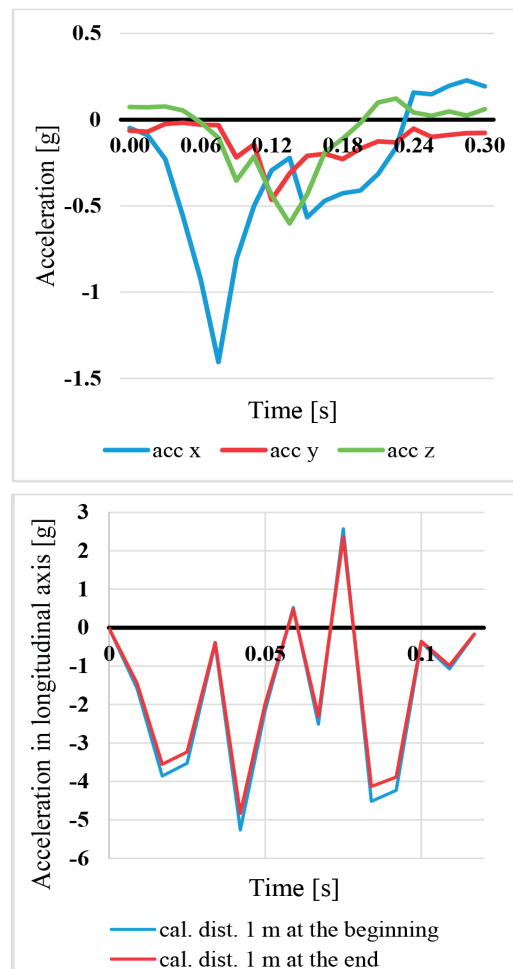
Fig. 5 Runs of accelerations in impact Res R03 acquired from data from device MT6 (up) and from video analysis (down)

In Figures 5 and 6 are stated runs of acceleration at two impacts as they were recorded by the device MT6 equipped with a tri-axial accelerometer and with video analysis of recordings from GoPro cameras. The time shift between peak values of longitudinal and vertical acceleration is visible in runs from MT6 device. Accessible data from monitoring units are not suitable for purpose of evaluating the run of acceleration, because they contain only the highest evaluated values and simplified runs of acceleration with interval of 0.1 – 0.3 s, which means too small frequency for evaluating such short-term actions as wagon impact tests are. In both figures is visible that runs of acceleration acquired from the video analysis are very irregular.

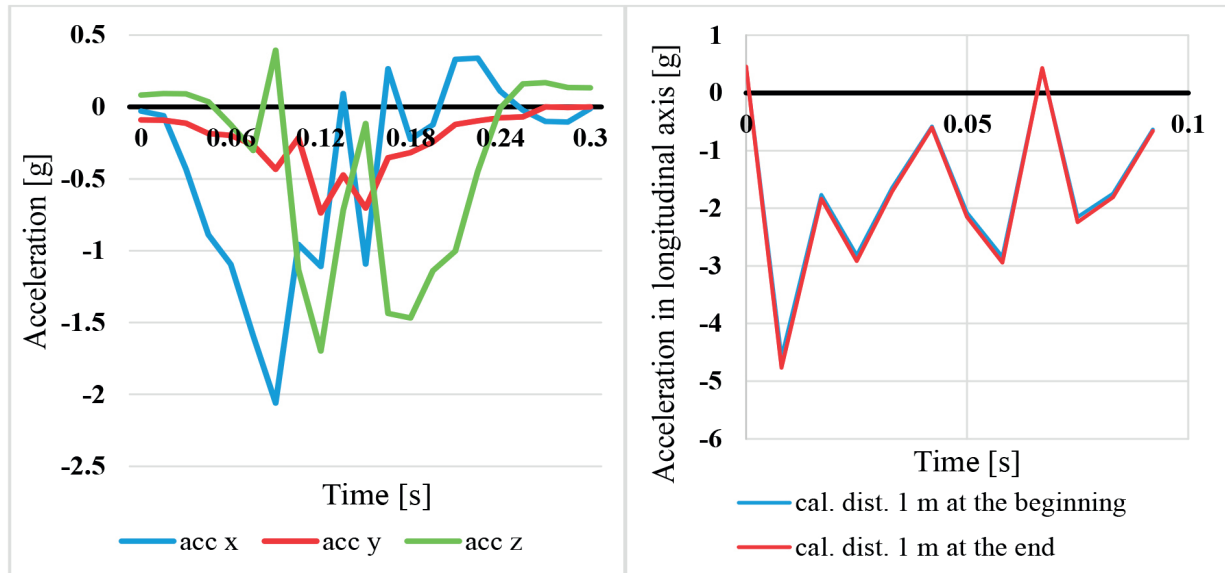
Fig. 6 Runs of accelerations in impact Res F05 acquired from data from device MT6 (on the left) and from video analysis (on the right)

The accelerations in the place of impact were measured by four monitoring units which are used for the monitoring of road, railway or intermodal transport and are also equipped with accelerometers with a function of accident situations detection. Units marked as A1 and A2 were placed in the same height as wagon buffers and in general these units recorded higher values of acceleration than units called X1 and X2 placed about 75 cm higher. Average values of accelerations in the axes x, y and z from all the measuring devices, except GoPro Hero 3 cameras (the data analysis does not allow to determine the accelerations in the axes y and z) and device Saver 9X (unsuitable data structure), are given in Table 3. Incorrect data from monitoring units A1 and A2 at impact test Res F05 are also not included to the average values. The last column states maximum values of acceleration in the vertical axis measured by MT6 (this device allowed to analyse runs of accelerations in all three axes during and after impacts). These maximum values occurred with time shift of 50 - 80 ms from occurrence of maximum values of accelerations in the longitudinal axis, as is visible in Figs. 5 and 6.

The highest accelerations were reached in the longitudinal axis x. In several cases the impacted wagon moved after the impact, mostly in the tests Res F01, Res F02, Res F05, Res F06 and Rils F08. Average values of accelerations in the y-axis and the z-axis were recorded as about 25 % and 43 %, respectively, of the average value of acceleration in the x-axis. Transverse acceleration in the y-axis in the three cases lightly exceeded 0.5 g which is the value considered for cargo securing to prevent the movement sideways in railway transport. In general, results from these tests indicate that transverse accelerations reach higher values in the impact tests in front direction when there is no space near the frontwall of the wagon. Accelerations actuating in the vertical axis z in their peak values mostly exceeded 0.3 g, as is stated in UIC Loading Guidelines, but their peak values actuated only for short-term. The device MT6 placed in the middle of tested wagons measured very high peak values of vertical acceleration in most cases, whereas in some cases it recorded two peaks, mainly in such cases when the coils skipped. Peak values in the vertical axis actuated for shorter time than that in the longitudinal axis (see Fig. 6). The problem for
