Renata Korenkova - Peter Krusinsky - Peter Pisca *

ANALYSIS OF THE IMPACT OF MICROCLIMATE IN A ROOF SPACE ON A GOTHIC TRUSS CONSTRUCTION

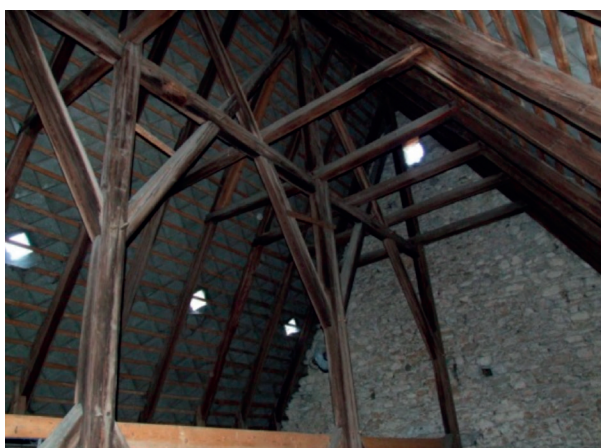
Fig. 2 View into the truss space

The Roman-Catholic church of the Most Holy Body of Christ was built as a stand-alone building, situated from the north to the west, in the middle of a fenced area in the historical centre of the village of Bela-Dulice (see Fig. 1). It probably arose in the first half of the 14th century. It has two separated truss structures, over the nave and the sanctuary. The truss over the nave was a subject of our investigation [2]. The steep truss over the nave has a rafter construction with collar beams, it is longitudinally bound with a central framed trestle (see Fig. 2), and it is dated from 1409d. It has 10 bonds, where 4 are full with 2 intermediate ones among them. In full bonds, central posts intersect collar beams; they are lapped over with rafters in the top. Symmetrical struts stabilize the post and join it with a tie beam. Rafters are mortised into the ends of tie beams. Tall oblique struts are used as a lateral reinforce. All joints are made using treenails. Central standing trestle is composed of a frame consisting of a sill beam, 4 posts which are, approximately in 3/5, divided with horizontal struts. Symmetrical bottom struts stabilize the posts in longitudinal direction, like in transversal one. Diagonal struts serve as a bracing for the entire framed structure. There are 3 larger openings in the roof space: the passage opening in the parting gable between the trusses over the sanctuary, and a smaller one in the upper part over the roof ridge of the sanctuary. Additional openings are: an entrance into the tower, a continuous slot between roofing and a profiled cornice – Fig. 3. The truss was renovated more times in the past; about 60% of original wall plates were replaced in 2011. Approximately 80% of the truss construction preserved its originality up to the present days.

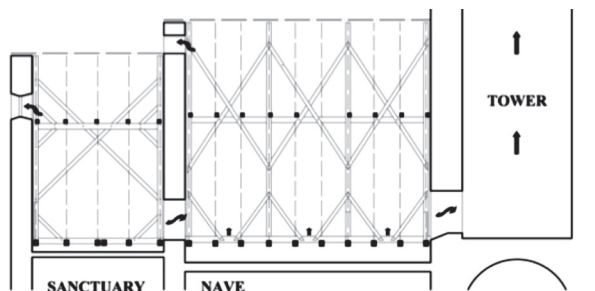
Fig. 3 The dispositional scheme of vents in the investigated truss; right - the truss cross-section, left - the truss longitudinal section

The examined pitched roof has a slope of $59^{\circ}64'$ [5] with gable walls. The roof deck comprises sheet copper roofing used in strips; the joints of particular strips have standing seams. As the roof space is open towards the outside - it has openings as in the lower so in the upper part of the roof deck, in the top of the gable wall, passage openings in the tower gable wall and in the truss gable wall over the sanctuary - the roof can be considered as a ventilated double-cladding pitched roof.

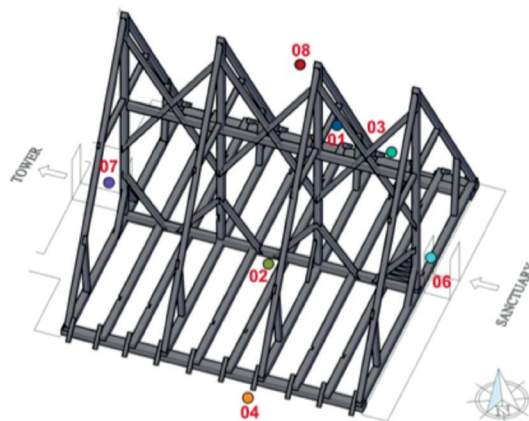
Fig. 4 The dispositional scheme of sensors V1 used as a measuring system

To enter reliable and real data into the airflow simulation, and to detect an actual as well as a long-term impact of microclimate in a roof space on the moisture accumulation in timber elements, the measuring system with two types of sensors for a particular space was designed. Particular temperature and relative air humidity sensors, and also sensors for scanning the temperature and absolute moisture of timber elements are found on spots where there is a precondition of airflow. Their disposition is symmetrical in relation to the roof ridge, i.e. they are disposed evenly on the western and southern side in the roof space. Some sensors are located in the lowest roof part, exactly in the exterior under the gutter cornice (sensor 01 and 02). Additional sensors have their positions in the exterior near the opening in the eastern

gable wall, in openings in gable walls leading into trusses over the sanctuary (06) and into the tower (07). Other sensors are found in the roof space - in the middle of the object under the roof ridge (08), and in the midpoint of the roof plane length (03 and 04) - see the scheme in Fig. 4.

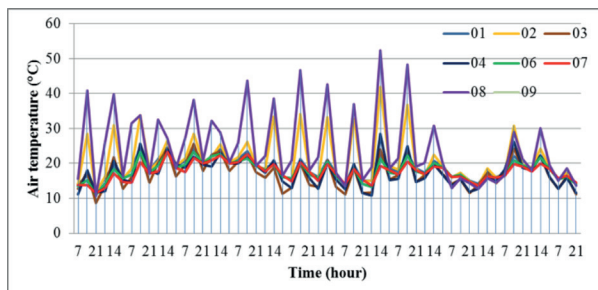
Fig. 5 The course of air temperatures recorded at 7:00, 14:00 and 21:00 o'clock - spring season 2012 (18.5.2012 - 5.6.2012)

Temperatures and relative air humidity are monitored with sensors at 15-minutes intervals. For calculations, data gathered at 7:00, 14:00 and 21:00 o'clock within summer time, and at 8:00, 15:00 and 22:00 o'clock during winter time was considered - Fig. 5 and Fig. 7. Average day temperatures and relative air humidity are calculated using obtained data - Fig. 6 and Fig. 8. All evaluated data from sensors, as in spring so in autumn season, reached temperature maximums at 14:00 o'clock - Table 1. Most sensors recorded temperature minimums at 7:00 o'clock; and all sensors in autumn season. As to complete evaluation, sensor No. 8 (located closely to the roof ridge) recorded the highest temperatures at 7:00, 14:00 and also at 21:00 o'clock. Relative air humidity goes to minimum in these spots. The roof ridge has no ventilation, thus there isn't any obvious airflow. There is sheet copper roofing used in strips on wooden slabs. The sensor No.07, found in the gable wall opening running into the tower, registered temperature minimums at 14:00 o'clock. At the same time, temperatures that were monitored with this sensor showed the smallest differences.

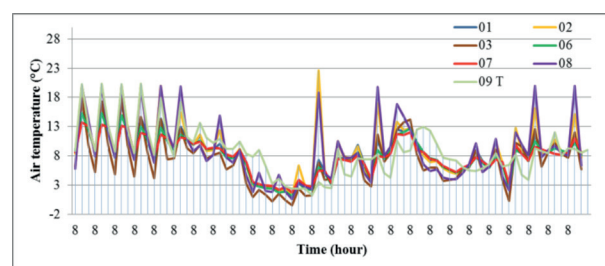
Fig. 7 The course of air temperatures recorded at 7:00, 14:00 and 21:00 o'clock - autumn season 2012 (18.10.2012 - 13.11.2012)

In most cases, temperature minimum was recorded with sensor No. 04, position of which is in the exterior on the northern side of a building, and with sensor No. 03 located near eaves in the exterior on the northern side of the building. Lowest temperatures in both seasons were found out using the outdoor sensor on the northern side of a building under the gutter cornice. Sensors No. 08 (under the roof ridge) and No. 02 (under roofing on the southern side of building) monitored considerable temperature fluctuations. It is these spots in the truss that air overheating occurs, which is caused by the effect of sunrays during the day.

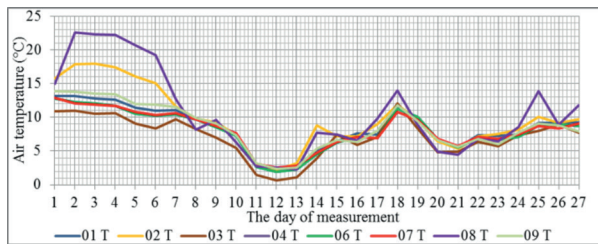
Fig. 8 Average day temperatures - autumn season 2012 (18.10.2012 - 13.11.2012)

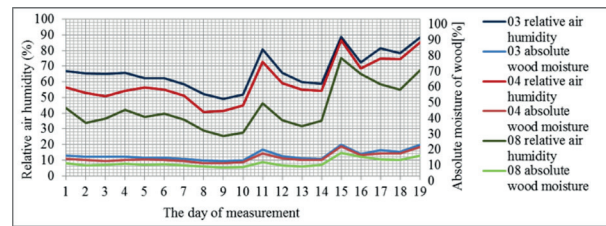
Fig. 9 The dependence of relative air humidity and absolute moisture of wood - calculated values, spring season 2012 (18.5. - 5.6.2012)

In accordance with calculations, absolute moisture of timber during the spring period in 2012 (see Fig. 9) fluctuated from 9.5 to 19.8%. The highest values of moisture (average moisture of 13.2%) are related to the timber elements on the northern truss side near eaves; the lowest ones (average moisture of 8.23%) regards the elements under the roof ridge. The highest values of moisture do not go over the critical limit which is optimal for arising such conditions that could cause damage of timber, e.g. ligniperdous insects, dry rot etc. [3].

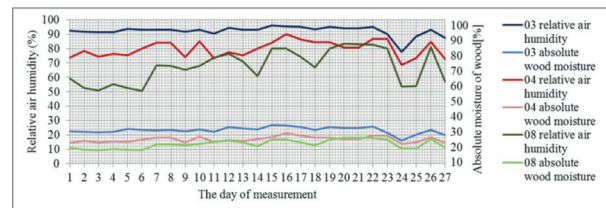
Fig. 10 The dependence of relative air humidity and absolute moisture of wood - calculated values, autumn season 2012 (18.10. - 13.11.2012)

Absolute moisture values during the autumn period in 2012 (see Fig. 10) ranged between 10 - 27%. Generally, relative air humidity is higher than in the spring and therefore moisture of timber elements is noticeably higher. The highest values of moisture (average 23.22%) were found out in timber elements on the northern side of the truss structure near eaves; the lowest ones (average 13.61%) concerned the timber elements under the roof ridge. In the view of the fact that moisture of timber elements exceeds critical values for the activity of ligniperdous pests, and the time during which the effect of higher relative air humidity is much longer, there is a high risk of occurring biotic damage of timber components.

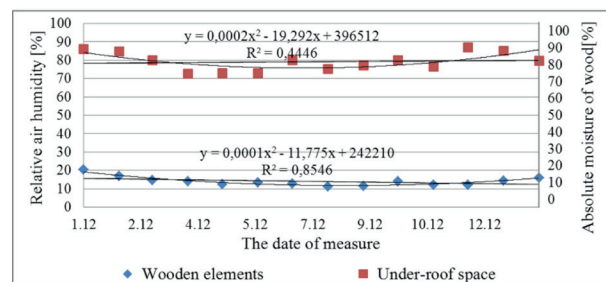
Fig. 11 Behaviour of relative air humidity in the roof space and values of absolute moisture, measured in timber elements of the fourth bond - the village of Bela-Dulice [8]

Values of moisture in timber components were confronted with the values that were obtained by direct measurements with the device Greisinger. Measured relative air humidity in the roof space reached the values of outdoor air characteristics. Year-long measurements regarding moisture in timber components of the fourth bond indicated that average values of absolute moisture of wood exceeded 20% only in one case - in January. Next month average moisture was 17%, and after that time values of moisture did not go over 13%. As late as in winter season the values were higher than 16% - see Fig. 11.

Calculated values were compared with values of absolute moisture of timber elements that were measured with the hand-device within experimental measurements using resistant hygrometer Greisinger. Measured absolute moisture of wood moved on lower level, in critical seasons it did not overrun critical values of absolute moisture of wood. On the basis of data confrontation it is possible to suppose that under the influence of venting in specific spots or areas in the truss space, there is a local change of conditions in microclimate, which can be seen as a change of moisture in particular timber elements.
