Jan Kec - Ivo Cerny - Jan Lustinec - Romana Pavelkova\*

## INFLUENCE OF REPAIRING USING WELDED STEEL PATCHES ON STRUCTURAL INTEGRITY OF A HIGH PRESSURE GAS PIPELINE

**Keywords:** pipeline, hydrostatic burst test, repair patches, full scale test.

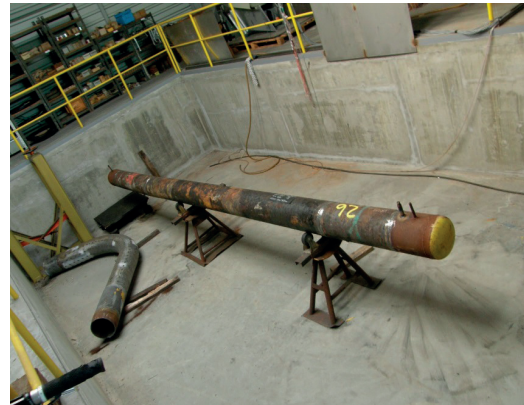
After the mechanical tests have been performed, the pipeline sections with repair patches were welded together to one pressure body - Figure 4. Both ends were blinded with bottoms. In the surroundings of patches, the thickness of the tube wall was measured in nodal points of the network of 100 x 100 mm. In the surroundings of patch A, the lowest value of the wall thickness was 7.01 mm and the highest one was 9.09 mm. In case of patch B, the lowest and highest values were 6.81 mm and 8.89 mm, respectively. Considerable differences in the wall thickness were quite apparent.

Figure 4 Pipeline with two types of welded repair patches
