EFFECTS OF ATMOSPHERIC CORROSION ON THE CAR PARK ROOF STRUCTURE

The paper presented shows the actual state assessment and the verification of structural reliability of the existing load-bearing structure of an exterior car park roof, emphasizing the estimation of corrosion losses in the steel structure that have considerably lowered its lifespan and obstructed its safe operation.

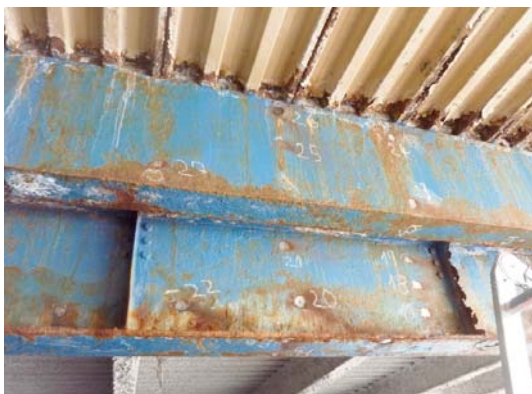
On visual on-site inspection of the existing structures it was concluded that Beams 1, 2 and 4 did not exhibit any signs of damage. It was further concluded that they were reliable and safe. The reason for their well-preserved condition might be their original good quality. On the contrary, Beams 3, 5 and 6 were greatly affected by corrosion, so it was essential to assess their real state, determine the actual corrosion losses in the individual fields of the examined beams as well as to examine the effects of external factors. The condition of the above-mentioned beams is shown in Figs. 2 and 3.

Fig. 3 Views of the steel frame details of the external car park roof structure (the condition before the renovation)
