THE VIBRODIAGNOSTICS OF DAMAGED GEARS OF PLANETARY GEARBOXES

This article deals with description of a diagnostic device used at the Department of Design and Machine Elements at the University of Zilina which has been built in order to measure, diagnose and evaluate gearbox faults by vibrodiagnostics. The article describes methods and damage creation process for tested gearboxes. Evaluation of different faults is also processed in this article as well as description of comparative measurements between real and artificially created pitting. Comparison of all measured data with SPM methods is also included.

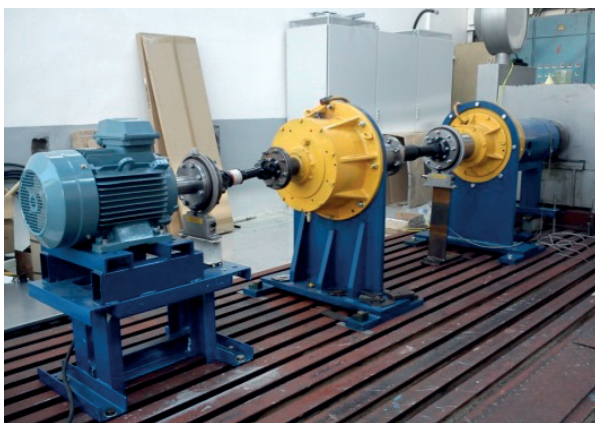
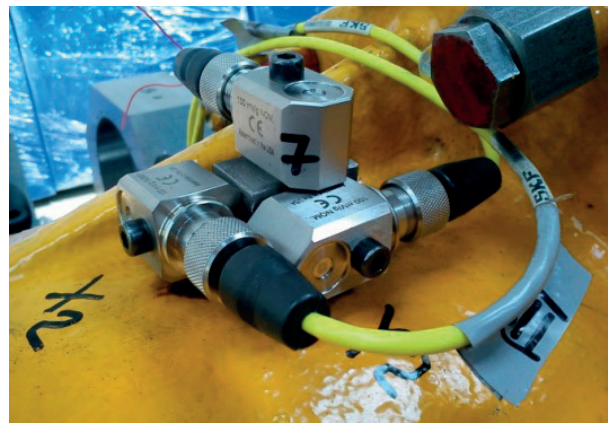
Fig. 1 The testing device used at the Department of Design and Machine Elements for diagnostics of planetary gearboxes' faults (left) and placement of vibration sensors (right)

The testing device consists of one 15 kW electromotor controlled by a phase shifter, two planetary gearboxes type A2000 mounted in series and also one dynamometer. Components

are coupled together by cardan shafts. The testing device is supplemented with noncontact sensors HBM T10F for RMP and torque measurement. Gearbox A 2000 is a planetary gearbox with two planetary gearings with involute spur gears [2].

The diagnostic apparatus was purchased from SKF and it contains six acceleration sensors with sensitivity of 100 mV/g, on-line diagnostic unit type IMx-S and one PC equipped with @plitude analyst software. Both frequency analysis and envelope method for signal processing are used to determine gearbox faults.

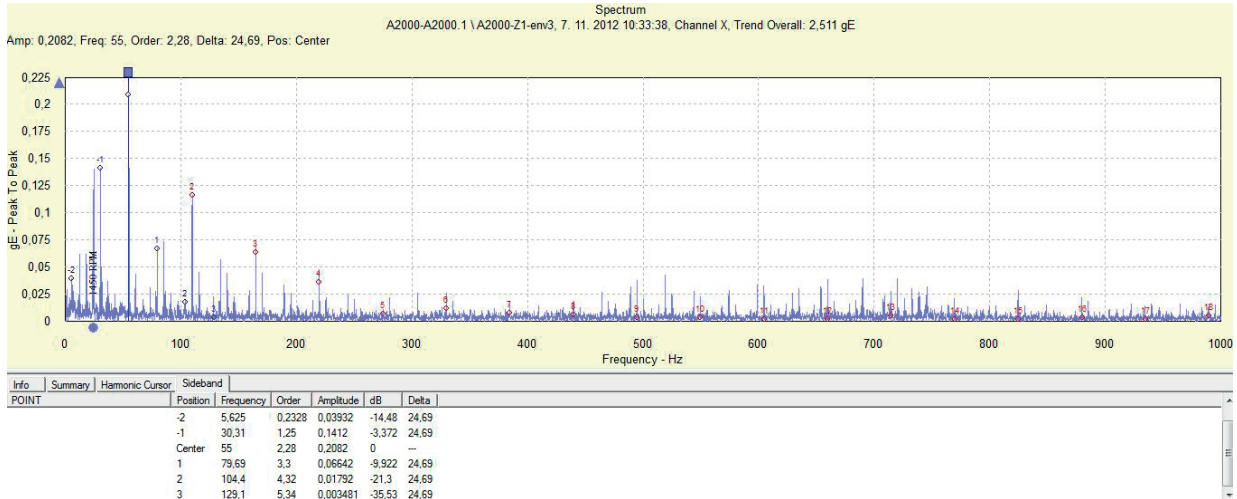
Fig. 2 The frequency spectrum of enveloped accelerations filter 3 for tooth of the sun gear damaged by the notch on its face area

accelerations spectrum filter 3 (Fig. 2). Frequency 55 Hz of damaged sun gear dominated throughout spectrum and its harmonic frequencies showed up (marked as red). Sideband was created around gear frequency with the delta equal to RPM frequency 24.69 Hz of damaged gear (marked as blue). Sideband can be clearly seen in vicinity of its harmonic frequency [3].

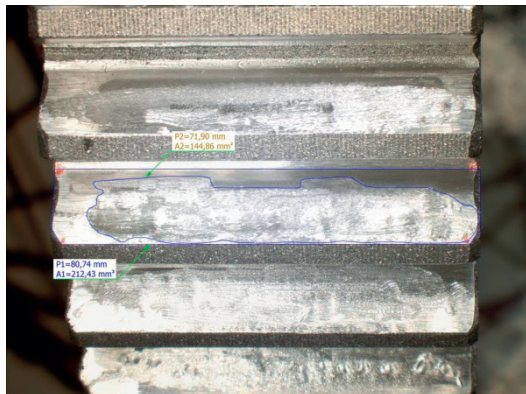
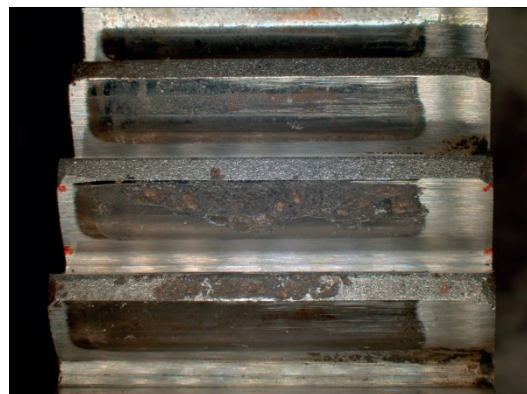
Fig. 3 Sun gear of planetary gearing damaged by artificially created pitting (left) and sun gear damaged by real pitting (right)

area as damaged by the notch) took place (Fig. 3 left). Artificially damaged sun gear was replaced by another sun gear damaged by real pitting on half of gear's teeth (Fig. 3 right). After both spectra were measured and frequency spectra were compared, we came to the conclusion that artificially created pitting has very similar effect when compared to real pitting (Fig. 4). This comparison confirmed that measured data match reality and test method was suitable for this application as well [8] and [9].

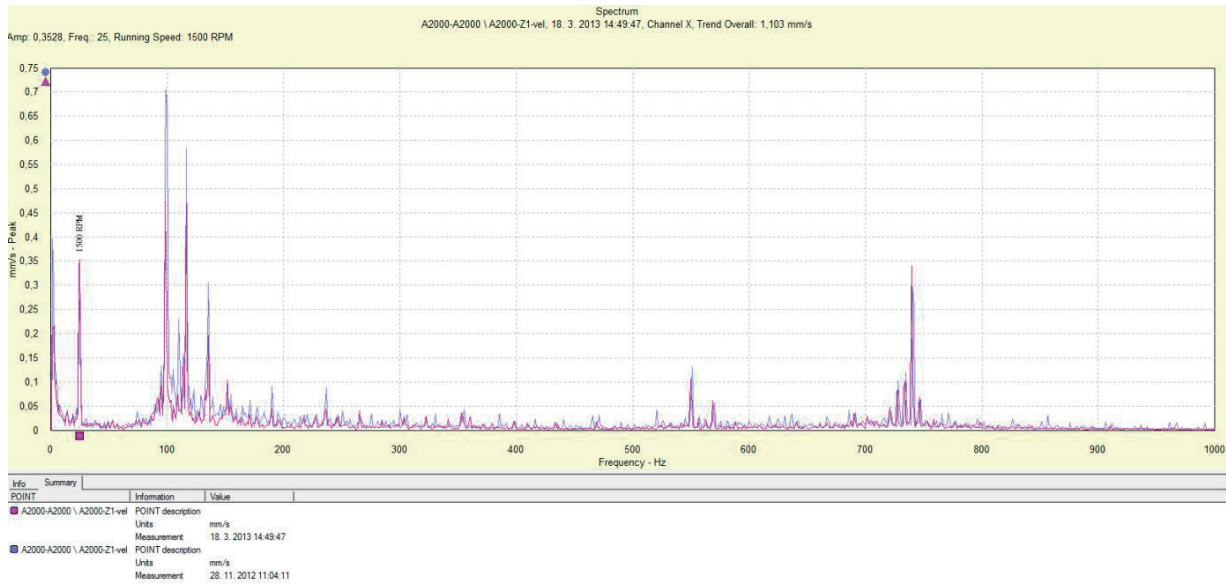
Fig. 4 The comparison of frequency spectra of gearbox with sun gear damaged by artificially created pitting on half of gear's teeth (blue) and sun gear damaged by real pitting (violet)

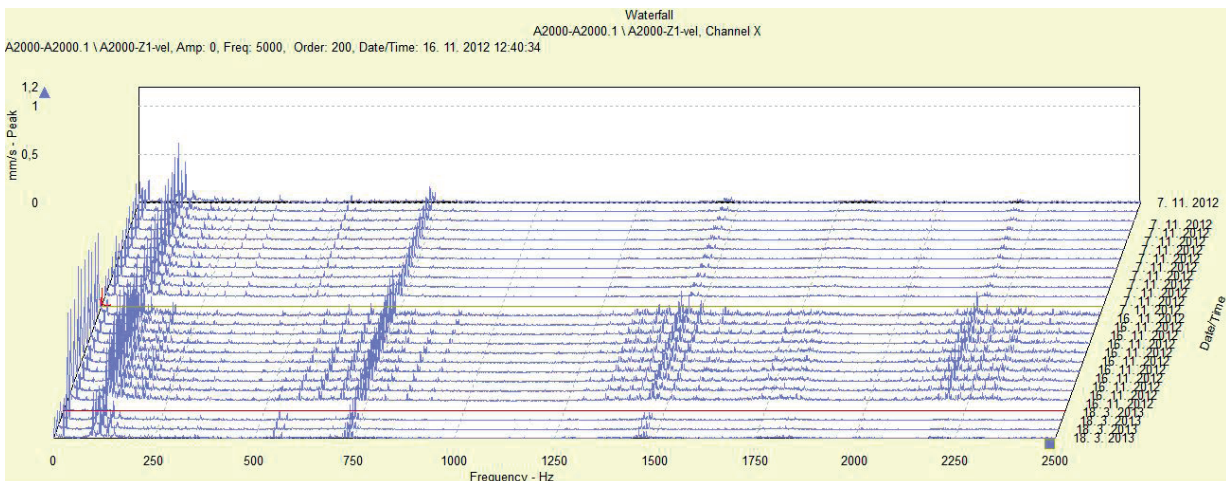
Fig. 5 Frequency spectrum of velocity of vibrations with differently damaged sun gears of first planetary gearing by pitting

Vibrations velocity frequency spectra with different pitting affected area of the sun gear of the first planetary gearing can be seen in Fig. 5. The upper part of spectra represents only one tooth damaged by pitting, middle part corresponds to all teeth damaged by pitting and lower part represents the gear damaged on half

of its teeth by real pitting. Straight lines between measurements reflect time when the testing device was offline.

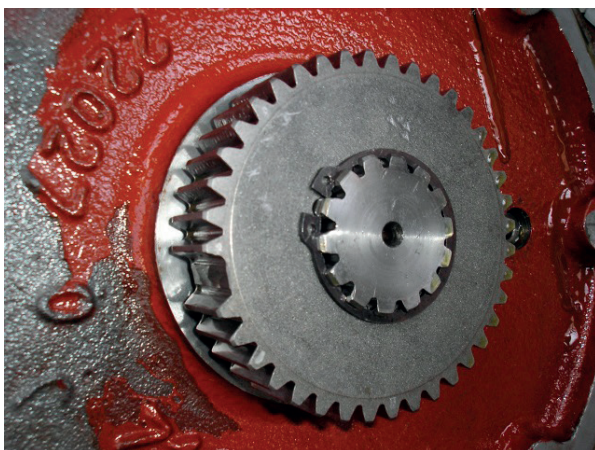
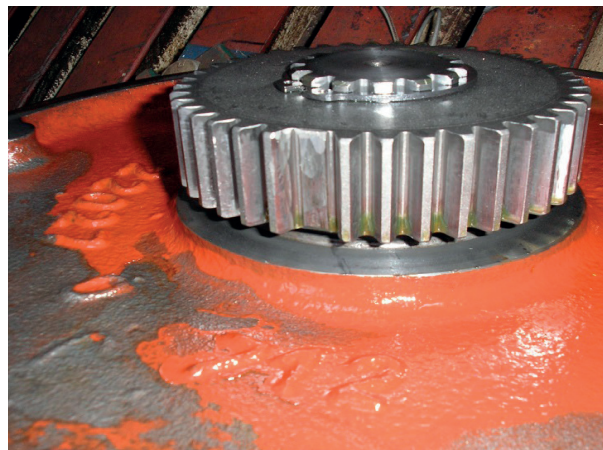
Fig. 6 Sun gear with one missing tooth

Another phase involved sun gear with one tooth partially broken and later with whole missing tooth. Measurements were made on gears which were previously damaged by pitting on half of their teeth (Fig. 6).

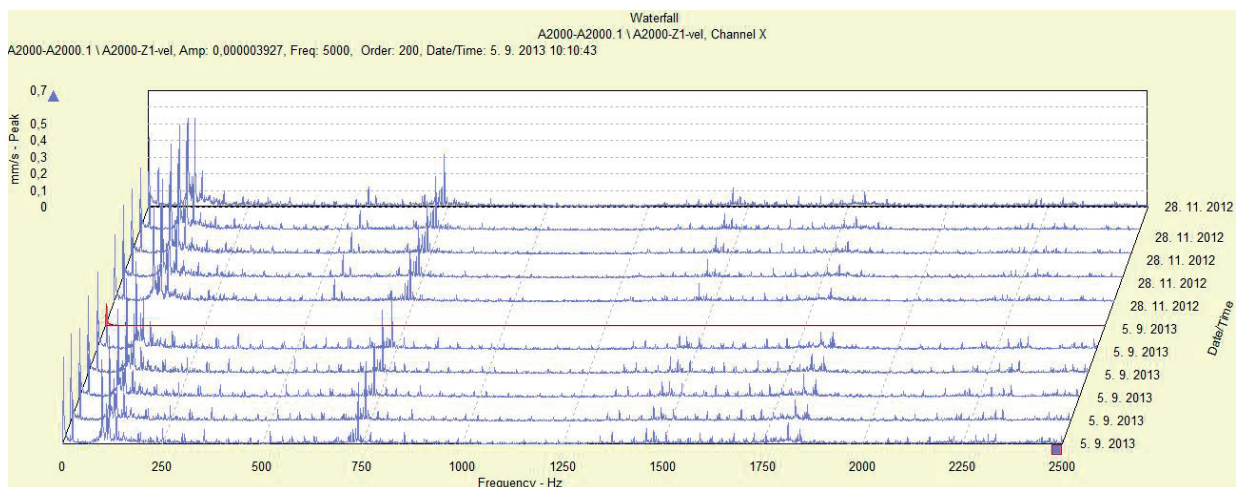
Fig. 7 The comparison of frequency spectra of vibrations for pitting created on half of teeth of sun gear (upper part) and for gear damaged by same pitting with one missing tooth (lower part)

There was no significant change in vibrations velocity spectrum (Fig. 7) compared to the sun gear damaged by pitting on half of its teeth [10]. Enveloped accelerations spectrum filter 3 - from 5 Hz to 1kHz (Fig. 8) also had similar characteristic compared to same sun gear with no missing teeth, but amplitude

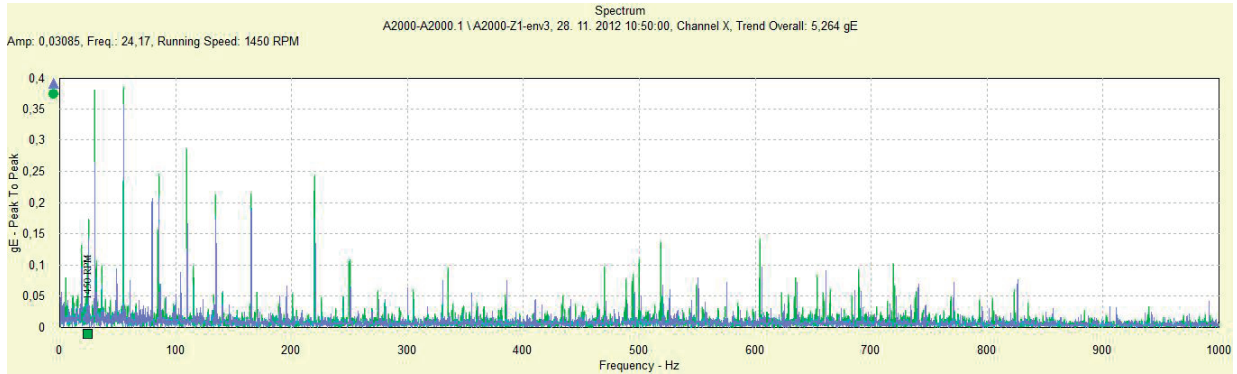
Fig. 8 The comparison of frequency spectra of enveloped acceleration filter 3 for pitting created on half of teeth of sun gear (blue) and for gear damaged by same pitting with one missing tooth (green)

of gear mesh frequency and its harmonic frequencies had higher values compared to pitting damaged sun gear.

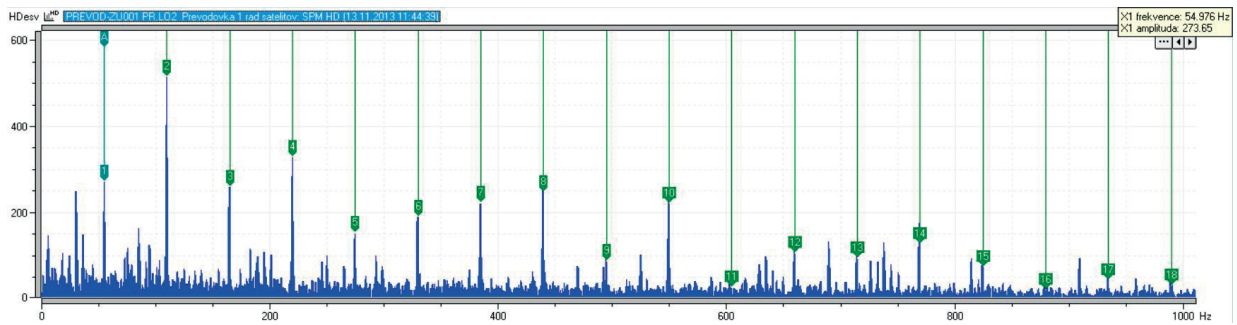
Fig. 9 Frequency spectrum measured by SPM HD method

Frequency spectrum measured by SPM HD method is shown in Fig. 9. Teeth frequency of damaged gear (54.976 Hz) and its harmonic frequencies within spectrum are marked by numbers. Figure 10 contains data measured by enveloped accelerations method filter 3 where teeth frequency (55 Hz) and its harmonic frequencies of damaged gear are also marked by numbers. Spectra

in both figures are very similar with small difference of amplitude magnitude for 6th, 7th and 8th harmonic frequency because these harmonic frequencies have much lower amplitudes with enveloped accelerations method.

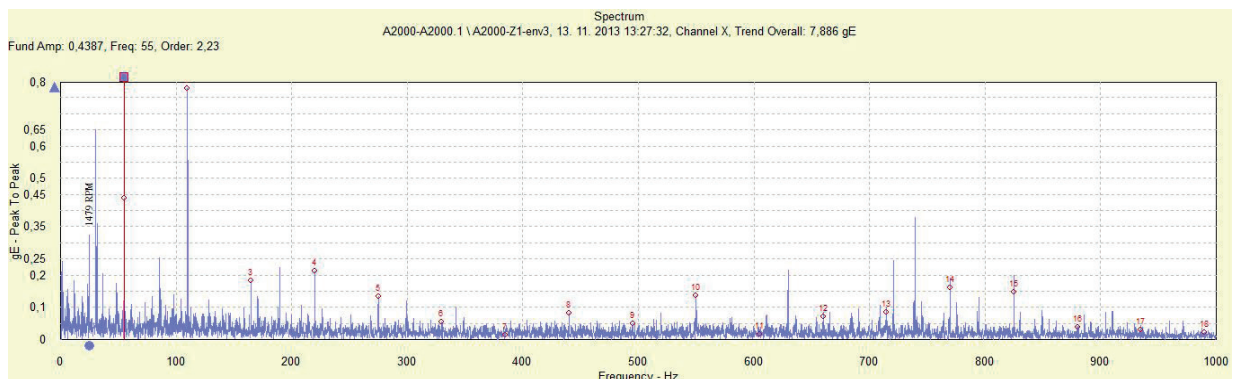
Fig. 10 Frequency spectrum measured by enveloped accelerations method (SKF)

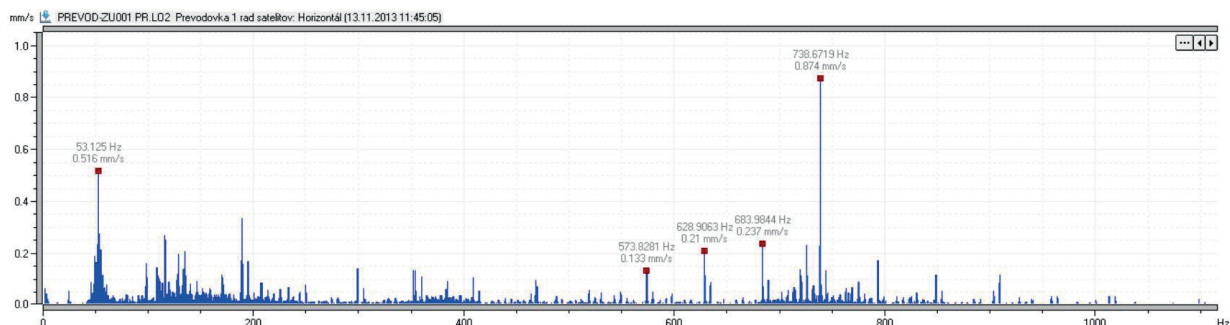
Fig. 11 Frequency spectrum of vibrations velocity measured by SPM Spectrum method

Vibrations velocity frequency spectrum obtained by SPM Spectrum method can be seen in Fig. 11. Spectrum's shape is very similar to SKF methods in direct comparison (Fig. 12), difference

is in amplitude magnitudes. Spectra in both figures highlighted amplitudes of sideband with the spacing of teeth frequency of damaged sun gear (55 Hz) and amplitude of sideband of gear mesh frequency of the first planetary gearing which has high value of amplitude dominating through whole spectrum.

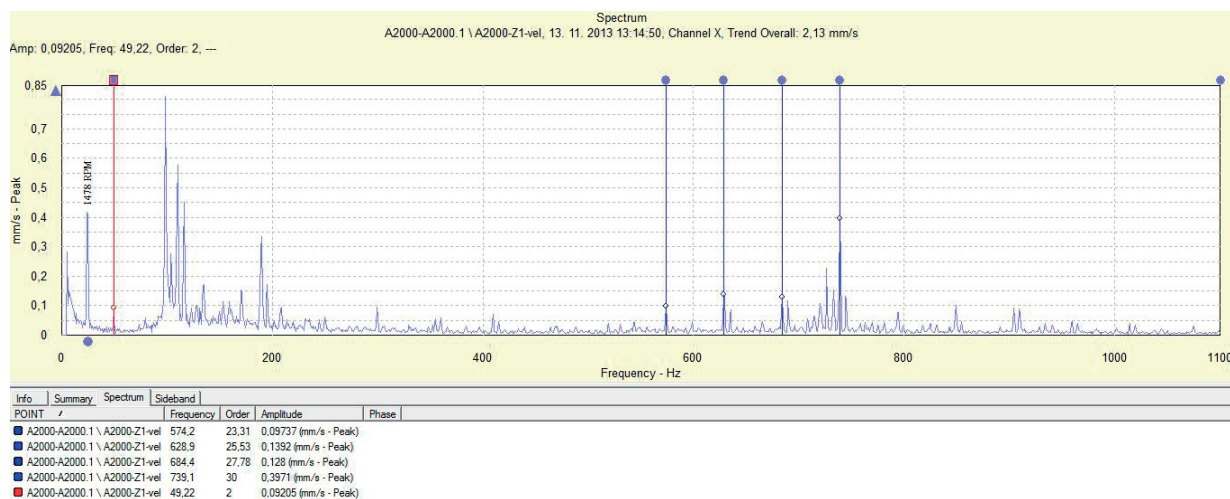
Fig. 12 Frequency spectrum of vibrations velocity measured by SKF diagnostic methods
