CORROSION RESISTANCE OF HSLA STEEL AFTER VARIOUS SURFACE TREATMENTS IN CHLORIDE ENVIRONMENT

The effect of mechanical and chemical surface treatment of high-strength low alloy steel S355J2 on its electrochemical characteristics was investigated by voltamperic tests in corrosive environment of 0.1M NaCl solution simulating sea atmosphere. Mechanical surface treatment was done by grinding on 1200 grit paper and by sandblasting. Chemical surface treatment was performed by iron phosphating in aqueous solution of H_3PO_4 and $FeCl_3 \cdot 6H_2O$. Thermodynamic and kinetic corrosion characteristics including corrosion potentials and corrosion current densities were measured and analysed by potentiodynamic polarisation curves and Tafel analyses respectively. The positive combination of these two techniques on corrosion properties of S355J2 steel surface was reported.

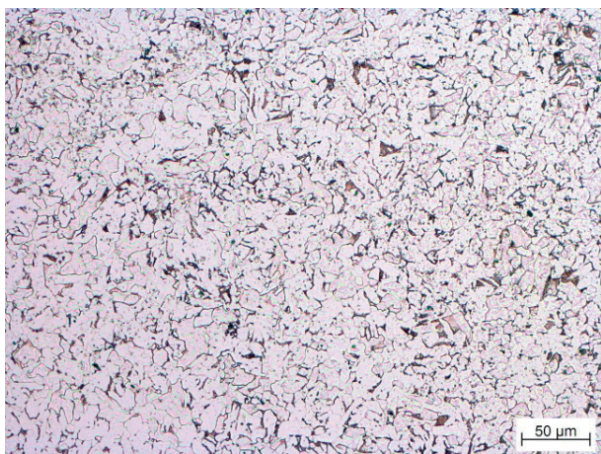
The samples for metallographic observation were prepared by conventional metallographic procedures. 3% Nital was used as an etchant for visualisation of the S355J2 steel microstructure (Fig. 1). The microstructure is created by ferrite-pearlite matrix with a low pearlite content (local pearlite occurrence) and with the grain size of about 10 microns. The microstructure was observed by the CARL ZEISS AXIO Imager.A1m (equipment financed by the project ITMS 26220220121) light metallographic microscope in the laboratories of Department of Materials Engineering, University of Zilina.

Fig. 1 Microstructure of S355J2 steel

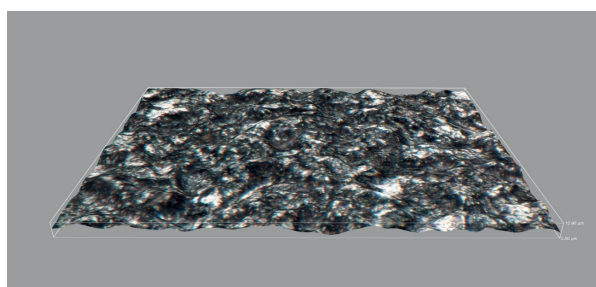
Surface 3D morphology of S355J2 steel after sandblasting is shown in Fig. 2. As can be seen, sandblasting caused mild surface deformation up to 10 microns of depth, which is appropriate in terms of surface roughness increase and surface oxide cleaning.

Fig. 2 Surface 3D surface morphology of S355J2 steel after sandblasting

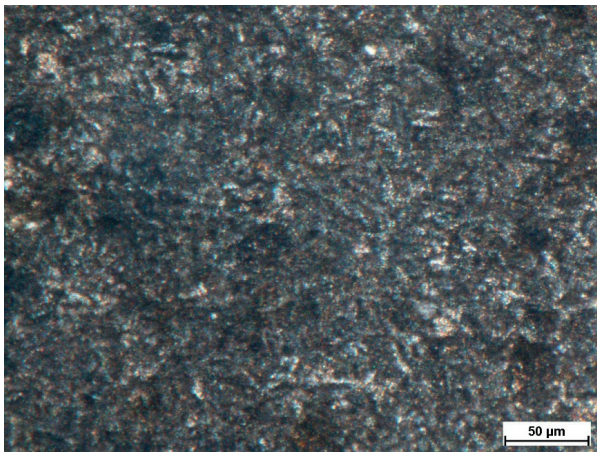
The formation of soluble primary ferrous phosphate leads to a concurrent local depletion of free acid concentration in the solution resulting in a rise in pH at the metal/solution interface. Hence, a certain amount of free phosphoric acid must be present to repress the hydrolysis and to keep the bath stable for effective deposition of phosphate at the microcathodic sites [14 and 15]. The morphology of created iron phosphate is shown in Fig. 3 at maximal magnification of the used microscope. Iron phosphate forms a continuous layer homogeneously covering the entire surface of the base metal in such a way that no evidence of previous grinding process is noticeable on the surface although iron phosphate crystals are of very low size. However, the layer is significantly porous, which is a typical feature of chemically prepared phosphates. This porous character of the layer is beneficial for the further oil or paint preservation of the surface.

Fig. 3 Surface morphology of S355J2 steel after iron phosphating

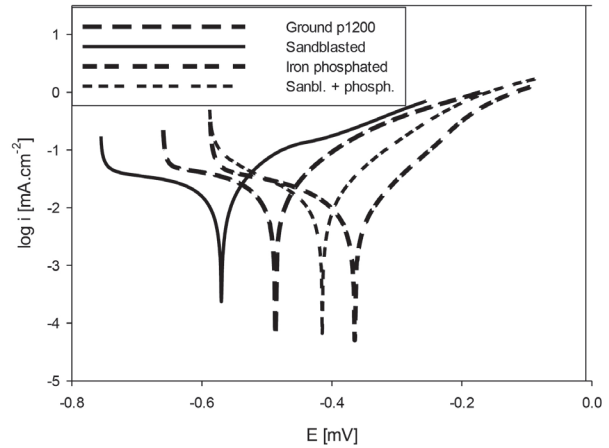
Figure 4 shows the measured potentiodynamic curves of S355J2 steel samples after various surface treatments in 0.1M NaCl corrosive solution. The thermodynamic (corrosion potential) and kinetic (corrosion current density, corrosion rate) characteristics obtained from the measured curves are listed in Table 2.

Fig. 4 Potentiodynamic curves of S355J2 steel after various surface treatments in 0.1M NaCl

Used mechanical and chemical surface treatment caused changes in both thermodynamic and kinetic characteristics of the base material. Thermodynamic stability of the surface is represented by the values of corrosion potentials E_{corr} in our case. More positive value of this electrochemical characteristic means that the surface is nobler and thermodynamically more stable. Sandblasting caused intensive destruction of the surface, which is an accompaniment to its cleaning process purpose. Destroyed surface with a higher concentration of structure defects and with larger area of an active surface resulted in lower electrochemical stability, which is reflected in 83 mV decrease of E_{corr} value in comparison with simply ground surface and sandblasted surface. A part of kinetic energy of sandblasting particles transformed into addition of internal energy of the base material, which caused its absolute value increase. As the result of higher surface activity, an increase of corrosion current density i_{corr} value and directly related value of corrosion rate r_{corr} is observed on sandblasted surface compared to the ground surface. However, this increase is not very significant and represents just 3.2 $\mu\text{A}\cdot\text{cm}^{-2}$ and 0.07 $\text{mm}\cdot\text{y}^{-1}$ respectively. It is a beneficial finding that corrosion resistance decrease caused by intensive sandblasting surface cleaning is acceptable.

stability of iron phosphate in 0.1M NaCl solution compared to the base metal resulted in more positive value of E_{corr} . E_{corr} of iron phosphated surface is moved by 122 mV to nobler values. Thanks to mechanical barrier of iron phosphate the diffusion of oxygen to base metal active surface is more difficult and concentrated mainly to the more porous areas. This complication for kinetics of corrosion process results in decrease of i_{corr} and r_{corr} values too. Corrosion current density of the surface with iron phosphate represents just 47 % of base metal corrosion current density. These findings prove significant positive effect of iron phosphating on corrosion properties of S355J2 steel surface.

Very interesting combination of mechanical and chemical treatment of steel surface leading to preparation of pure and porous surface ideal for further preservation operations also brings positive effect on corrosion properties of S355J2 steel. In this case, positive effect of iron phosphating is more intensive than negative effect of sandblasting, which finally causes the improvement of both thermodynamic and kinetic electrochemical corrosion characteristics of double treated surface compared to simply ground surface with 1200 grit paper. Generally, two processes occur during iron phosphating in the first stage of this chemical treatment. The formation of iron phosphate on the one hand and the active dissolution of the base metal by phosphoric acid on the other hand. This active dissolution plays an important role in our case of sandblasted surface because at least a part of destroyed active surface layer can be removed in this way. However, the corrosion properties of this double treated surface
