Pavol Kohut – Gustav Kasanicky *

EVALUATION OF CRASH TESTS OF THE INSTITUTE OF FORENSIC ENGINEERING, UNIVERSITY OF ZILINA, AIMED AT EES

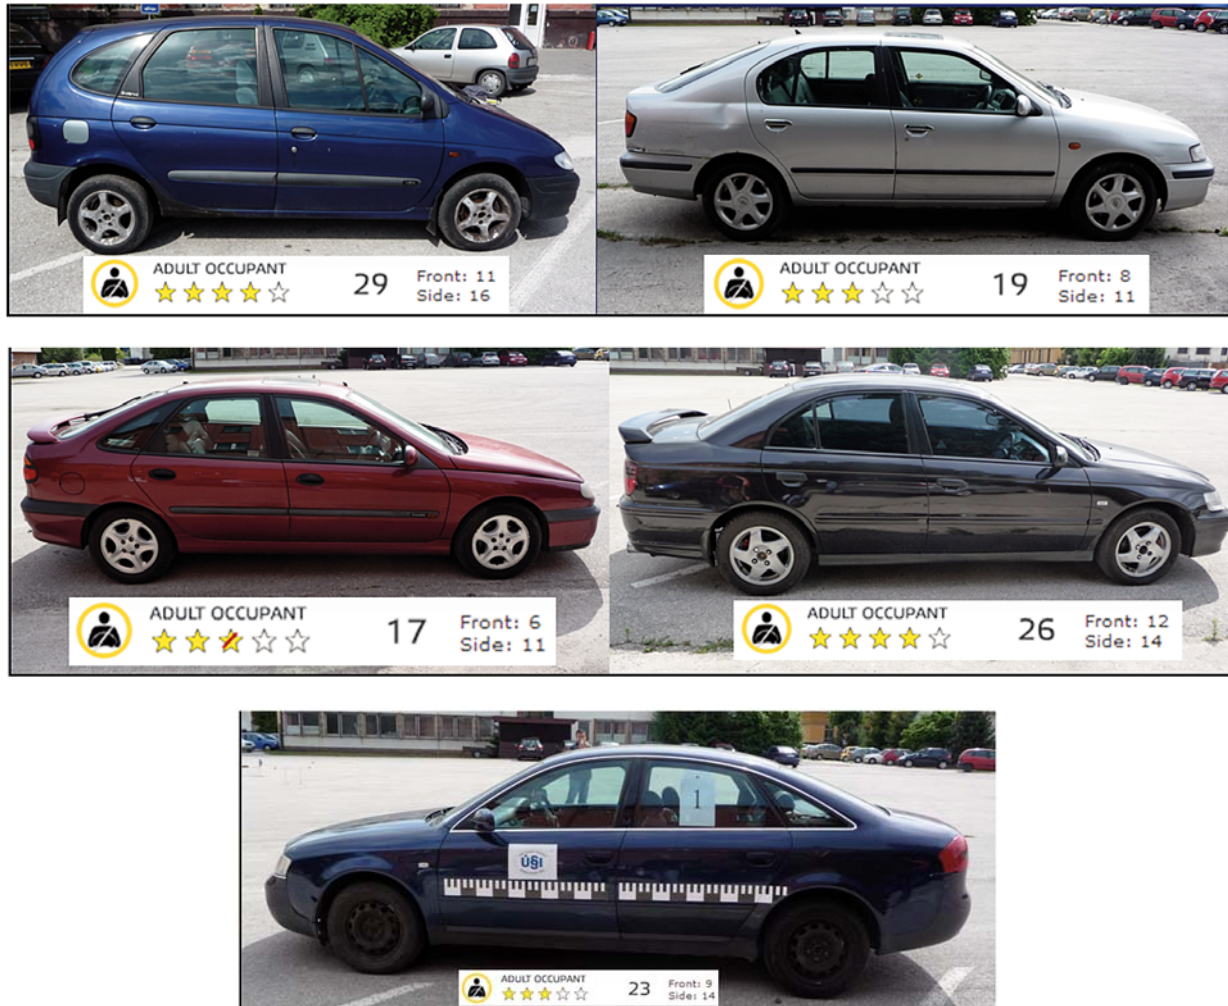
Fig. 1 Photo documentation of passenger cars (before crash test)

Photo documentation of individual vehicles before relevant crash test, including Euro NCAP evaluation of a given vehicle, is shown in Fig. 1.

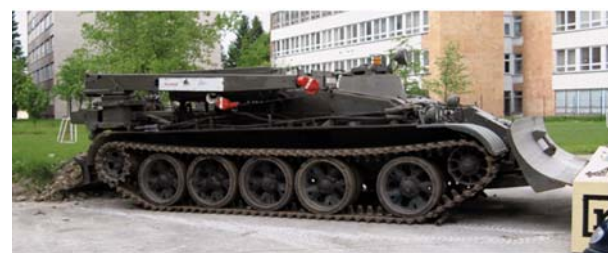
Fig. 3 Recovery tank

But the given weight of the barrier was not sufficient to ensure a condition that no significant displacement of the barrier occurs, and therefore, the barrier was fixed using a blade of a recovery tank of weight 35,000 kg (see Fig. 3).

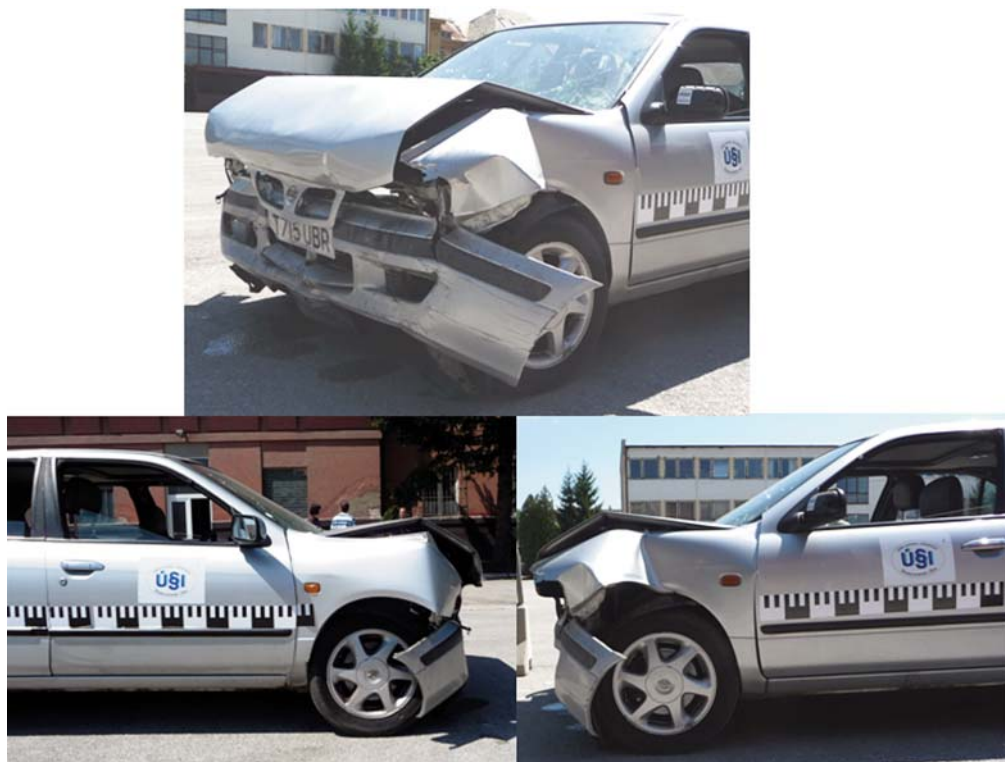
Fig. 4 Damage of the car Nissan Primera (EES = 54 km/h)

The following photos show (Figs. 4, 5, 6, 7 and 8) the damage to the vehicles after given crash tests, while in the description of the photo is always included the EES value, corresponding to the given damage.

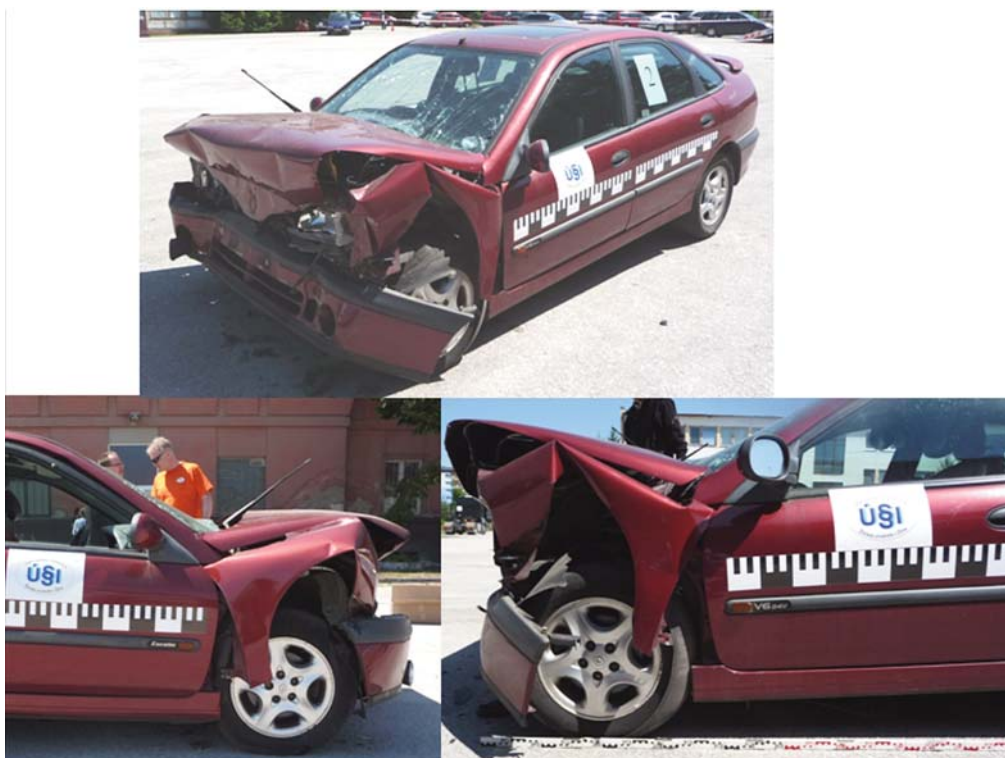
Fig. 5 Damage of the car Renault Laguna (EES = 62 km/h)

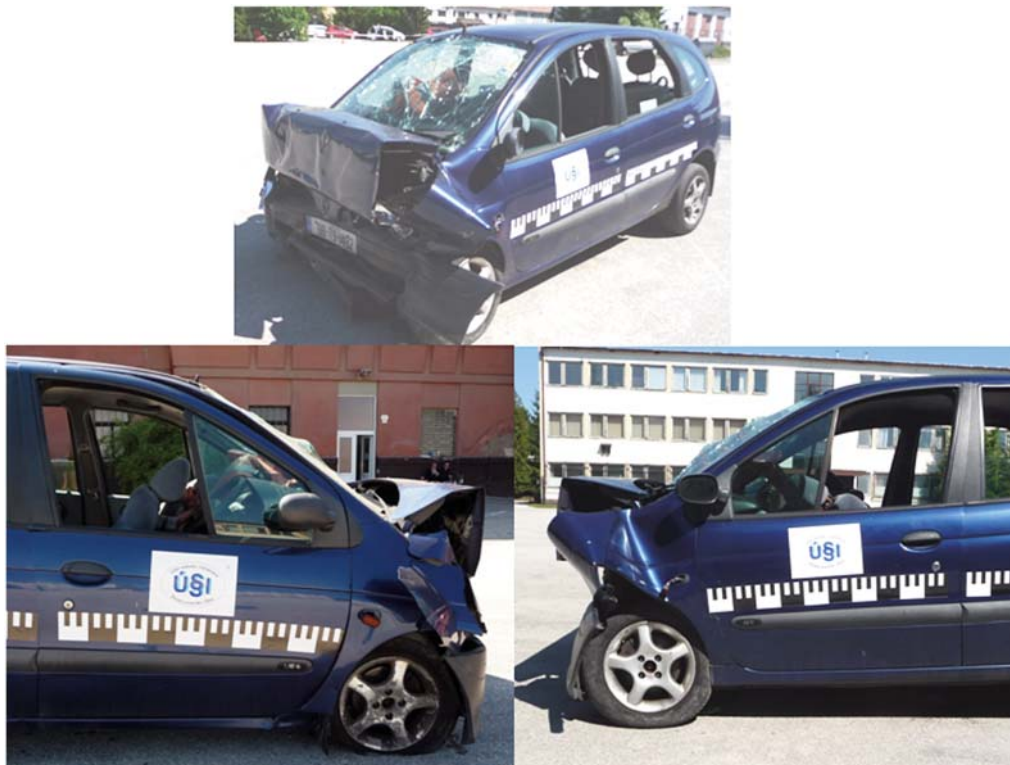
Fig. 6 Damage of the car Renault Megane Scenic (EES = 72 km/h)

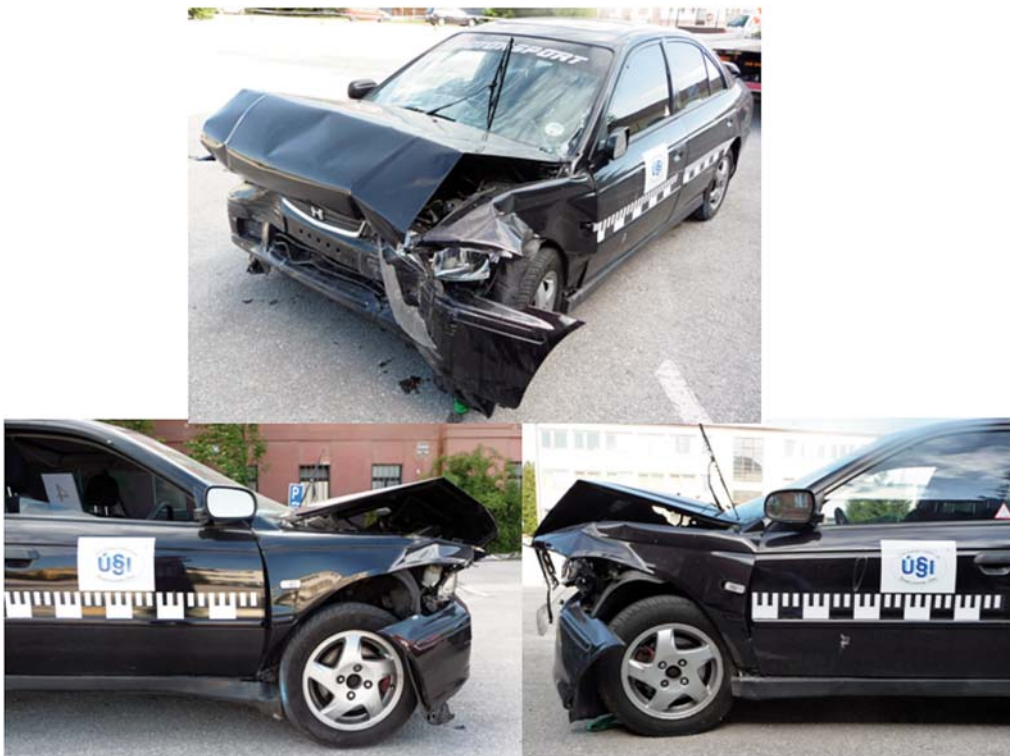
Fig. 7 Damage of the car Honda Accord (EES = 58 km/h)

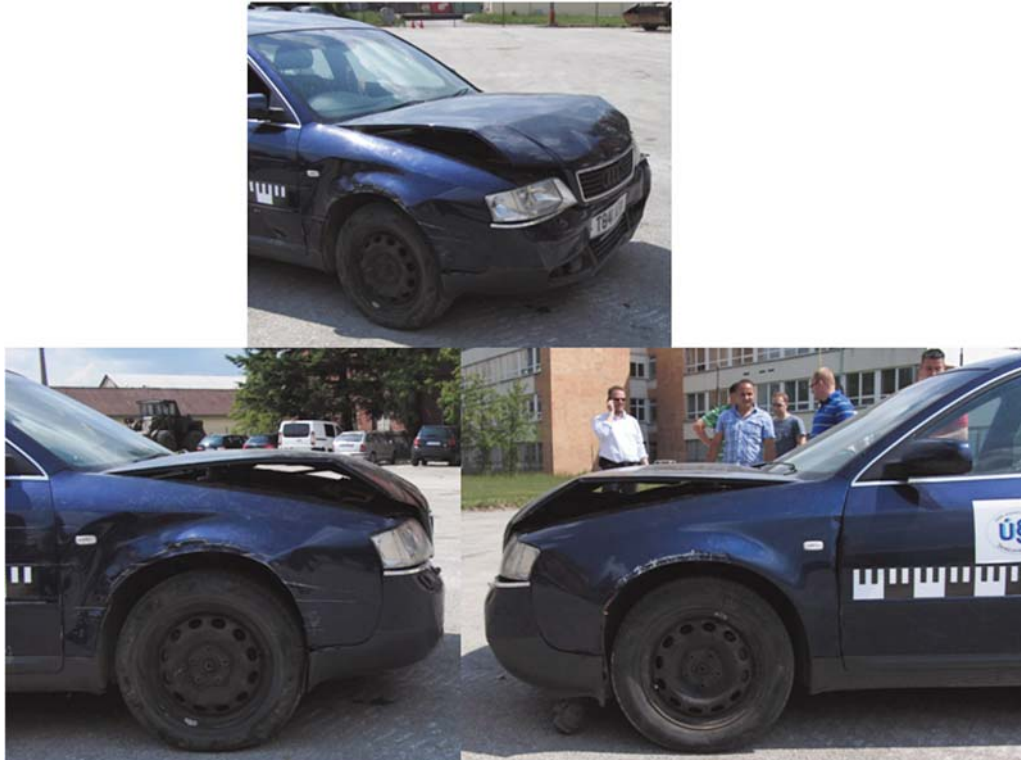
Fig. 8 Damage of the car Audi (EES = 18 km/h)

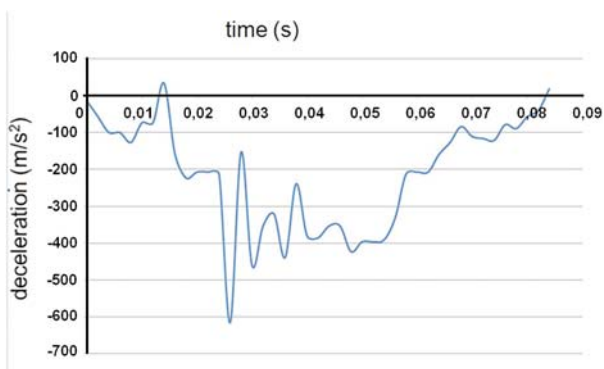
Fig. 9 Time - deceleration diagram

The course of a vehicle deceleration was captured by the crash meter, while the time-dependent course of Renault Laguna vehicle deceleration is shown in Fig. 9.

In Fig. 9 above is recognizable considerable oscillation caused by the natural frequency of the measuring device, by a fixing method of the measuring device, as well as by the oscillation of the measuring point (trunk floor of the vehicle) during the impact. For further evaluation it was therefore necessary to filter out the resulting oscillation, and thus the time-dependent course of decel-

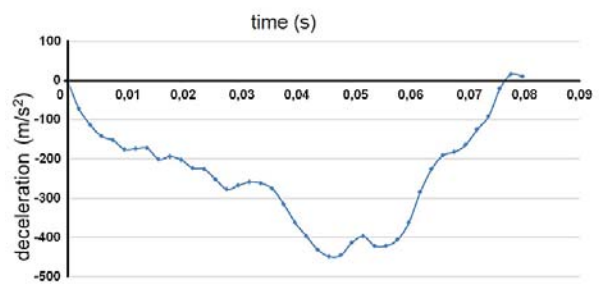
Fig. 10 Time - deceleration diagram (Renault Laguna)

eration of the given vehicle was obtained (for each vehicle). In Fig. 10 the filtered course for Renault Laguna vehicle is shown.

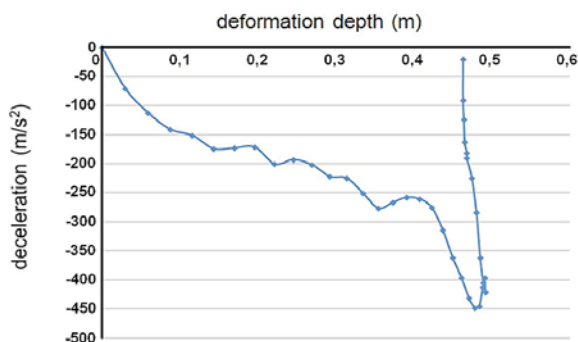
Fig. 13 Deformation depth - Deceleration diagram (Nissan Primera - EES = 54 km/h)

Consequently, from the obtained data of the path and deceleration a path-deceleration diagram was constructed (during the tests). In Figs. 11, 12 and 13 the individual diagrams for the tested vehicles are shown. For Renault Megane Scenic vehicle, the crash meter broke down and the correct record was not captured.

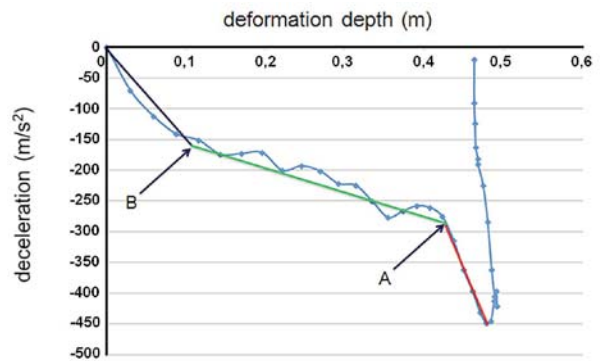
Fig. 14 Deformation depth - Deceleration diagram (Nissan Primera - EES = 54 km/h)

In all three diagrams the course of deceleration depending on the deformation depth can be divided into three approximately linear areas with characteristic points A and B (see Fig. 14).

1. The position of point B (approximately 0.1 m and 150 m/s^2) is almost identical for all three vehicles (Nissan Primera, Honda Accord and Renault Laguna).
2. The position of point B in terms of achieved deceleration (approximately 300 m/s^2) is almost identical.
3. The position of point B in terms of deformation depth is similar for the vehicles Honda Accord and Renault Laguna (about 0.53 meters), and different in comparison to the vehicle Nissan for about 0.43 m.

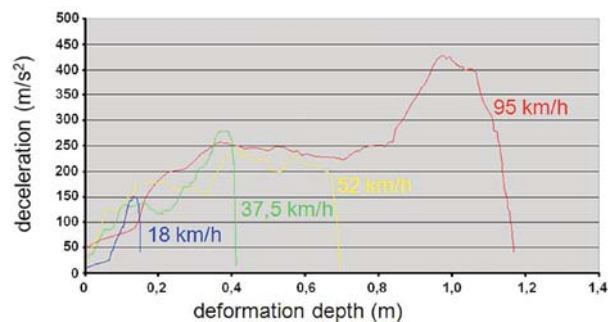
Fig. 15 Deformation depth - Deceleration diagram (Ford Escort - DSD LINZ 1996)

For comparison of the presented diagrams with an older generation of vehicles an analogous procedure with 4 crash tests of a Ford Escort vehicle was performed. It was executed by the company DSD LINZ (Austria) in 1996 [1]. The given courses and impact velocity for a given crash test are shown in Fig. 15.

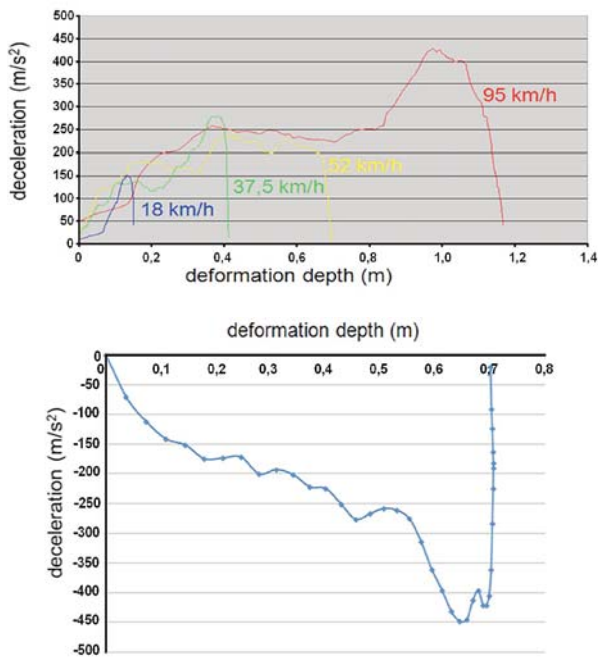
Fig. 16 Comparison Deformation depth - Deceleration diagrams of cars Ford Escort (Crash tests DSD LINZ 1996) and Renault Laguna (Crash tests Institute of Forensic Engineering, University of Zilina 2012)

ufacture about 1986) versus crash tests performed by the Institute of Forensic Engineering, University of Zilina (see Fig. 16) it can be stated that for the vehicles produced around 2000, there is almost a linear increase between the points marked as A and B. Consequently, from point B there is a significant increase of deceleration which means a significant increase of stiffness at the deformation depth of 0.5 m.

For the vehicles Ford Escort an area could be identified where the deceleration was almost constant within a relatively large range of the deformation depth. Such effect was not detected for the vehicles tested by the Institute of Forensic Engineering, University of Zilina. A significant increase of deceleration (and hence stiffness) for the vehicles Ford Escort occurs only at the deformation depth of about 0.85 m.

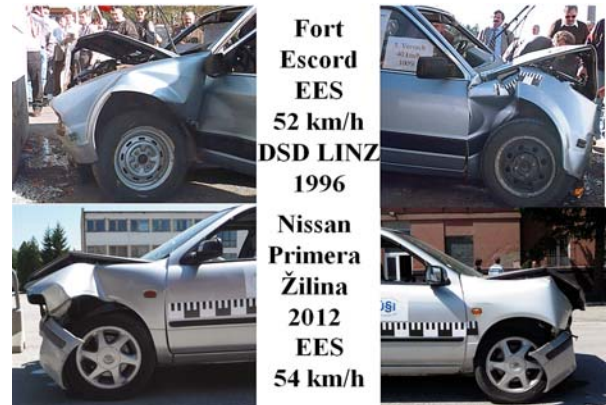
Fig. 17 Comparison damage of cars Ford Escort (Crash tests DSD LINZ 1996) and test car Nissan Primera (Crash tests Institute of Forensic Engineering, University of Zilina 2012) [2]

difficult to properly identify the EES of the given vehicle (under conditions where EES exceeds 50 km/h) versus the older generation of vehicles (which were subject of tests - Crash tests DSD LINZ 1996). This is due to the significantly different course of deceleration and, therefore, also due to the course of stiffness of vehicles, at crash velocities above 50 km/h. Such difference is evident also from the comparison of the extent of damage, as shown in Fig. 17.

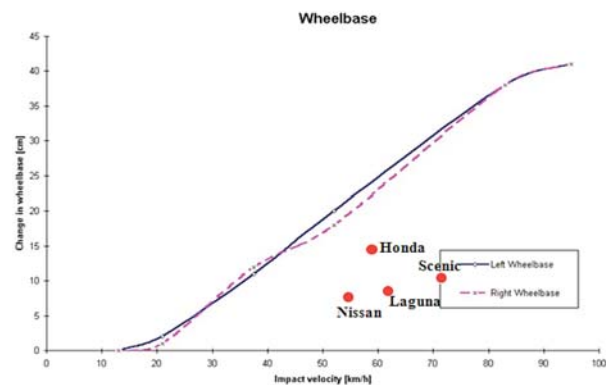
Fig. 18 - Comparison Change in wheelbase for cars Ford Escort (Crash tests DSD LINZ 1996) and for test cars Honda Accord, Nissan Primera, Renault Laguna and Renault Megane Scenic (Crash tests Institute of Forensic Engineering, University of Zilina) [2]

The significant difference between the vehicles Ford Escort and vehicles tested by the Institute of Forensic Engineering, University of Zilina is reflected also in terms of dependency of a shorter wheelbase and impact velocity (see Fig. 18).
